Damage survey after The 2016 Kumamoto Earthquake

-Confirmation of tough Implant structure-

Dr. Tadahiko Okumura

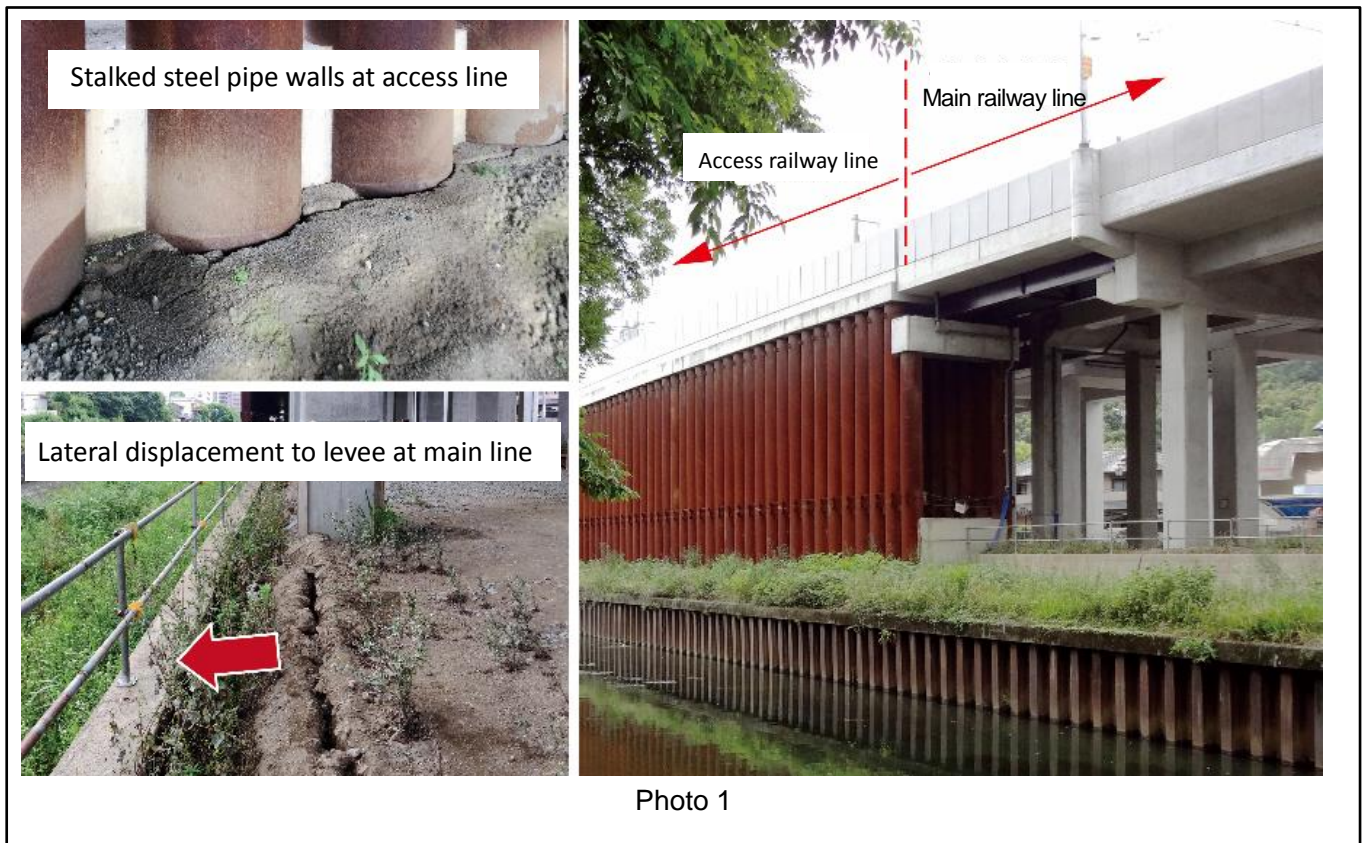
Photo 1

The typical example of earthquake damages is a viaduct construction site of local railway and Kyushu Shinkansen (Bullet train) between Fukuoka Prefecture and Kagoshima Prefecture near Kumamoto station of JR Kyushu Railway Company. The slight cracks on the ground surface in access railway line were investigated at the site of continuous steel pipe walls of diameter 800 mm. However main body of Implant structures had no damage, though levee walls and soils adjacent to main railway line deformed largely laterally (See photo 1).

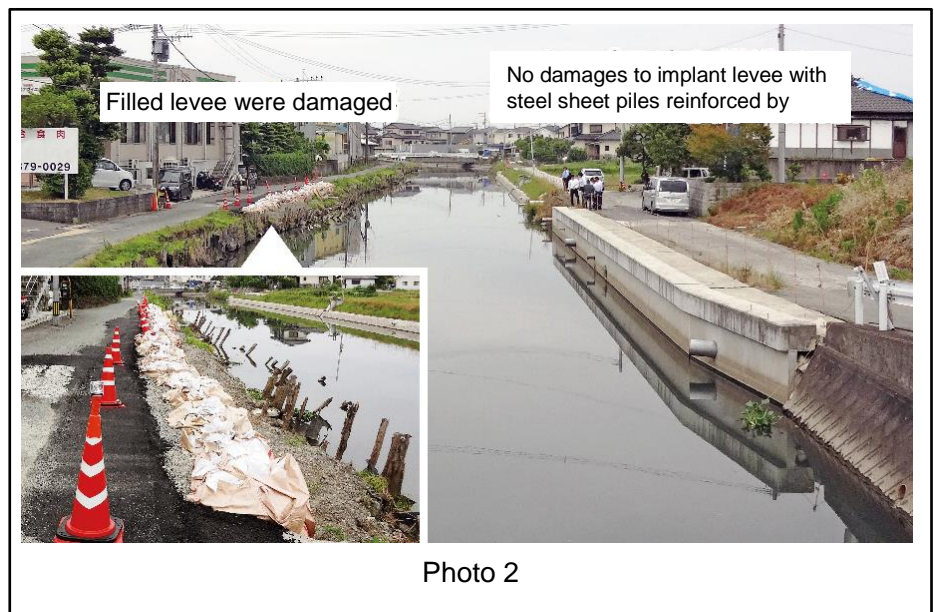
Photo 2

At the discharge channel sites in east area in Kumamoto Prefecture, there were no damage at the levees reinforced by concrete sheet piles and embankment levees have some damages (See photo 2).
