# Steel Pipe Piles, Tubular Sheet Piles, Steel Sheet Piles Confronting Natural Disasters

Toshiharu Hirose

Japanese Technical Association for Steel Pipe Piles and Sheet Piles (JASPP)

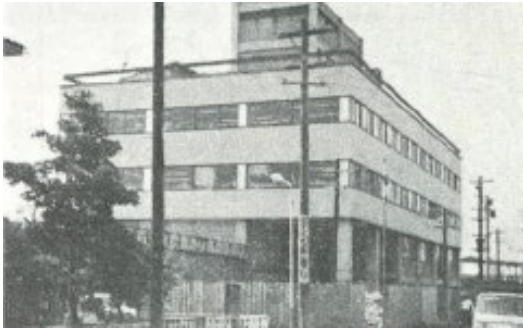
The Niigata Telecommunications Department Office Building (Photo 1.1) suffered damage with a maximum subsidence of 530 mm and a maximum tilt of 1/40 to 1/50, but no harmful cracks were found in the structure.

Photo 1.1 Niigata Telecommunications Dept. Office Building<sup>1)</sup>

In this case of building restoration, in addition to the following reasons: (1) there was no damage that might hinder its continued use, (2) it was not desired to spend the cost of newly rebuilding it, (3) similar re-damage should be avoided, considering the construction cost and construction period, a method was adopted in which "as a structure to support the building, steel pipe piles were to be pressed into the foundations of the columns to raise the building horizontally". For the restoration, while using the second floor and above of the building, steel pipe piles with a length of 1.0m were added, and the number of steel pipe piles corresponding to the column load were pressed in with a jack. Concrete was placed on the top of the pile, which was used as a jack fulcrum when raising the building (Fig. 1.1).

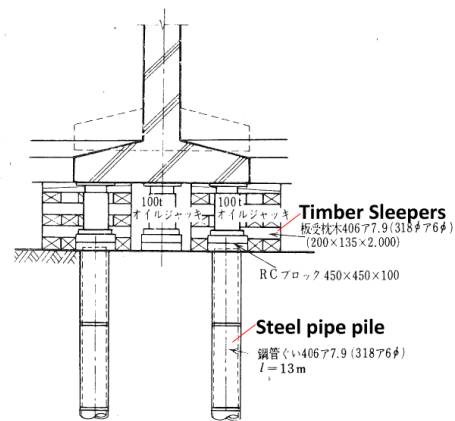
Fig. 1.1 Detailed Drawing of Leveling<sup>1)</sup>

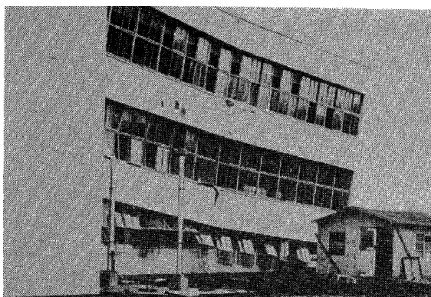
Photo 1.2 Damaged building of Misawa Commercial High School<sup>2)</sup>

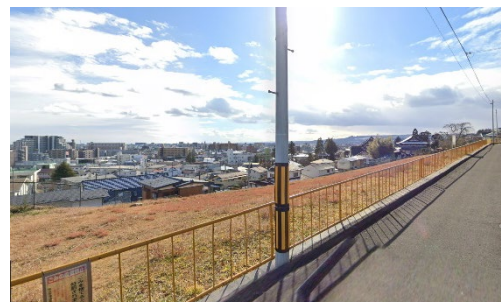
Photo 1.3 Affected area in Sendai City<sup>3)</sup>

In this earthquake, excavation surveys were actively carried out on the foundation piles of building structures, and it was clarified that (1) PC piles (prestressed concrete piles), especially AC piles (high-strength concrete piles), were significantly damaged, (2) in the case of the buildings which had damaged piles, the ground was not extremely soft, but slightly soft. On the other hand, in the hilly residential area near the center of Sendai city built after 1960, many landslides occurred on the embankment. It was reported, however, that there happened no damage from the Tohoku-Pacific Ocean Earthquake that occurred later in March 2011, in the area where the collapsed land had been turned into a green space and a concrete leaning retaining wall had been constructed with a steel pipe pile foundation that also had served as an earth retaining wall, as a restoration method. (Photo 1.3).

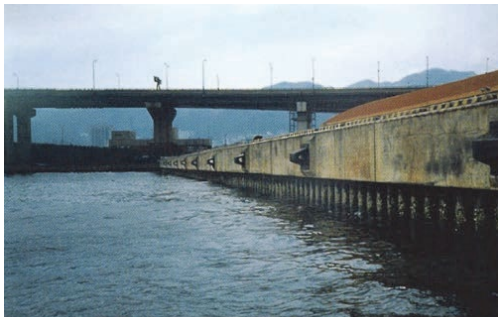
Photo 1.4 West side of Maya Wharf<sup>6)</sup>

At Port Island and Rokko Island, gravity caisson quays suffered severe damage, while pier structures suffered minor damage. “The Maya Wharf No. 1 Jetty West Quay (Photo 1.4)” was a seismic revetment with a horizontal design seismic intensity of 0.25. In the vicinity of the base of this jetty, a counterweight fill was placed on the sea side of the existing steel plate cell foundation, and further, a double-layer structure was adopted with a new quay-wall of steel pipe sheet piles with battered piles installed (Fig. 1.2). In addition, the tip of the pier had a very solid double-foundation quay with a steel plate cell on the land side and a caisson on the sea side, and although there were some cracks in the concrete due to uneven subsidence at the connection part between the horizontal pier and the caisson, there was no functional problem after the disaster.

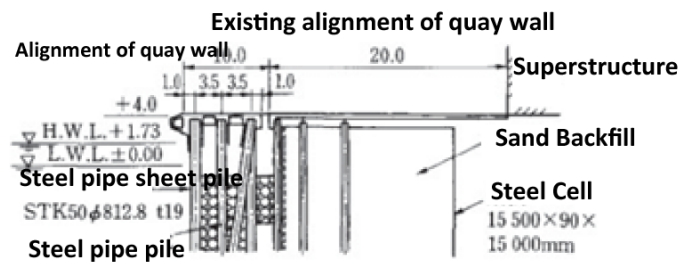
Fig. 1.2 Foundation of the west side of Maya Wharf<sup>7)</sup>

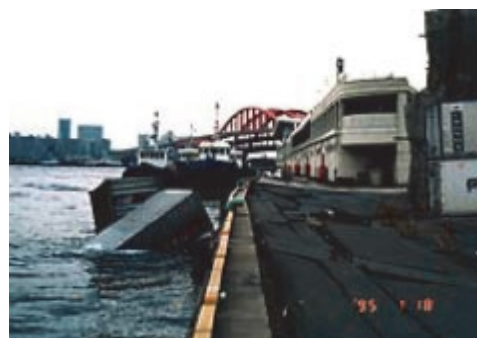
Photo 1.5 Shinko No.4 Pier (-12m quay)<sup>8)</sup>

Shinko Pier No. 4 (-12m quay) (Photo 1.5), located at the base of the Shin-Kobe Ohashi Bridge leading to Port Island, had been used as an international passenger berth. Regarding the restoration method, as there were constraints because it was in the water area in front of the slip (between jetties), and the shed was close behind, a method was adopted in which steel pipe sheet piles were to be placed in front of the existing caissons, and underwater concrete was to be filled between them.

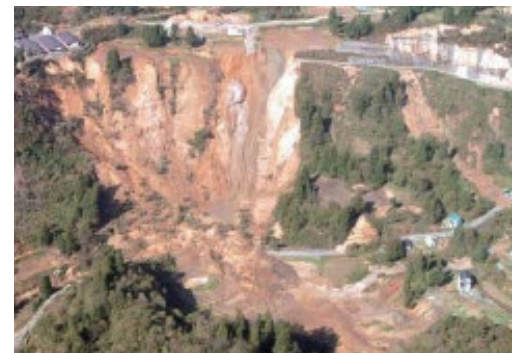
Due to the rainfall caused by the typhoon that had passed three days before the earthquake, landslides occurred one after another on the slopes of the hills. In the former Yamakoshi Village, houses collapsed with earth and sand (Photo 1.6), and there was damage caused by the outflow of irrigation water from Nishikigoi farming ponds making use of terraced rice fields. In mountainous tributaries, collapsed sediment clogged river channels, forming natural dams that cut off traffic routes, leaving many communities isolated.

Photo 1.6 Landslide at Former Yamakoshi Village<sup>9)</sup>

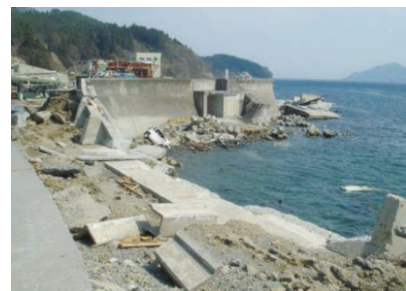
Photo 1.8 Seawall damage at Sanriku Town, Ofunato city<sup>10)</sup>

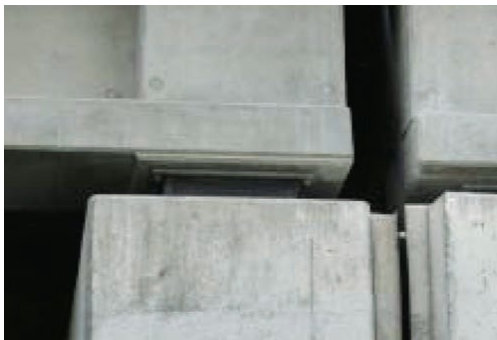
Photo 1.9 Bearing deformation<sup>11)</sup>

No major deformation was found in the main bodies of the bridge foundations, except for the bridges whose superstructure and substructure were washed away by the tsunami. As for the bridges that were washed away, it was assumed that the damage to the foundations themselves due to the seismic motion was minor. As damage to the foundation bodies due to the earthquake motion, although some deformation of the bearings and cracks on the embankment slopes at the abutments were confirmed, no major deformation was confirmed in the foundation bodies, and they were found almost sound (Photo 1.9).

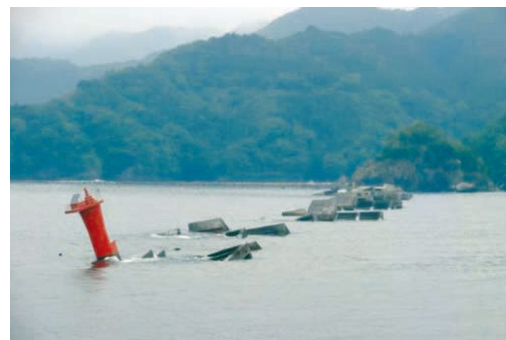
Photo 1.10 Damage to Kamaishi Bay mouth breakwater<sup>10)</sup>

The post-earthquake tsunami caused major damage to breakwaters and seawalls in many areas of the Tohoku region, including collapse, etc. (Photo 1.10), but damage to quay walls and seawalls was limited.

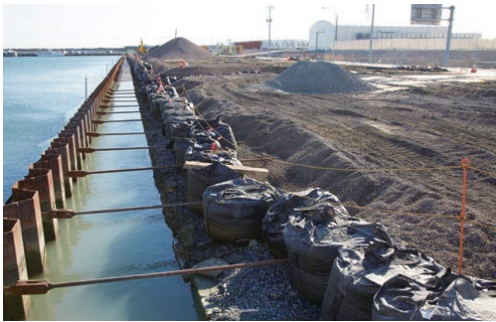
Due to crustal movement and liquefaction caused by the earthquake, the entire fishing port area settled by approximately 1.3m (average value), and various facilities such as piers and wharves were destroyed or damaged by flooding. The designed water deep -7m quay (extension 270m) and -6m quay (extension 700m) settled about 1.15m in the entire area, and the head of the steel sheet pile in front of the revetment was pushed out to the sea side with a maximum of 46 cm in and out of the sheet pile normal line. Also, the apron collapsed and was constantly submerged.

Photo 1.11 New Installation of steel sheet piles of designed water depth - 7m quay<sup>13)</sup>

While restoring the original shape, a design was made for the purpose of raising the height of the subsidence, and regarding the steel sheet piles that caused the normal deviation, new sheet piles were installed slightly forward the existing sheet piles (Photo 1.11). A new steel pipe pile was also installed for the H-shaped steel that had collapsed in the existing apron. A steel sheet pile was driven at 1.7m forward the normal line to the old revetment, Steel piles with 600 mm in diameter and 12 to 17 m in length were driven into the apron area, and the front steel sheet piles were tied with about 13m long tie rods to serve as an anchor (Fig. 1.3).

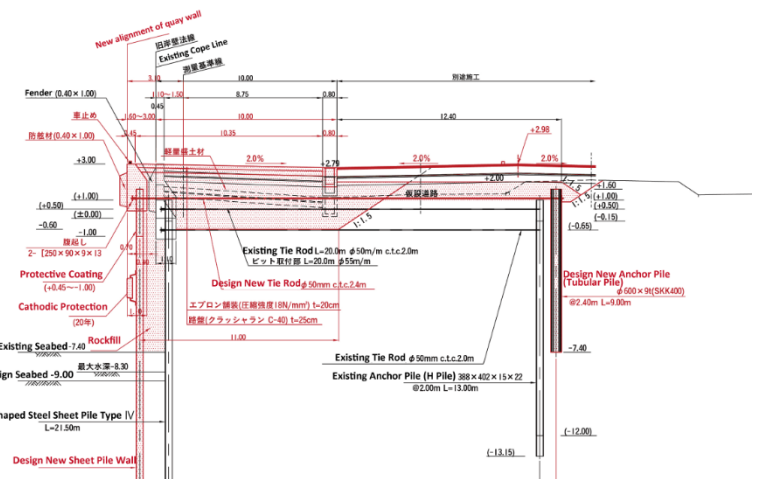
Fig. 1.3 Designed water depth - 7m quay wall restoration standard cross section<sup>13)</sup>

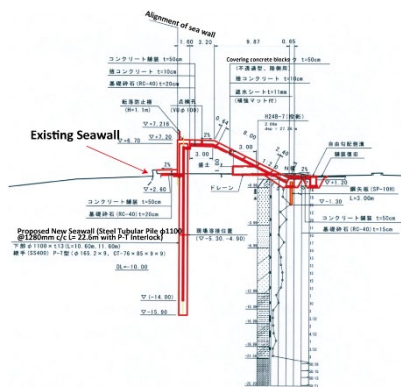
An upright concrete embankment with TP (Tokyo peil) + 3.3 to 3.5m, which was built in the 1960s and 1970s, settled by approximately 1m due to the earthquake, and besides, the front of the seawall was scoured by the tsunami surge and collapsed during the undertow, resulting in two levee breaches.

Fig. 1.4 Ishinomaki Port Higashihama coastal seawall standard cross section<sup>14)</sup>

A new seawall was decided to be constructed as a disaster recovery project, and a plan of an upright embankment with an embankment structure of continuous self-supporting tubular sheet piles with a height of TP + 7.2m was adopted (Fig. 1.4). A normal coastal embankment required a slope on the sea side in order to ensure the specified strength without affecting the harbor road behind it, so a relatively expensive construction cost and a long construction period were issues. For this reason, a continuous wall made of self-supporting tubular sheet piles was adopted as an upright embankment on the sea side which also would be able to suppress lateral flow during liquefaction (Photo 1.12).

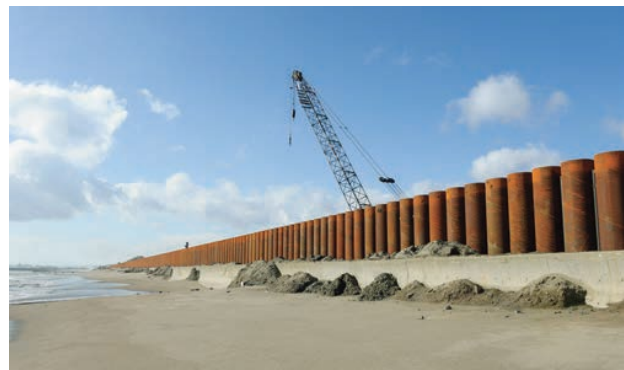
Photo 1.12 Installation of tubular sheet piles on the Higashihama coastal embankment of Ishinomaki Port<sup>14)</sup>

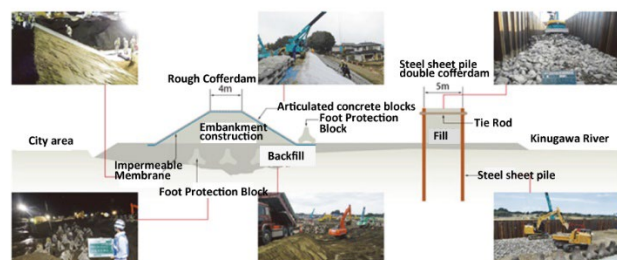
Fig. 2.1 Rough cofferdam, steel sheet pile double cofferdam/standard sectional view<sup>16)</sup> (Provided by Kanto Regional Development Bureau, Ministry of Land, Infrastructure, Transport and Tourism)

The restoration work for the collapsed levee was carried out for two weeks as an emergency restoration by means of a rough cofferdam and steel sheet pile double cofferdam (Fig. 2.1). After that, in January 2016, during the non-flood season, the main restoration work was started. After removing the rough cofferdam and the steel sheet pile double cofferdam that had been constructed during the emergency restoration work, the embankment foundation was replaced, impermeable steel sheet piles were installed to prevent water leakage thorough embankment, and the embankment and bank protection work was carried out and completed at the end of May.

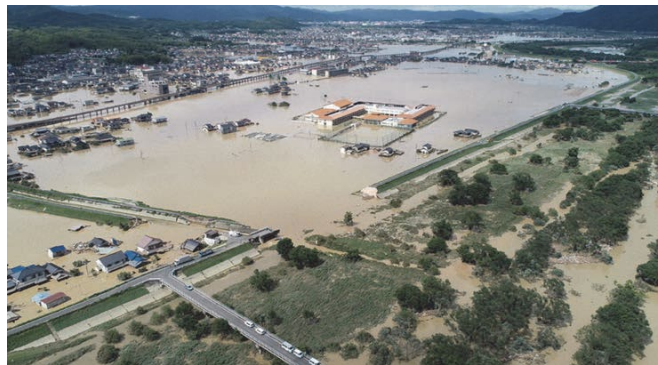
In Mabi-cho, Kurashiki City, Okayama Prefecture, low-lying land spreads at the confluence of the Oda River and the Takahashi River, and there often occurs flood damage due to the backwater phenomenon. Although it was an area with high flood risk, urbanization was progressing rapidly with the development of railways and roads. In the Oda River, which was affected by the Takahashi River whose water level rose because of the heavy rain, the backwater phenomenon caused the embankment to burst for about 100m at the confluence region with the Takama River. In addition, there occurred embankment collapses at 8 spots, and the water overflowed at 4 spots, flooding an area of 1,200 ha and flooding 4,600 houses (Photo 2.2). The turbid current that flowed into the floodplain surrounded by the embankments of the Takahashi River and the Oda River had no place to escape in the closed area, and the maximum inundation depth reached 5m. Many residents were unable to escape, and 51 people died.

Photo 2.2 Collapsed Odagawa embankment<sup>18)</sup>

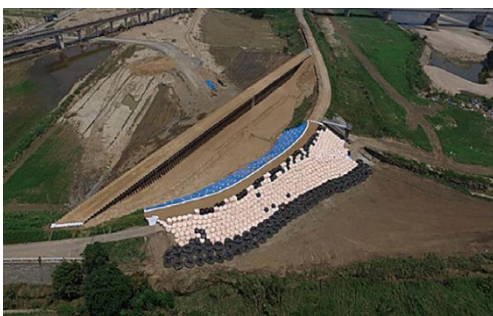
Photo 2.3 Double cofferdam of steel sheet piles driven 24 hours a day<sup>18)</sup>

The Oda River's emergency countermeasure work consisted of rough coffering of the embankment where it had collapsed using sandbags and sheets. After that, a steel sheet pile double cofferdam was constructed behind the rough cofferdam in order to construct a temporary embankment for temporary use. The construction of the steel sheet piles was carried out around the clock (Photo 2.3), and the emergency work was completed in a total of 14 days (Photo 2.4).

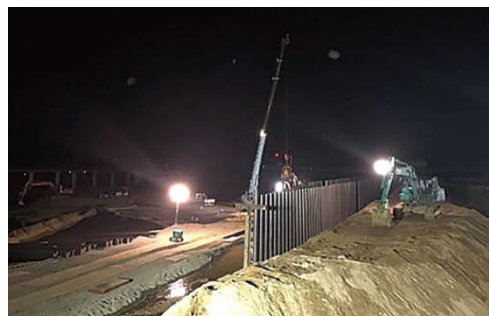
Photo 2.4 Completion status of steel sheet pile double cofferdam<sup>18)</sup>
