Field reconnaissance insights from the 2024 Noto earthquake

ABSTRACT

Key words: 2024 Noto earthquake, reconnaissance, Sheet pile, Liquefaction, Landslide

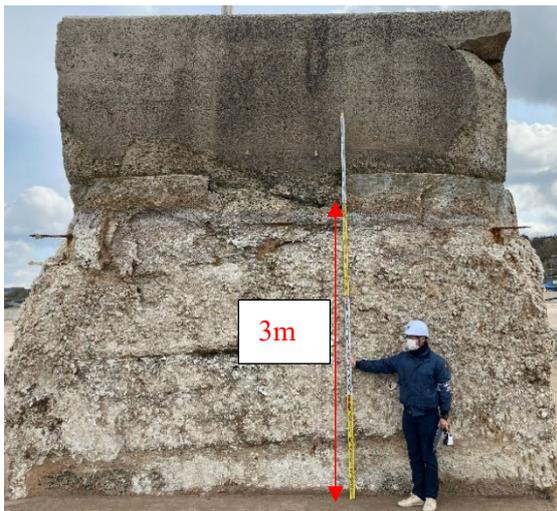
The 2024 Noto Peninsula Earthquake significantly altered the region's coastal landscape. SAR intensity images captured by the ALOS-2 satellite before and after the earthquake show extensive land emergence, particularly around Minazuki Bay, where the coast extended seaward by about 200m. This was due to a substantial uplift of approximately 4m in the region. Utilizing both satellite imagery and aerial photography, it was estimated that a total of 4.4 km² of new land was exposed along the coasts of the Noto Peninsula. **Fig. 5a** depicts a section of a concrete wall at Kuroshima Port in Wajima, which was raised nearly 3m. **Fig. 5b** illustrates the near-vertical and east-west directional deformation of the Earth's crust.

Fig. 5 (a) Coastal crust uplift at Kuroshima Port in Wajima **(b)** Crustal deformation distribution map (Modified from GSI crustal deformation Map, 2024)

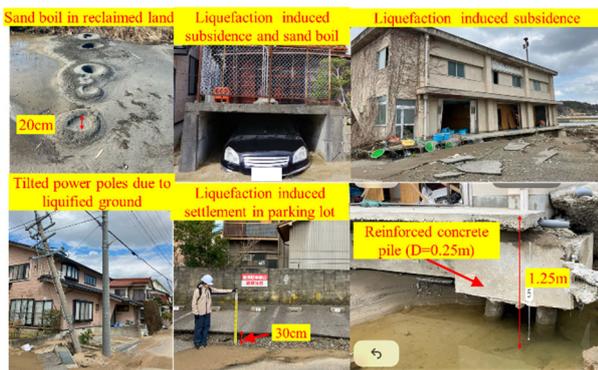
Fig. 9b illustrates examples of free-field liquefaction sites (such as farmlands) where volumetric soil settlement and sand boils were observed. Liquefaction of reclaimed lands behind waterfront structures in ports was also observed in all previously mentioned regions.

Fig. 9. (a) Liquefaction Susceptibility map (NIED, 2024) (b) Liquefaction induced subsidence

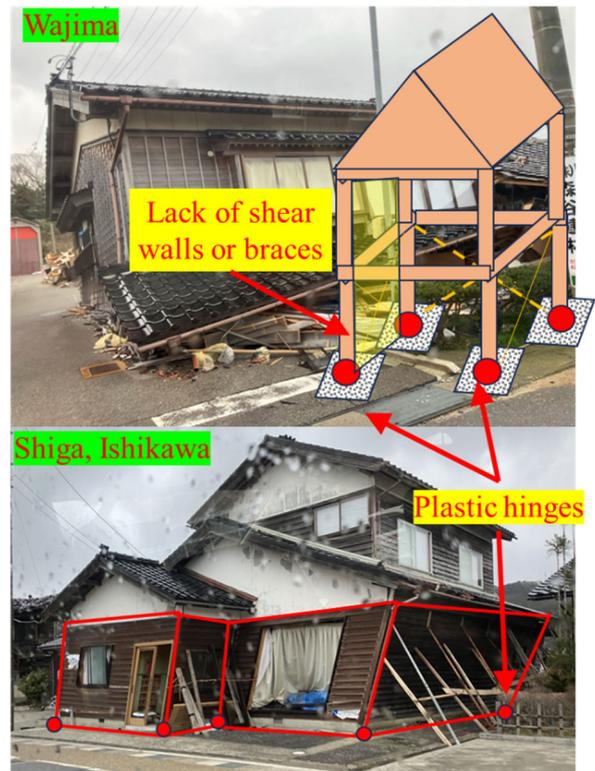
Field observations indicated that wooden houses in Suzu, Wajima, and Noto experienced partial damage or complete collapse during the Noto earthquake (**Fig. 10**).

The primary failure mechanism was the hinging of wooden columns at the base and at the connections between the first and second floors, triggered by significant horizontal displacement and inertial forces. Since seismic forces acting on structures are proportional to their mass, the heavy weight of the roofs and the uneven distribution of dead loads appear to have exacerbated the extent of the damage.

Moreover, the absence of shearing walls or braces, which features like Implant™ structures in the form of sheet piles (Kondo et al., 2023) could provide, is another contributing factor to the potential damage.

Fig. 10 Examples of Wooden structures destruction

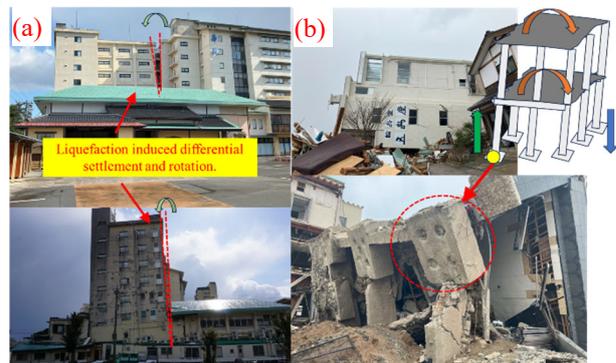
Field observations indicate that reinforced concrete (RC) buildings generally exhibited good stability, with the majority sustaining minimal or no damage due to the presence of shear RC walls and pile foundations. However, there were instances where RC buildings sustained damage due to differential settlement and rotation following the onset of liquefaction or a significant loss of soil shear strength, which undermined the foundation's bearing capacity (see Fig. 11a).

An illustrative case is a seven-story RC building constructed in 1972 (see Fig. 11b) with centrifugal RC piles designed (JGS Report on 2024 Noto Earthquake) according to the 1968 Japanese Industrial Standards (JIS). This building experienced extreme subsidence on one side and uplift on the other, causing it to tip over.

Fig. 11b shows that the pile caps were separated from the pile bodies due to insufficient uplift resistance (axial capacity). The piles had an outer diameter of 35 cm and an inner diameter of 20 cm. To fully understand the overturning mechanism, an in-depth underground

investigation through excavation is necessary. For now, it can be inferred that the axial uplift capacity was likely exceeded. Considering that concrete's tensile strength is approximately 10% of its compressive strength, and once the concrete cover cracks, the pile can no longer bear any load. Therefore, steel piles might be a more viable option if the pile head connection is properly executed.

Fig. 11 (a) Liquefaction induced differential settlements and rotation (Wajima) (b) RC building collapse (Wajima)

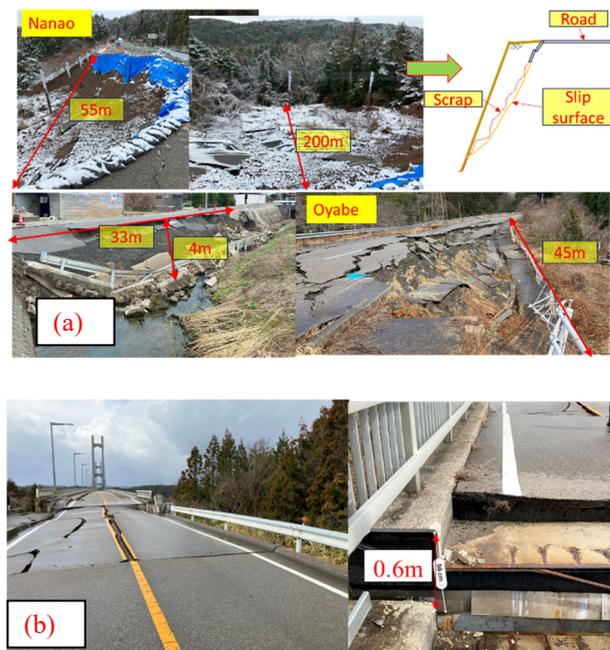
Fig. 13a illustrates an example of road embankment failure in Oyabe and Nanao. This failure was probably caused by insufficient compaction of the embankment and deep slope failure, with a horizontal distance from the head of the scarp to the canyon of approximately 200 meters over potentially weathered rock respectively.

Another example of embankment failure occurred at a twin bridge in Nanao, where the embankments on both sides of the bridge sustained damage. This was due to earthquake-induced lateral deformations, a result of the absence of a transition concrete slab between the bridge deck and the embankments, as well as a lack of adequate lateral protection, such as reinforced concrete walls or sheet piles (**Fig. 13b**).

Fig. 13. (a) Road embankment failure (b) bridge embankment failure

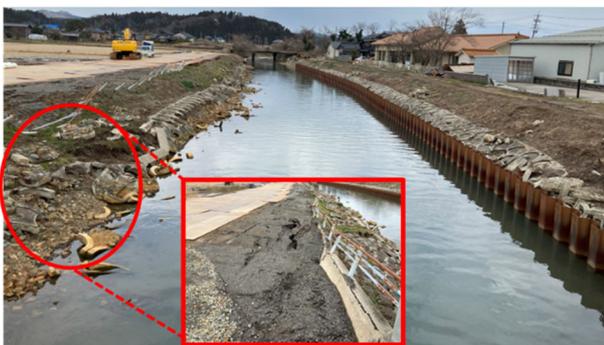
The majority of the observed waterfront structures were gravity walls (including concrete caissons and segmental block walls), concrete walls, and anchored and unanchored sheet pile walls. It was discovered that the seismic performance of these structures correlated with geotechnical conditions. There was a notable correlation between the performance of port and waterfront structures, land reclamation practices, and the apparent quality of execution. In general, reclaimed lands, especially those with substandard execution (poor compaction or ground improvement), were vulnerable to damage from liquefaction.

Fig. 14 Collapse of unreinforced concrete facing blocks and well performed sheet pile walls

In contrast, in the absence of liquefaction in the backfill or foundations, gravity walls, particularly sheet pile walls, exhibited good performance. Significant permanent deformations of gravity walls and sheet pile walls were observed in areas with widespread liquefaction.

Sheet piles or sheet pipe piles exhibit better performance (**Fig. 14**) compared to gravity walls during earthquakes due to their enhanced flexibility and deeper penetration into the ground, which provide greater resistance to seismic forces and soil displacements, ensuring more effective stabilization and reduced risk of failure under seismic loading.
