# Flash Report on Damage Caused in Mexico City, Mexico, by the 2017 Puebla-Morelos Earthquake

Tsuneo OHSUMI

## ABSTRACT

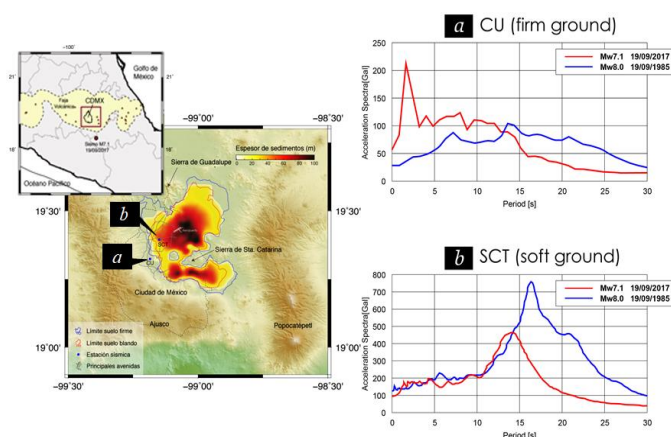
**Fig. 2.1** shows a comparison of the Fourier spectra of different heights at sites CU (rocky ground) and SCT (soft ground) for the 1985 earthquake (blue) and the 2017 earthquake (red). According to UNUM report [1], Peak Ground Acceleration (PGA) in 1985 was 160 Gal, while in 2017 PGA was 91 Gal. Peak Ground Acceleration (PGA) is a measure of the severity of ground shaking. However, accelerations in the soil during the 2017 earthquake were most likely greater than those recorded in 1985 because of the complex movement pattern and high spatial variability.

In 1985, the ground response was amplified up to 7–8 times at building sites located on the lake bed in contrast to those located on hard rock in Mexico City. During the 1985 earthquake, PGA at the soft soil site (SCT) was significantly higher than at the rocky site (CU).

**Fig. 2.1** Comparison of the Fourier spectra of different heights at sites (a) CU (firm ground) and (b) SCT (soft ground) for the 1985 earthquake (blue) and 2017 earthquake (red)

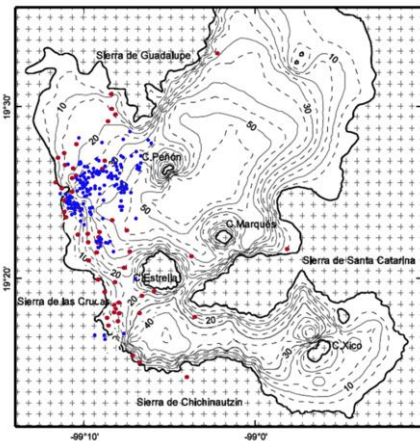
**Fig. 2.2** shows a comparison between seriously damaged structures from the 2017 earthquake (red) and the 1985 earthquake (blue). The thickness of soft soils is also shown; the base map derived from Martinez Gonzalez, Jose (2015) [2]. The seriously damaged structures in 2017 were concentrated in areas with 10–20 m soil thickness, while seriously damaged structures from 1985 were concentrated in areas with 30–40 m soil

**Fig.2.2** Map showing the thickness soft soils and damaged structures (base map from Martinez Gonzalez, Jose, 2015) [2].

Heavily damaged structures in the Mexico City area related to the 2017 earthquake are underlain by areas consisting of soft soils 10–20 m in thickness.

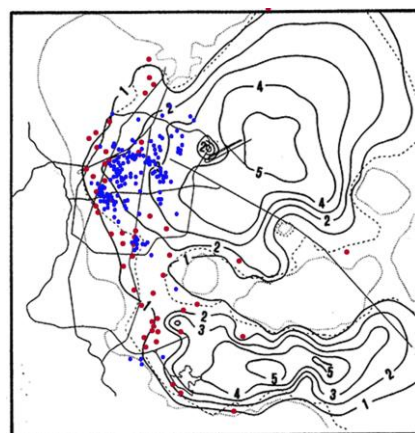
**Fig. 2.3** shows a comparison between seriously damaged structures from the 2017 earthquake (red) and the 1985 earthquake (blue). Periods were measured using microtremor measurements, with the base map derived from Reinoso, E. and Lermo, J. (1991) [3]. The seriously damaged structures in 2017 were concentrated 1–2 s areas, while seriously damaged structures in 1985 were concentrated in 3–4 s areas.

**Fig. 2.3** Comparison between seriously damaged structures. Periods were measured using microtremor measurements, with the base map derived from Reinoso, E. and Lermo, J. (1991) [3].

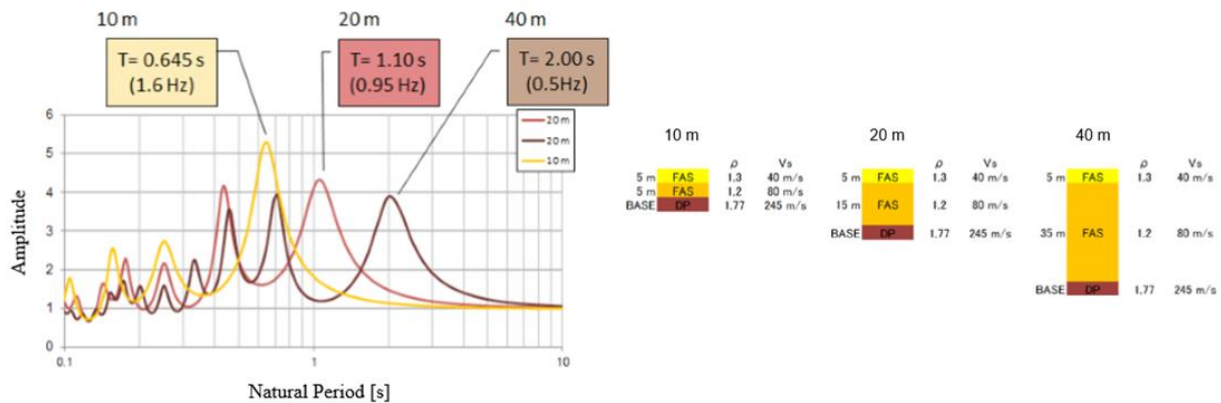
**Fig. 2.4** shows transfer functions obtained from 10 m, 20 m and 40 m within the simplified soil profiles and sedimentary layers from one-dimensional analysis of the dominant frequency. The Vs values of the ground were set from Facciolia and Flores (1975) [4] to FAS, which is normally consolidated clay, and DP, which is a sand layer

**Fig. 2.4** Transfer functions were obtained from 10 m, 20 m and 40 m in the simplified soil profiles.

In the 10 m case, the dominant period of transfer functions is 0.645 s (1.6 Hz) and the amplification of ground motion is 5.3. In the 20 m case, the dominant period of transfer functions is 1.1 s (0.95 Hz) and the amplification is 4.3. In the 40 m case, the dominant period of transfer functions is 2.0 s (0.5 Hz) and the amplification is 3.9. In the 1985 earthquake, which had long-period components of earthquake motion, caused high amplification in soft soils. However, in the 10 m case, which is shallow and segmented, the higher contrast  $V_s$  value of segmented layers and the basement contributed to increasing the amplification of ground motion in the 2017 earthquake, which had short-period components of earthquake motion.

In the 10 m case, which is shallow and segmented, the higher contrast  $V_s$  value of segmented layers and the basement contributed to increased amplification of ground motion in the 2017 earthquake, which had short-period components of earthquake motion.

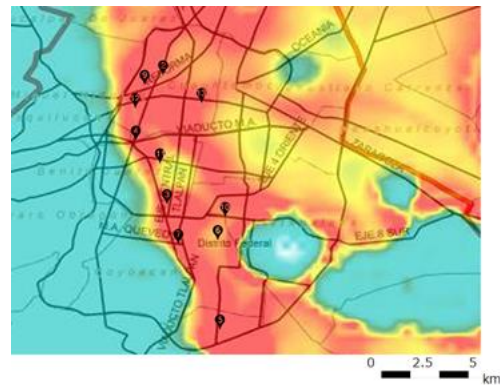
**Fig. 3.3** shows the demolition level structures with the

acceleration distribution for the 1.0 s period estimated from the roofs of buildings. All structures are within the 1.0 s acceleration period area (base map from UNAM, 2017) [5].

**Fig. 3.3** Map showing the distribution of the 13 structures designated for demolition level within the 1.0 s acceleration period area.  
(base map from Martinez Gonzalez, Jose, 2015).

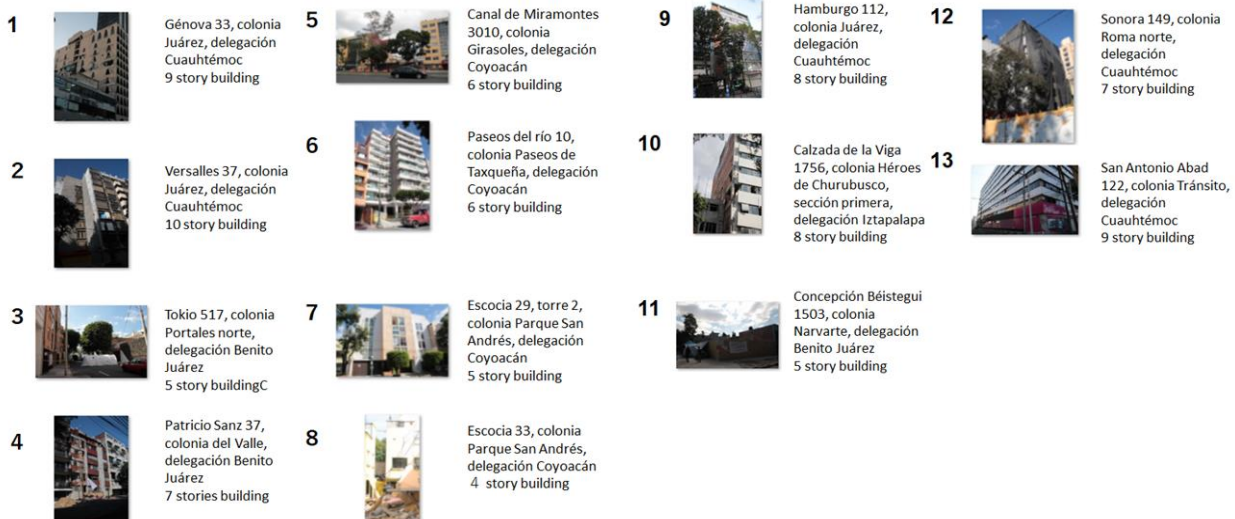
After obtaining approval from the Emergency Committee, the demolition work started on October 10, 2017 in the CDMX. There are 13 buildings already confirmed for demolition, since it was specified that in the first three cases, the state will use surveyors and an engineering team to determine the demolition method. These 13 buildings were selected as survey points in this study as shown in **Figs. 3.1** and **3.2**.

**Fig. 3.2** Photographs of 13 buildings designated for demolition (photo taken by T. Ohsumi and Y. Dohi on November 19, 2017)

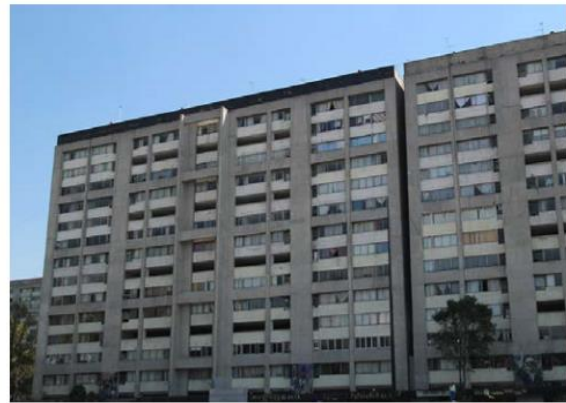
We visited the Tlatelolco Complex area to verify this renovation. Structures designed and built with earthquake-resistance showed no discernible damage after the 2017 earthquake based on external inspection. **Fig. 3.5** shows the lack of externally visible damage evident in the renovated Tlatelolco Complex after the 2017 earthquake.

**Fig. 3.5** Photograph showing the lack of externally visible damage evident in the renovated Tlatelolco Complex after the 2017 earthquake. (photo taken by T. Ohsumi on November 19, 2017)

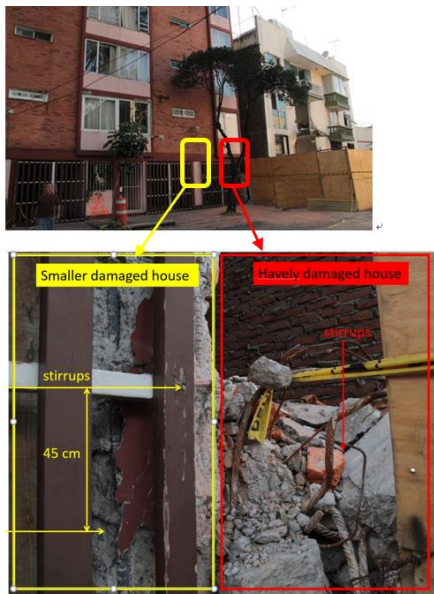
Two adjacent housing blocks were built in the same period in 1970, as shown in **Fig. 3.6**, and both buildings will be demolished. However, the building on the right was heavily damaged and the parking lot on the first floor collapsed. The housing block on the left was inspected, and found to have higher quality concrete than the right block. Also, the building column construction used hoops/stirrups at a 45 cm pitch, while the

hoops/stirrups were of very poor quality in the housing block on the right.

**Fig. 3.6** Comparison of damage to two housing blocks. Note the heavily damaged housing on the right with poor quality hoops/stirrups (photo taken by T. Ohsumi at November 19, 2017)

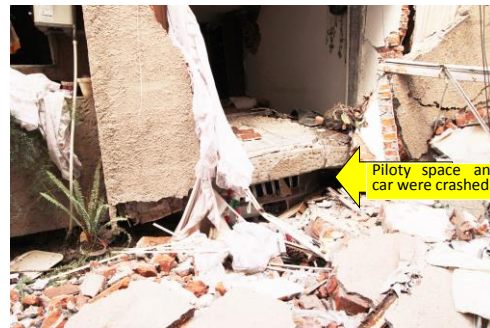
According to National Population Council, the estimated population for the metropolitan section of Mexico City in 2009 was approximately 8.84 million people. According to the most recent definition agreed upon by the federal and state governments, the Greater Mexico City population is 21.3 million people, making it the largest metropolitan area in the Western Hemisphere, the tenth-largest agglomeration, and the largest Spanish-speaking city in the world. Most housing developments are constructed with a dense overlapping structure (**Fig. 3.7**), and the first floor has a piloty space. The piloty structure of this space is typically weakly built, and they have collapsed in many housing (**Fig. 3.8**).

**Fig. 3.8** Piloty space crashed and the car were crushed. (photo taken by T. Ohsumi on November 19, 2017)

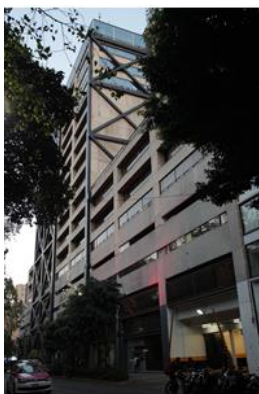
In Mexico City, braces are installed on buildings to decrease the risk of blocks falling off, or bricks in the wall falling out of the plane of the building. Thus, a gable wall between the brace is used to sustain a resilience method. Buildings reinforced with steel braces are shown in **Fig. 3.9** and typical diagonal reinforced concrete bracing with masonry infill is shown in **Fig. 3.10**.

**Fig. 3.9** Photographs of buildings reinforced with steel braces.

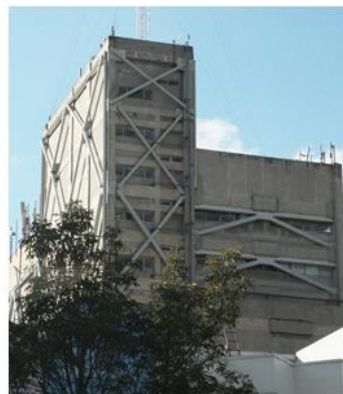
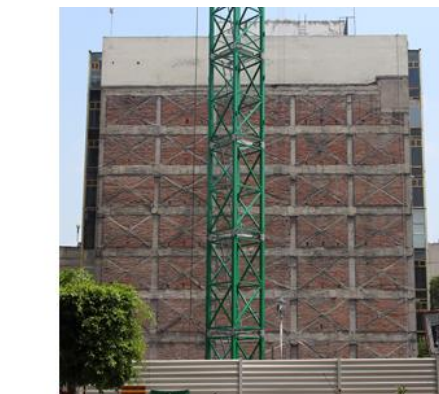
**Fig. 3.10** Masonry building which was reinforced with concrete columns. (photo taken by T. Ohsumi on November 18-19, 2017)

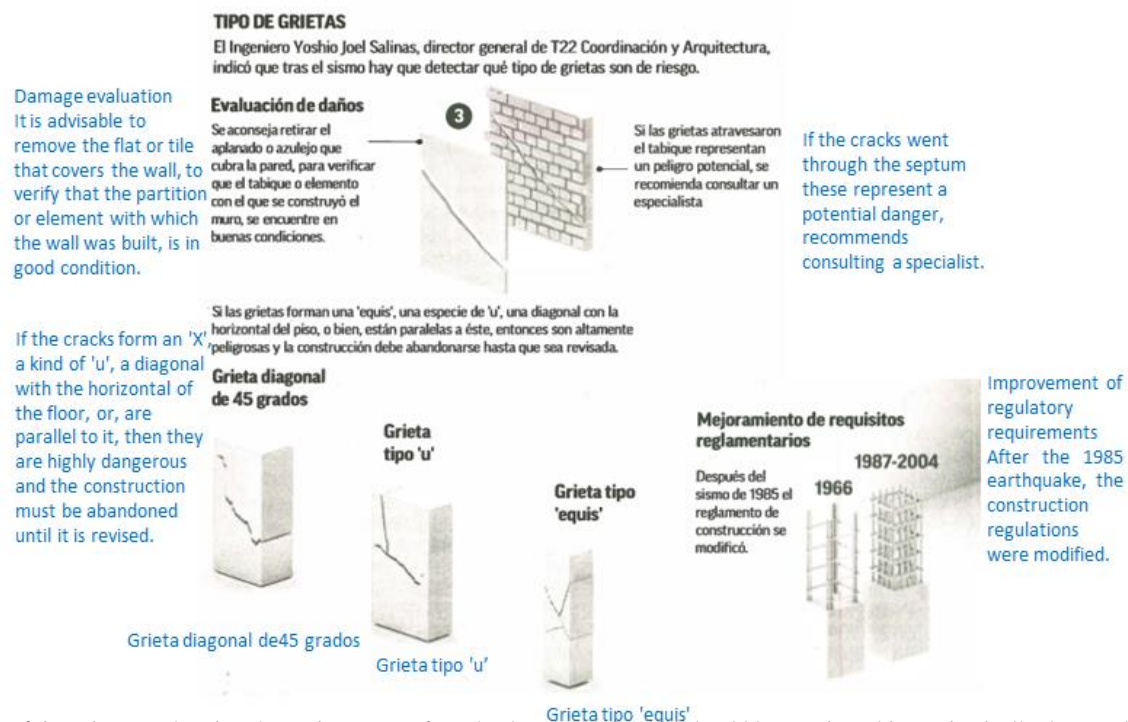
The engineer Yoshio Joel Salinas, general director of T22 Coordination and Architecture, indicated that after the earthquake it is necessary to detect the types of cracks evident in buildings in terms of their relative risk of further failure (**Fig. 4.1**).

**Fig. 4.1** Diagram showing the various type of cracks that can occur and should be monitored in a seismically damaged structure (courtesy of EL FINANCIERO, September 26, 2017)
