## Reinforcement of Damaged Bridge Pier by Scouring Using Steel Pipe Piles

This report introduces a case where railways bridge piers were damaged by scouring and restored using steel pipe piles. The Kumanouegawa Bridge of JR Kyushu was damaged by flooding in July, 2012, one of the bridge piers settled and tilted to the upper stream. Regarding the permanent repair intended for train operation at a normal speed after the immediate repair intended for the resumption of train operation at a slow speed, it was judged to be optimal to install steel pipe piles into the river bed in such a manner that they surround the footing of existing foundation and to connect them with the side surface of footing by reinforced concrete. In the actual construction, since the height of the lower surface of the girder of the bridge from the river bed is only about 4.0 m, the driving method of the piles had to be applied even at a construction site with low-height space. For this reason, steel pipe piles, were installed by press-in method which enables construction in this small space. The driving of the steel pipe piles was started in winter when the water level of the river was low, and the constructio

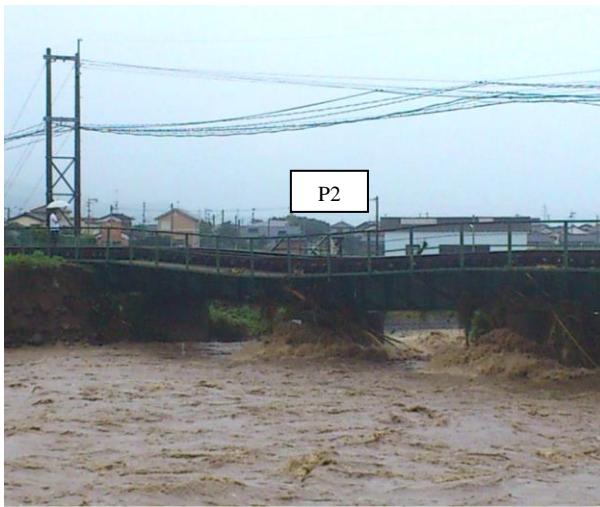
The Northern Kyushu Downpour of July 2012 recorded a maximum hourly rainfall of 78.5 mm and a maximum continuous rainfall of 336.0 mm, causing severe damage in northern Kyushu. On the Kumanouegawa River, as shown in Fig. 2, the water level rose as high as it almost reached the crest of the bridge piers under the impact of this downpour. At Kumanouegawa Bridge, the foundation was scoured, and the fine-grain component of the bottom surface ground was sucked out at the elliptical bridge pier P2 with a footing thickness of 0.6 m and a bridge pier height of 3.76 m, causing the bridge pier to settle (about 300 mm) and lean (49/1,000 rad upstream and 21/1,000 rad toward Oita Station) (Fig. 3). The revetment near the bridge pier P1 was washed away. It has been pointed out that bridge

Fig. 2 View during the flood

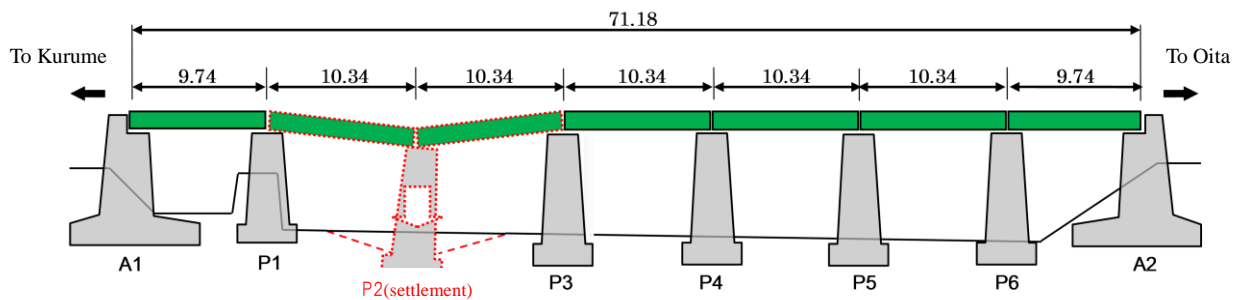
piers P3 to P6 that were not damaged by the flooding had been prone to be destabilized by past scouring, and various countermeasures including those by the foot protection method had been taken. However, the bridge pier P2 had been shorter than the other bridge piers and had been covered with an earth cover from its footing crest to a height of about 1.5 m, so countermeasures had not been taken at this bridge pier.

Fig. 3 Overview of the damaged bridge pier

Regarding the repair of the damaged bridge pier P2, such tentative work as is described in the following was done to quickly reopen the bridge for slow-moving train operation before the work to be done for train operation on the bridge at the prescribed speed.

- Clarifying the natural frequency by an impact vibration test to confirm the state of the bottom surface of the foundation
- Preloading work for removing the looseness on the bottom surface of the foundation.
- Repairing the concrete of the bearing supports
- Trial driving by a test train

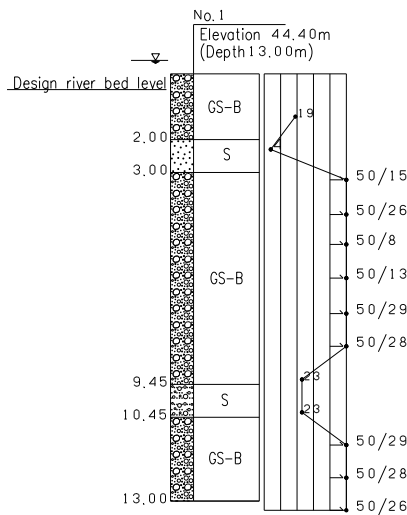
Fig. 4 Borehole log

At this location, there is a gravel layer mixed with round stones with a *N*-value of 19 near the design riverbed level, but there is also a sandy layer with a *N*-value of 4 from 2.0 m to 3.0 m below the designed riverbed level. Below the sandy layer, there is another gravel layer mixed with round stones with a *N*-value over 50, and the diameter of some of the round stones exceeds 300 mm.

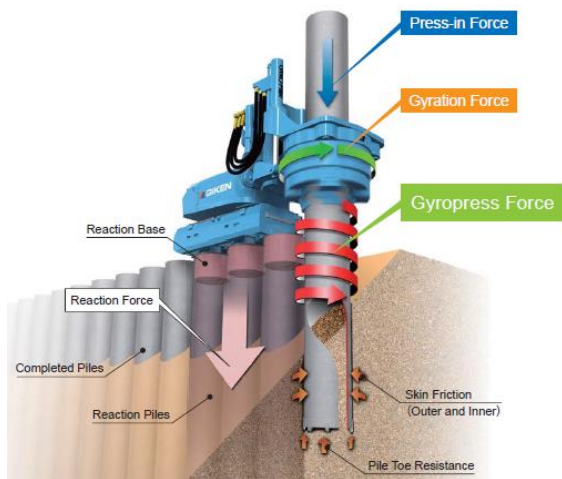
Fig. 6 Overview of the gyropress work method

resolved by adopting the gyropress work method using steel pipes instead of steel sheet piles, as shown in Fig. 6, permitting the execution in the reduced space.

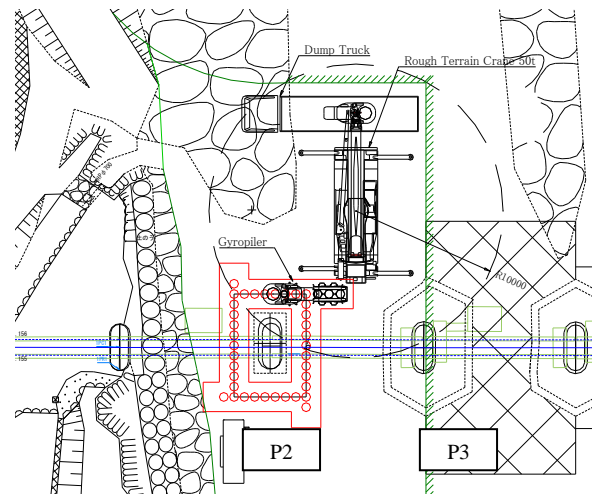
Fig. 8 Layout of the restoration execution machines

execution. For this execution, part of the river was blocked with a cofferdam, as explained in Section 2.1. The cofferdam was executed by arranging large sandbags so that they enclose the bridge pier P2 and construction

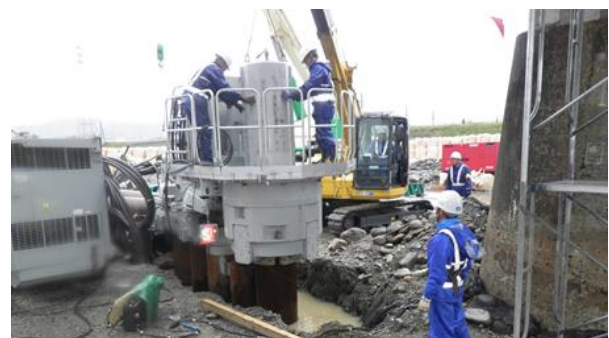
Fig. 9 View of the steel pipe pile press-in work

The ground supporting the bridge pier P2 was, as explained in Section 2.2, a gravel layer containing round stones whose diameter exceeded 300 mm, but the adoption of the gyropress work method allowed the press-in of the steel pipe piles without any impact by the round stones and other objects. Specifically, although the construction work was done under a bridge where trains were operated, 5 piles were installed per day, which led to the completion of the press-in of 37 steel pipes in 8 days.

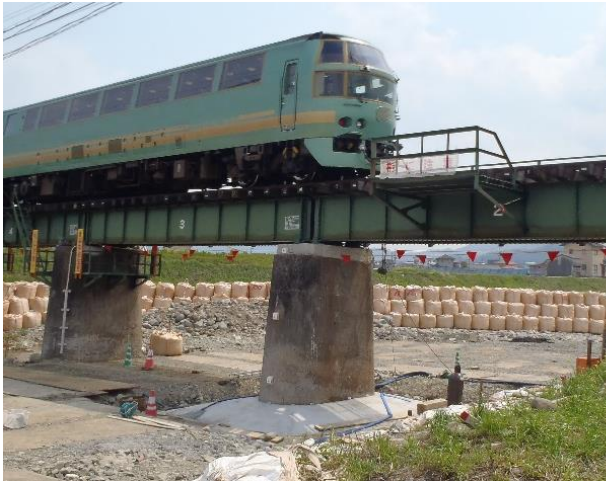
Fig. 10 Work completed

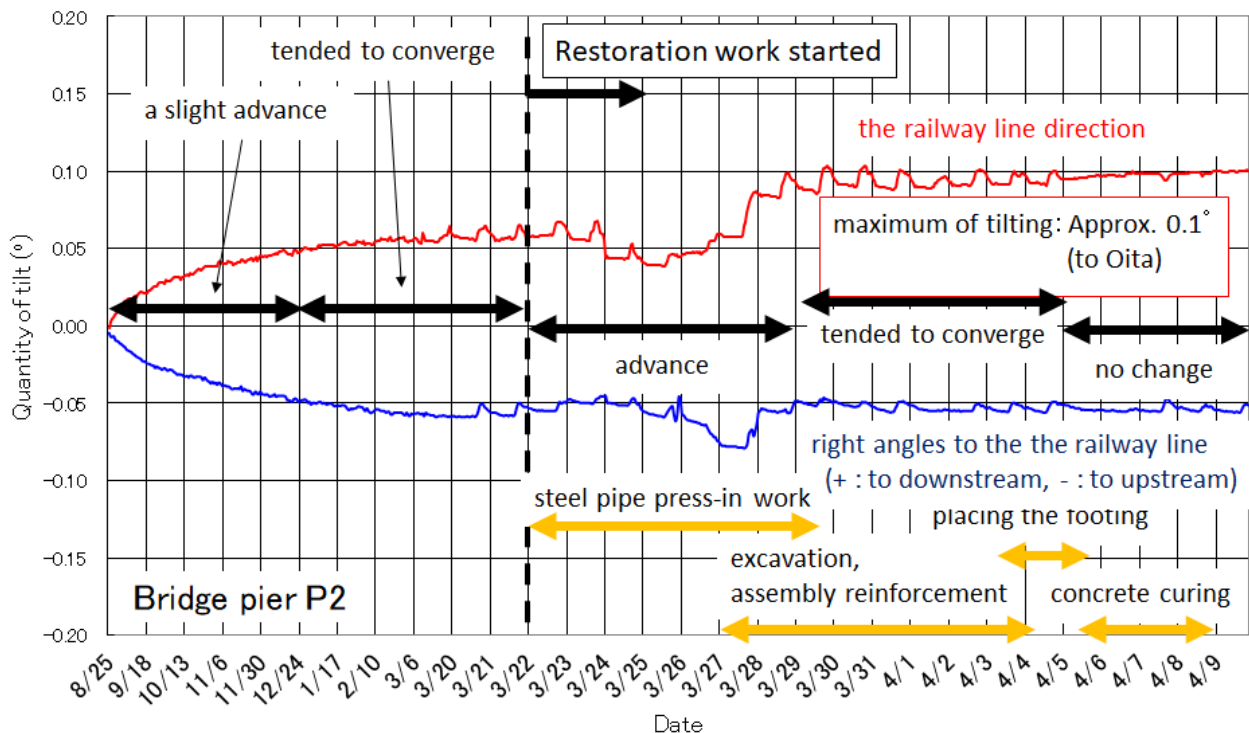
Fig. 11 Change in tilting

completion of the immediate work. When trains were first allowed to cross the bridge at a slow speed after the execution of the immediate work, a slight advance of tilting upstream and toward Oita Station was seen. About four months later, tilting tended to converge at about 1/1,000 rad (approximately 0.06°) in both the direction of the railway line and the direction at right angles to it.

After the restoration work started, the advance of tilting (tilting toward Oita and upstream) was seen during the steel pipe press-in work and during the excavation between the steel pipes and the body concrete after the completion of the press-in work. Nevertheless, even the cumulative tilting never exceeded 1.6/1,000 (approximately 0.1°), which means that the work-stopping value was not reached and that the work was completed successfully without obstructing the train service. After the steel pipes and the body were connected by reinforcing bars following the completion of the excavation, the progress of the measured values showed a tendency to converge. This is considered to be a result of the integration of the steel pipes and the body.
