IPA News Letter

Case History-1 Restoration and Reconstruction of Kyu-Kitakami River

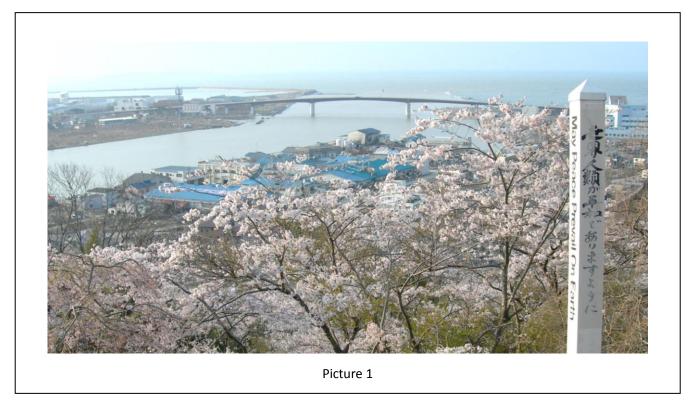
The estuary area of Kyu-Kitakami River was significantly damaged due to the earthquake and tsunami in the Great East Japan Earthquake in 2011. Picture 1 was taken from the Hiyoriyama Mountain in Ishinomaki City in Miyagi Prefecture, one month after the disaster. This Hiyoriyama Mountain is famous for the cherry blossoms and is usually very crowded with the visitors. However, in 2011, it was very quiet spring with few visitors. The city was destroyed by tsunami, and the disposal of the disaster wastes and the search for the missing continued, with the support from inside and outside of Japan. On the other hand, the cherry blossoms were blooming beautifully and the poem monument was standing still saying 'May peace prevail on earth'.

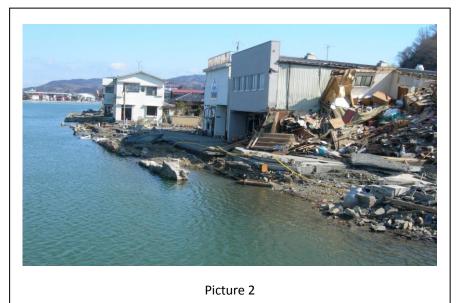
The river side was significantly eroded by tsunami. Because of this erosion, only small room was left between the river and the houses. As this area is also influenced by the tide, an immediate action was required to prevent the erosion. The noise and vibration due to the construction process should be as small possible, taking into as consideration the lives of the residents. In addition, the space for the construction was limited, as shown in Picture 2.

The first example is the construction at the right bank in Kadowaki district. 450 SPU-2W type sheet piles and 170 SPU-4W type sheet piles were used in this revetment. As there were a lot of stones on the river bed, Hard Ground Press-in Method was adopted.

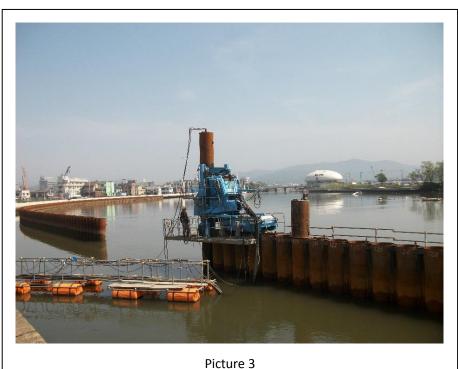
The second example is the construction in Kadowaki and Chuo district at the right bank, as shown in Picture 3. 600 tubular piles with the diameter of 800mm and 1000mm were used in this revetment. As the ground condition was very hard, Gyropress Method was adopted. The number of teeth on the pile base was varied depending on the hardness of the ground.

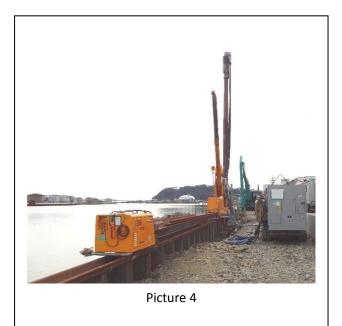
The third example is the construction in Sumiyoshi district at the right bank, as shown in Picture 4. 100 SPU-2W type sheet piles and 850 SPU-4W type sheet piles were used in this revetment. As there was little space for supplying the sheet piles to the piling machine, GRB Non-staging System was adopted. Sheet piles were transported on top of the installed piles from the upstream side of the site.

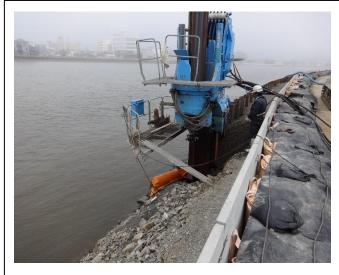
Picture 5

The final example of the revetment construction, as shown in Picture 5. This is the construction at the left bank in Hachiman and Fudocho district. 370 SPU-3W type sheet piles and 200 SPU-4W type sheet piles were used in this revetment. Here, the existing revetment was adjacent to the planned line for the sheet pile installation. In addition, there was rubble near the existing revetment. To cope with these difficulties, Hard Ground Press-in Method was adopted.
