Typhoon Hagibis: Japan suffers deadly floods in October, 2019

Catastrophe caused by Typhoon Hagibis

Site Investigation and Restoration Work

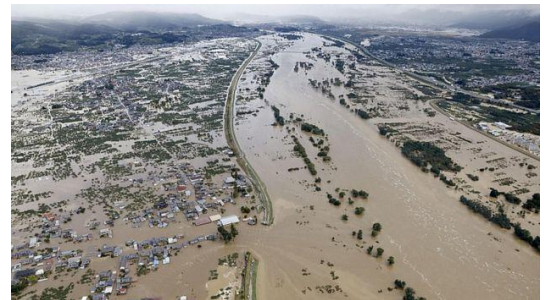
Typhoon Hagibis hit eastern Japan on 12th of October 2019, and brought immense damage arising from heavy rain and flood over a large area. 88 people were killed and 7 people were reported missing nationwide (as of 31st of October). Also, a total of 140 levees at 71 rivers were failed, and total 281 rivers overflowed their levees due to the disaster. According to the report from the Fire and Disaster Management Agency (FDMA), 84,383 residences in total were flooded or damaged by the disaster. Photo 1 shows a view of flooding at Chikuma River.

Photo 1 Torrential rain has caused rivers to flood along Chikuma River.

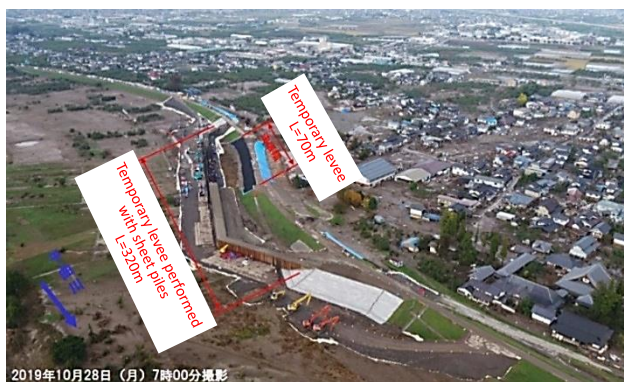
GIKEN LTD. conducted a site investigation regarding the disaster, specifically putting emphasis on the place where the damage was severe such as Nagano and Kanagawa Prefectures. While investigating, GIKEN LTD. visited the persons in charge of the management of the levees. This is a brief report on the circumstances of one of the disaster areas along Chikuma River and a restoration work performed in the construction site as is shown in Photo 2.

Photo2 Overview of Construction Site

A levee constructed in Chikuma River was failed over the length of 70 meter, therefore a temporary levee was constructed by filling soils to prevent further damage. However, Nagano city office considered that the temporary levee is not enough. Therefore, another temporary levee work by installing sheet piles was performed. 2 Silent Pilers and 2 vibratory hammers were operated for the second temporary levee construction from evening of 16th of October and completed the construction work on 30th of October. Total 1,700 sheet piles (L=16m, W=40cm) were installed to construct the temporary levee with a height of 5.5m and horizontal length of 320m. Upon the completion of the construction, Nagano city canceled evacuation order of the area. Photo 3 illustrates the plan of recovery work, and Photo 4 presents a view of recovery work using Silent Piler.

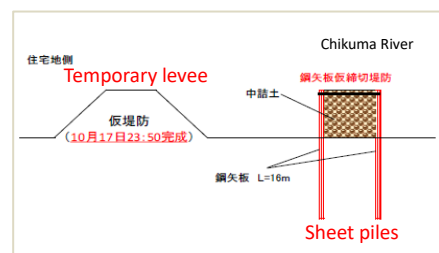
Photo 3 Cross-Section of Construction

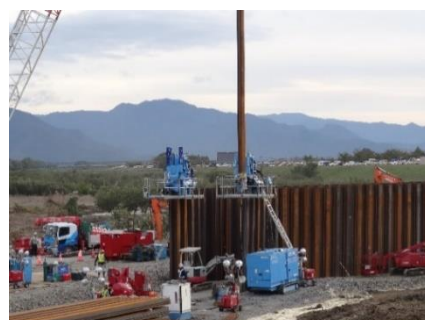
Photo 4 Construction of sheet pile wall by Silent Piler
