Report

The worst water-related disaster in Japan since 1982

The Investigation Report by the GIKEN Team

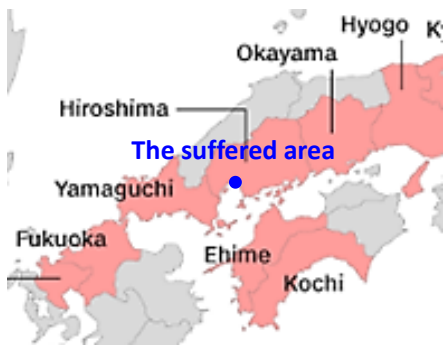
Figure 2 Saka-cho Nishi, Aki-gun, Hiroshima prefectures

1. Saka-cho Nishi, Aki-gun, Hiroshima Prefecture (Ohshiro-ike Reservoir) ... Figure 2

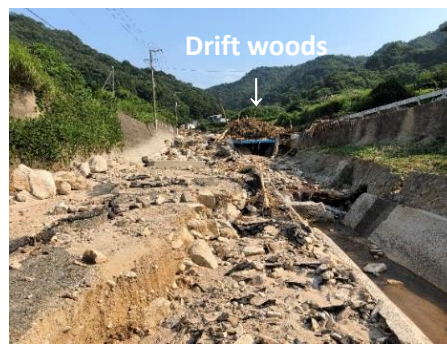
Photo 2 Driftwoods were caught on a bridge

The reservoir dike, which is located upstream, collapsed. After the dike collapsed, debris, driftwood flowed into the lower basin. In the lower basin, driftwoods were caught on a bridge and at river curves, and the damage extended because the debris overflowed (Photo 2 & Photo 3).

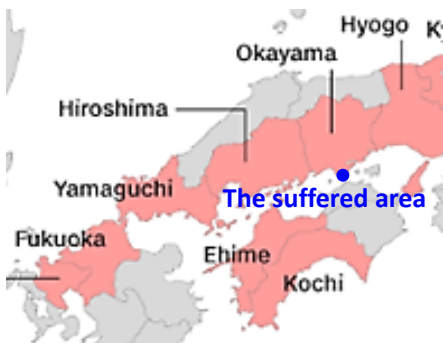
Figure 3 Mabi-cho, Kurashiki-shi, Okayama Pref.

2. Mabi-cho, Kurashiki-shi, Okayama Pref. (Oda River, Suemasa River) ... Figure 3

The water of the Oda River, which is a side stream, was dammed up when it joined up with the Takahashi River, which is the main stream, and a “backwater phenomenon” occurred. Because the water level suddenly rose, the Oda River embankment collapsed near the place where the both rivers join, which caused serious inundation damage to the whole area of Mabi-cho. In addition, there was a collapse of the embankment of Suemasa River, which is a sidestream of the Oda River. It was inferred that the embankments were scoured by the overflow due to the heavy rain. Removal and recovery work by the the Ministry of Land Infrastructure, Transport and Tourism (MLIT) and the Self Defense Forces of Japan (SDF) was carried out (Photo 4). At the collapsed embankments, tentative recovery work with the double steel sheet pile structure was done (Photo 5).
