## Series Report: Reports from USA (Part 4) Applications of the Press-in Piling Method to Emergency Bridge Foundation Repair

### CSX BRIDGE PIER REPAIR WORK IN COLUMBUS, OHIO, UNITED STATES OF AMERICA

## UTO BRIDGE ABUTMENT EMERGENCY REPAIR IN KAGOSHIMA, JAPAN

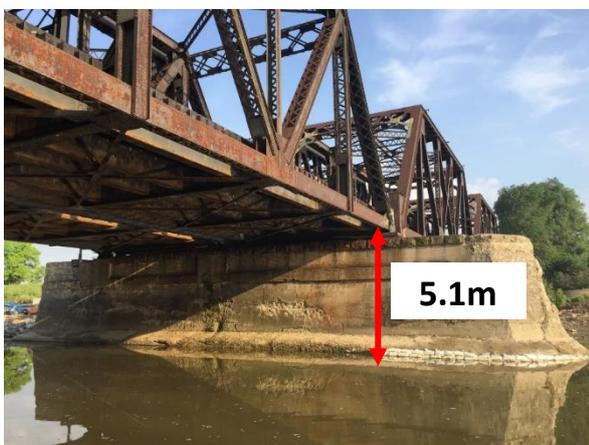
Fig. 1. Bridge Pier with Damaged Foundation

CSX Transportation is one of a few freight railroad companies based in the United States, which has more than 30,000 km of route track in the eastern parts of the U.S. and Canada. One of its rail bridge piers in Columbus, Ohio was heavily scoured around its foundation, needing emergency repair work in 2015 (Fig. 1). The original pier foundation was on timber piles with a concrete footing. The repair work was to drive micropiles around the original footing first with a larger concrete encasement footing to be constructed after a sheet pile cofferdam was built. See Figs. 2 and 3 for the structural details.

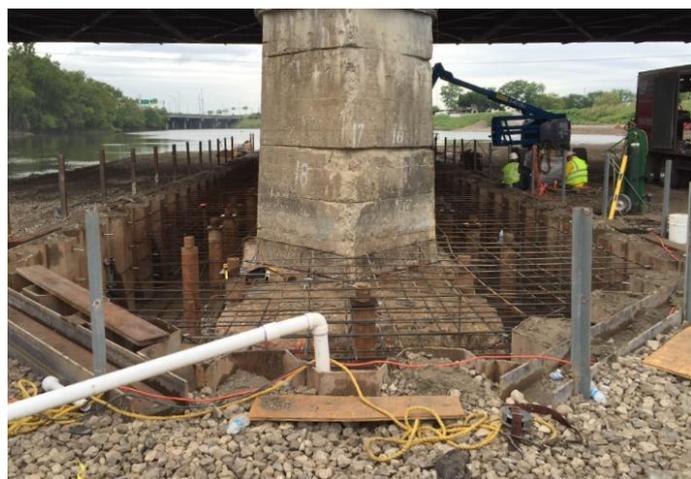
Fig. 6. Sheet Pile Cofferdam and Micropiles for Larger Encasement Footing

In order to work under the bridge girder, short sheet pile sections were brought over to the press-in piling machine by a small track loader with a special arm to hold the short sheet piles in position after their lower sections had been pressed in (Fig. 5). Each new section was then spliced by welding to the lower section in place. With the sheets spliced together, the press-in piling work continued. Approximately 9 sets of welded sheets were pressed-in per 10-hour shift. Fig. 6 shows the concrete pier with the existing concrete footing, lines of new micropiles, and steel bar reinforcement placed inside the sheet pile cofferdam.

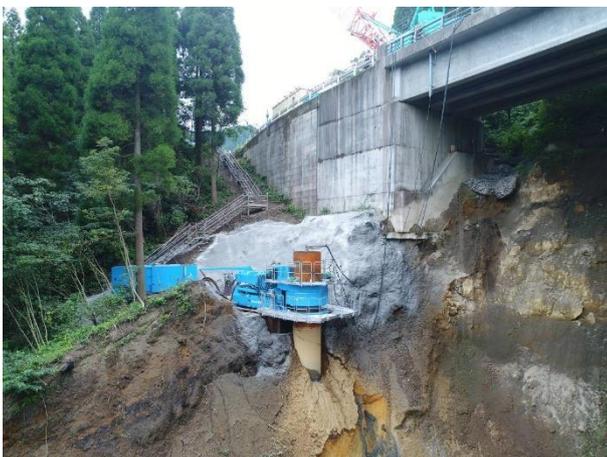
The Kyushu region of Japan experienced very heavy and continuous rain in a short period of time on June 20, 2016 and the following couple of days. More than 250 mm of precipitation was recorded during a 24-hour period in the City of Kagoshima where the Uto Bridge was located. The bridge section was immediately closed when deep erosion of the slope just in front of its abutment was reported. See Fig. 7 for the degree of erosion nearly exposing the abutment's foundation at the beginning of the project.

Fig. 7. Severe Erosion in Front of the Abutment

The highway agency in charge determined that a pressed-in pipe pile retaining wall would be the only safe and reliable solution to expediently protect the abutment because of the very steep and unstable slope created by the flooding right underneath it in addition to extremely difficult construction access.

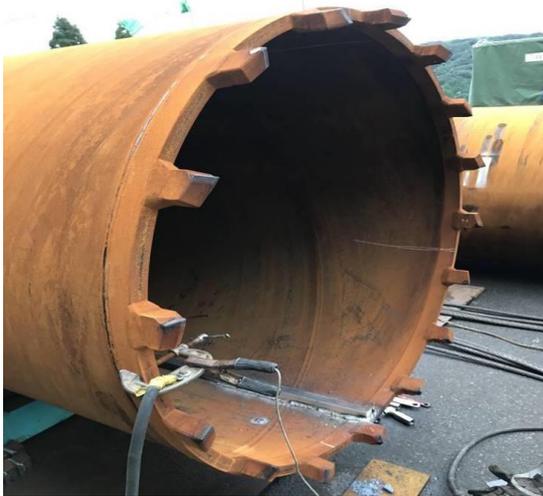
Fig. 10. Cutting Shoe of Pipe Pile (Sacrificial)

Uto Bridge has a slightly curved 42-meter-long single span with a two-lane highway supported by its concrete girder. Fig. 9 shows the plan view of this emergency repair work to prevent further erosion around the foundation. 15 of 1,500mm diameter pipe piles were pressed in to form a very solid earth retaining structure. The pile's length varied from 15.5 to 24.5 meters with the wall thickness from 15 to 21 mm. Each pile was spliced once, twice, or three times depending on the pile's location and its overall length. The pile driving was planned to start from the downstream side because of easier access compared to the other side. The soil condition was from weathered to fresh sandstone covered with a thin surface clay layer spared from the storm water. The sandstone was expected to have an average equivalent N-value of 275. See Fig. 10 for the cutting shoe of the pile that enabled the pile installation into the sandstone. The Gyropress piling machine rotated and simultaneously pressed pipe piles into the ground (Takuma et al., 2013). Fig. 11 shows the installation of one of the piles in the middle of the heavily eroded and unstable slope.

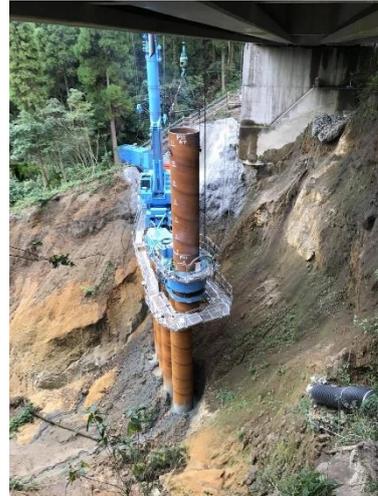
Fig. 11. Pile Installation on Heavily Eroded

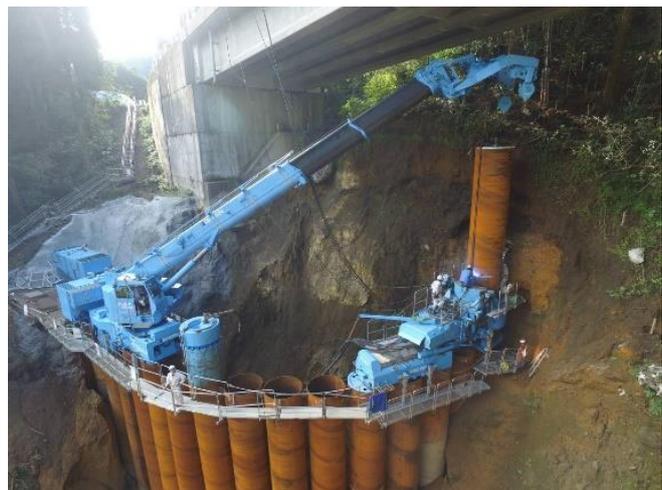
Fig. 13. Last Pile Supported by Clamp Crane during Splicing

Fig. 13 shows installation of the last pile under the girder with the pile supplied by the Clamp Crane. Once the pile installation was completed, both the Clamp Crane and the Gyropress machine were walked backward to the reaction stand next to the side of the abutment and disassembled there for demobilization. Fig. 14 shows the completed pipe pile wall after the equipment was removed off the piles. 200 mm wide steel strips were welded onto both sides of each pile to fill the 80 mm wide gaps between piles as designed.

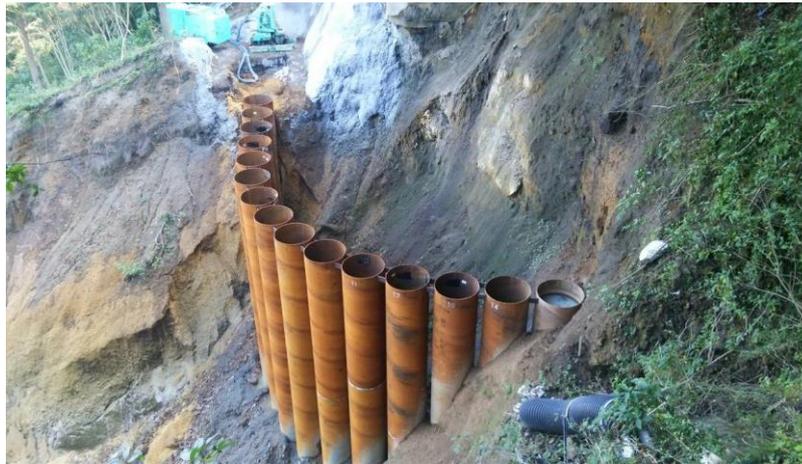
Fig. 14. Pile Installation Completed

The press-in force and torque were closely monitored real time for smooth installation with minimal vibration. Thanks to the combination of the rotating cutting shoes and the press-in force simultaneously exerted on the piles, the necessary press-in force for installation was relatively small, considering that the piles were installed deep into fresh sandstone. The piles were not for carrying vertical load so the vertical loading capacity was not calculated or tested.

Finally, a reinforced earth embankment was placed against the abutment inside the retaining wall for its stability. The pressed-in pipe pile wall provided a highly reliable earth retaining structure to secure the once threatened abutment.
