# Disaster Countermeasures and Recovery Technology for Existing Railway Structures

Masayuki Koda

Director, Structures Technology Division  
Railway Technical Research Institute (RTRI)

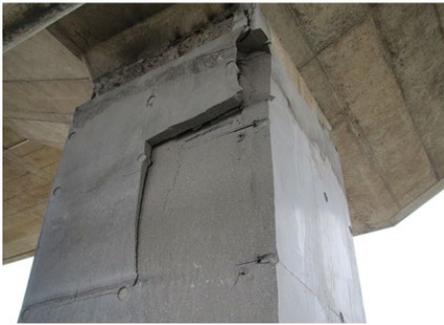
Fig. 1. Example of damage caused by aftershocks from the 2011 off the Pacific Coast of Tohoku Earthquake

The 2011 off the Pacific Coast of Tohoku Earthquake was an unprecedented huge trench-type earthquake with a magnitude of 9.0[1]. Regarding the earthquake damage of railway structures, there was no collapse of the structures thanks to the effects of shear reinforcement measures and measures to prevent the collapse of bridges that were implemented after the Hyogo-ken Nanbu Earthquake; however, there was a characteristic damage due to a huge earthquake, including utility pole breakage over a wide area, viaduct column damage, damage caused by repeated aftershocks(Fig.1), ground liquefaction damage in the Tokyo urban area, and enormous tsunami damage in Tohoku coastal areas.

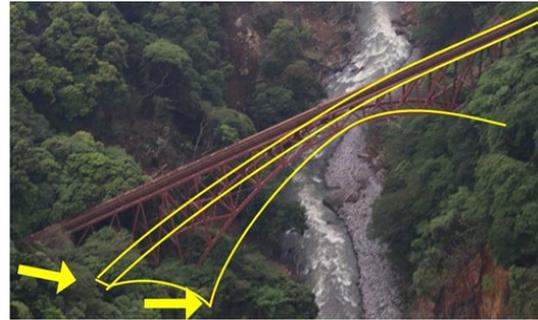
Fig. 2. Example of damage caused by the Kumamoto Earthquakes in 2016 (Minamiaso Area; assumed bridge deformation shown by yellow lines)

The Kumamoto Earthquakes, which were inland earthquakes, included a foreshock with a magnitude of 6.5 due to the Hinagu fault, which occurred on April 14, 2016, and the main shock with a magnitude of 7.3 due to the Futagawa fault which occurred two days later [2]. Observations revealed that the covered concrete at top of viaduct columns forming part of Kyushu's Shinkansen Structure in the plain of Kumamoto had been peeled off and that bridge bearings had been damaged. However, this was within the scope of consequences assumed in Railway Design Standards. On the other hand, many large-scale landslides occurred in mountainous areas and intermountain regions centered on the Minamiaso area, and the subsequent aftershocks occurring in succession caused damage and deformation to progress, leading to more extensive damage (Fig.2).

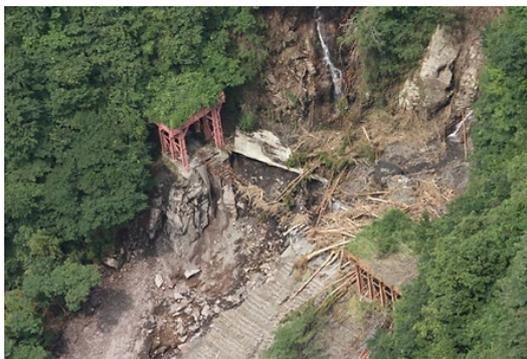
Fig. 3. Example of damage caused by Heavy Rain in Northern Kyushu in July 2012

The Heavy Rain in Northern Kyushu in July 2012 was described by the Japan Meteorological Agency as "rain of unprecedented intensity for Japan". The total recorded rainfall was over 800 mm in three days and caused major river disasters to northern Kyushu, mainly in Kumamoto, Oita, Fukuoka, and Saga Prefectures [3]. The heavy rainfall also damaged valley fills, embankments, and river bridges, including the Hohi Main Line, which runs through the intermountain region (Fig.3).

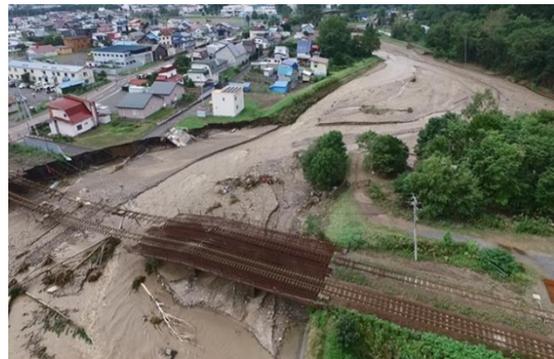
Fig. 4. Example of damage caused by Typhoon 10 in 2016 (river bridge)

The heavy rains in 2016 was caused by Typhoons 7, 9, 10, and 11. Three typhoons landed in Hokkaido in succession over a single week, and heavy rain caused flooding of rivers and sediment-related disasters mainly in eastern Hokkaido. Subsequently, heavy rain generated by a front at the end of August and the approach of Typhoon 10 caused great damage such as the outflow of river bridges on the Nemuro Main Line and coastal revetments on the Hidaka Main Line (Fig.4) [4].

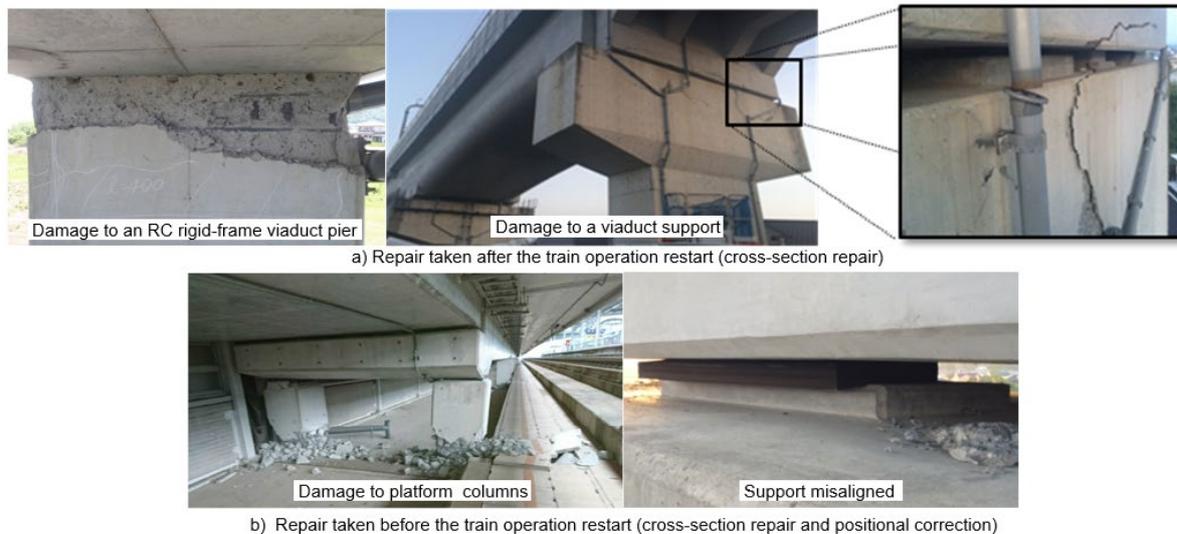
Fig.12. Technical support for the diagnosis of the Kyushu Shinkansen viaduct damaged by the Kumamoto Earthquakes in 2016

The Kumamoto Earthquakes damaged the rigid-frame viaduct columns and bridge bearings on the Shin-Tamana to Shin-Yatsushiro section of the Kyushu Shinkansen line. There were well over 1000 columns and bearings, and there was concern that it would take a long time to investigate each damaged location, formulate a recovery plan, and then carry out repairs. As such, a strategy was adopted, where recovery would be achieved step-by-step: damaged sections would be ranked by degree of damage, and based on an index of whether they needed to be repaired or not prior to resumption of train operations. Operations would then be resumed with speed restrictions, which could then be gradually lifted. As a result, train operations restarted on the Hakata-Kumamoto section on April 23, 2016 (9 days after the disaster) and restarted on all the Kyushu Shinkansen lines on April 27(Fig.12).
