Press-in piling applications: Permanent stabilization of an active-landslide-slope

ABSTRACT: The road surface of a national highway failed in Japan, due to a landslide caused by typhoons. For the restoration of the road, the installation of steel tubular piles with ground anchors was selected to protect traffic safety in consideration of the possible occurrence of soil mass erosion and loss at the toe of the slope. In this construction project, the quick restoration of one-way alternating traffic was required by installing the piles without delay. Furthermore, installing the piles into the bedrock (bearing stratum) was a technical challenge. To address the requirement and technical issue, the rotary press-in piling (Gyropress Method) and the Non-staging System were selected. This paper aims to review the applicability of press-in piling technology to the pile installation on an active-landslide-slope by reporting the outlines of the disaster rehabilitation work, design of permanent measures, and the construction plan and implementation.

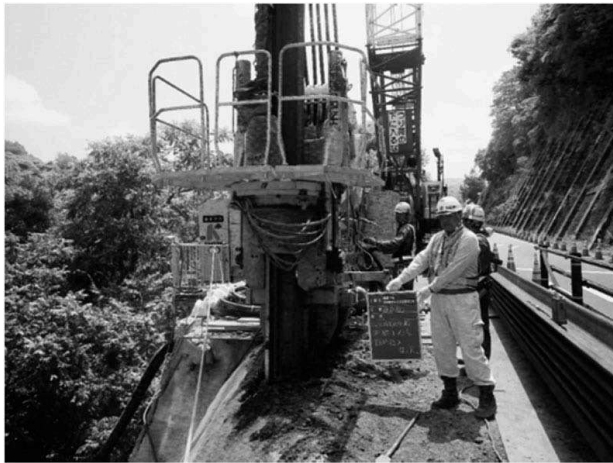
Figure 9. Installation of reaction piles.

- [3] Press-in steel sheet piles as reaction piles (Figure 9).
- [4] Remove equipment used for the installation of reaction piles, and carry equipment for the installation of tubular piles in the initial piling location by a truck and a crane.

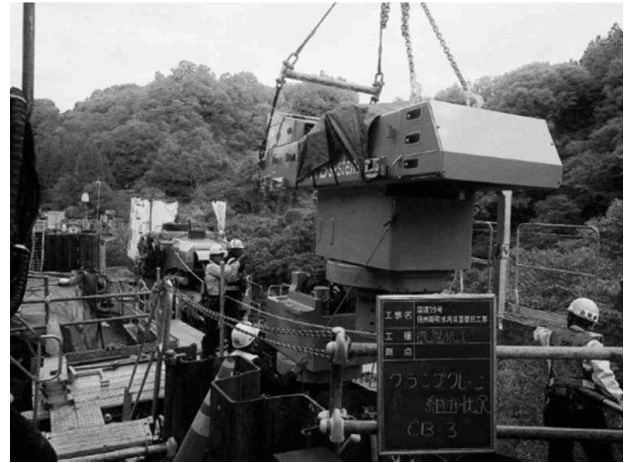
Figure 12. Assembly of a clamping crane.

- [7] Install 15 tubular piles using the Gyro Piler and the crawler crane.
- [8] Install the Non-staging System (such as clamping crane, Pile Runner, and transportation trackway) on the installed tubular piles (Figure 12).

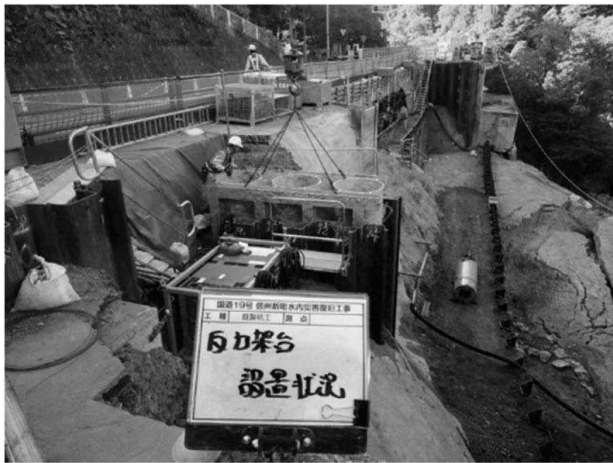
Figure 10. Installation of a Reaction Stand for tubular piles.

- [5] Install a Reaction Stand for tubular pile press-in work, and fix it to the reaction piles (Figure 10).
- [6] Assemble the rotary press-in piling machine (hereinafter referred to as Gyro Piler), which was carried in the site in three parts, on the Reaction Stand (Figure 11).

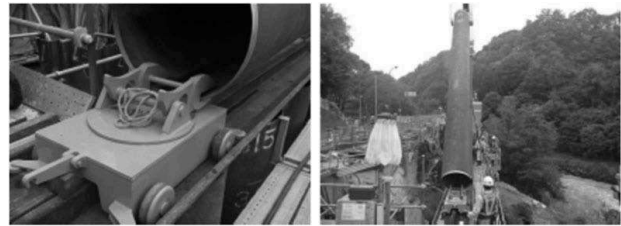
Figure 15. Lifting a tubular pile with a Pile Roller.

It was necessary to crane the tubular piles with care because the work space available right next to the one-way alternative traffic was extremely limited. The way to solve this issue with originality and ingenuity was the use of a Pile Roller for tubular piles (Figure 15).

By using a Pile Roller, the tubular piles were able to be lifted smoothly with reduced friction between metallic objects. In addition, the range of the crane and lifted piles' movement could be minimized so that safety was enhanced.
