## Case History: Press-in sheet pile on the collapsed riverbank

### ABSTRACT

**Key words:** Case History, Failure, Press-in, Sheet Pile, Riverbank

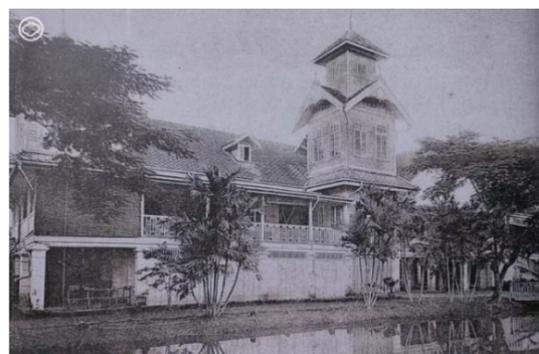
**Fig.1** The historical building and canal

For over a hundred years, humans excavated canals in the Bangkok area, which were primarily used for transportation and economic purposes. There is a canal in Langsuan, Lumpini sub-district (city center of Bangkok) which locates adjacent to historical buildings as shown in **Fig.1** According to historical data, this building was constructed in 1920 and defined as architecture of King Rama VI. Due to urbanization and city development, most of the canals were backfilled for construction of the road. However, both the canal and historical building in the Langsuan area have endured to the present day, albeit serving different purposes over time.

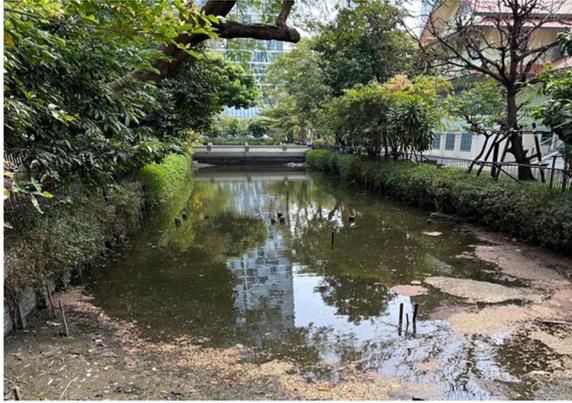
**Fig. 2** The old canal used as retention pond

The riverbank of the canal was protected by the old soldier piles and lagging walls for approximately 40 years. Presently, the canal is used as a retention pond to store excessive water before draining to the public drainage

system (**Fig.2**) Moreover, this area including the historical building is protected from flooding especially during rainy days. As the canal has been used for a long time, a lot of sediment has accumulated on the canal bed, which has reduced the water storage capacity. Then, canal dredging was conducted in order to make the canal prepare for the upcoming rainy season.

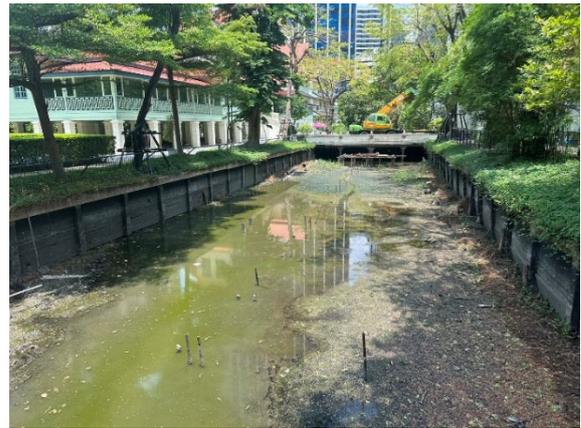
**Fig. 3** Canal bed after water pumping

The team started with pumping out the water, which revealed that the canal bed was approximately 1 m below the level of the surrounding walkway before dredging (**Fig.3**). **Fig.4** shows the working platform which is made of timber piles and steel plates, which only a small excavator can be placed on.

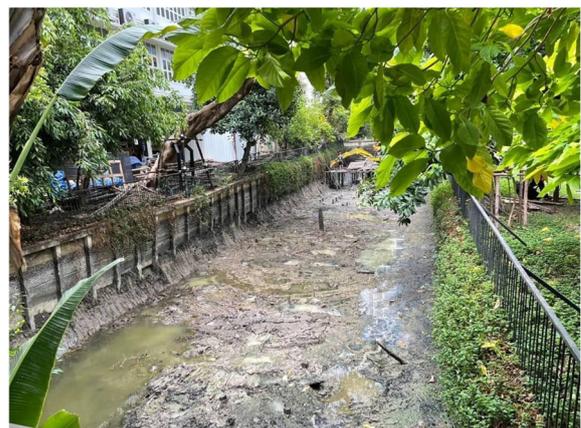
**Fig. 5** Canal bed after dredging excavation

Dredging took place at a depth of 1.5 m which is 2.50 m from the riverbank and ground level of surrounding structure as shown in **Fig.5**. Unfortunately, the riverbank of the canal and the wall collapsed and moved towards the canal (**Fig.6**). Water was filled back to maintain the stability of the riverbank as it was the fastest way to mitigate the effect of the incident.

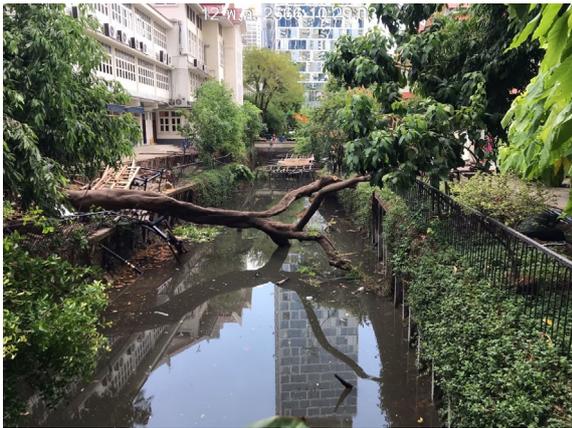
Fig. 6 Collapsed riverbank and wall

Since the collapse occurred, surrounding properties were also damaged. Surveys of settlement and monitoring of cracks were conducted. The historical building beside the canal was in the area of greatest concern, but fortunately, the structure of the building was strengthened for a year before the carrying out of canal dredging. There was no any crack observed in wall and column of the historical building. However, the concrete slab next to the building the building was cracked and settled into the canal following the displaced riverbank.

Once the failure occurred, then the soil mass at the riverbank moved toward the canal. The void between the foundation of the building and existing soil was exposed. Soil backfilling with timber pile row installation was carried out for the surrounded buildings. Monitoring of further effect on the surrounding was conducted, with settlement points and tilt meters installed for measurement.

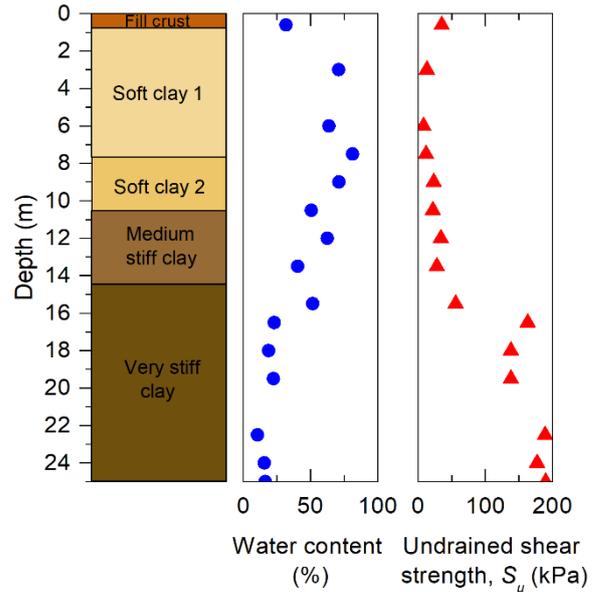
Fig. 7 Soil profile

The finite element analysis (FEM) was conducted in Plaxis 2D software (Brinkgreve et al., 2002), for which the condition of plane-strain was applied. According to the soil report, from the ground surface to -0.75 m there was a fill crust layer overlaying a soft clay layer of 10.25 m thick. Medium stiff clay was found at depths ranging from -11.00 m to -15.00 m overlaying a layer of very stiff clay. The soil profile is illustrated in Fig.7. All soil layers were modeled using the Mohr-Coulomb soil model which has been widely used for Bangkok subsoils (Rukdeeuchai, et al., 2009). Due to the short-term period of the activities, an undrained type C condition was applied in the analysis. A cohesion parameter as undrained shear strength ( $S_u$ ) governed the material behavior in the undrained type C condition while frictional angle of material was zero ( $\phi_u = 0$  degree). Soil parameters used in the analysis are summarized in Table 1.

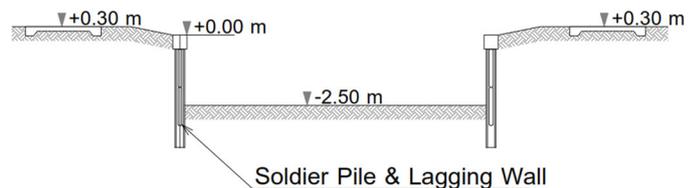
Fig. 8 Schematic of old riverbank protection

Fig.8 shows a schematic of the old riverbank protection. The riverbank of the canal was slightly sloped and covered with grass and bush for landscaping, then the topsoil (fill material) of the slope was also considered in the analysis. The modelling of the problem was performed, and the FEM mesh used in the analysis is shown in Fig.9. 4 m.-long concrete soldier pile and lagging wall were modelled as a plate structural element at the canal riverbank. Before dredging, the canal was filled with water, which led the surrounding soil to a fully saturated state at the beginning. The dredging activities were modeled as stage by stage based on the realism.

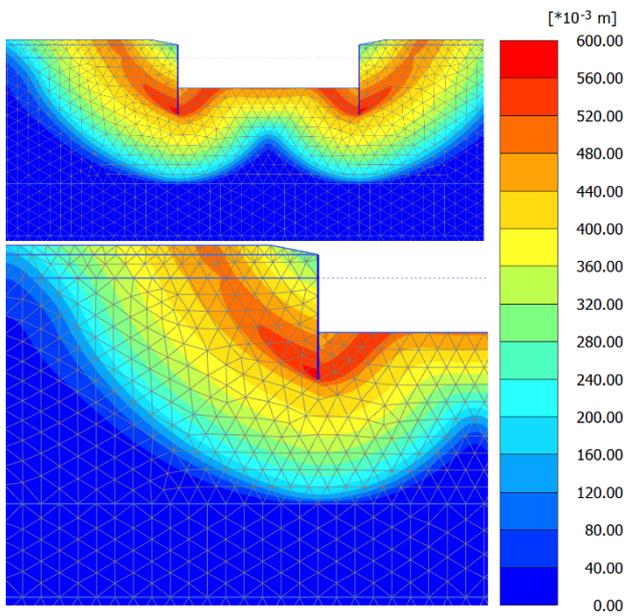
Fig. 10 Resultant displacement shading at final excavation

Fig.10 shows the shading of resultant displacement occurred at the final stage (dewatering and excavation of 2.50 m deep from the riverbank). It is seen that the maximum resultant displacement is approximately 600 mm. The results at the final stage are further discussed to clarify the cause of failure. Fig.11 shows schematic of typical retaining wall and symbols list.

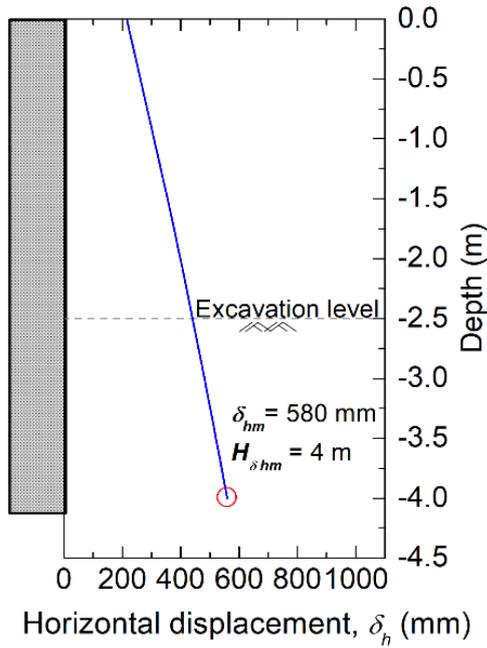
(a) Horizontal displacement of soldier pile and lagging wall

Horizontal displacement of the soldier pile and lagging wall along its depth is plotted in Fig.12a. The maximum horizontal displacement of 580 mm is highlighted and found at a depth of 4 m (the toe of soldier pile and lagging wall). Vertical displacement in terms of ground surface settlement behind the riverbank at final excavation is also observed and shown in Fig.12b. The maximum ground surface settlement is 442 mm, which locates at 3.24 m behind the soldier pile and lagging wall, related to the crack and settlement found on the walkway along the canal.

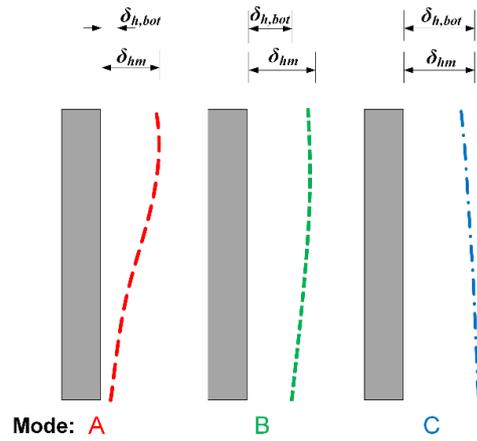
Fig. 13 Deformation modes of retaining wall (Waichita et al., 2019)

The characteristic of wall's horizontal displacement, where the maximum magnitude is at the toe of retaining wall, is similar to those field data observed in Wang et. al (2010). This horizontal displacement characteristic can be classified as mode C deformation pattern (Fig.13) according to Waichita et al. (2019); even though the retaining wall systems are difference.

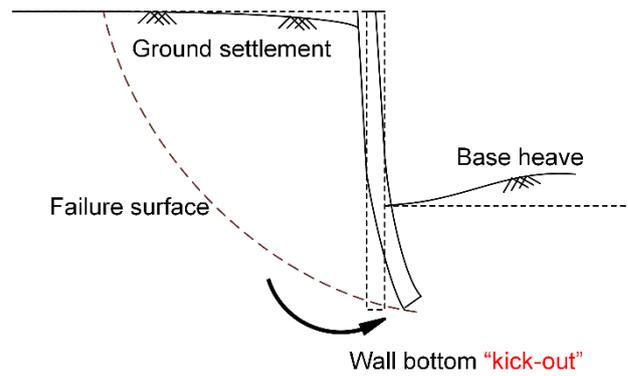
Fig. 14 Wall bottom kick-out phenomenon

This phenomenon is called “wall bottom kick-out” as shown in Fig.14. The ground surface is settled and dragged by the movement of soil and wall at the failure surface. The movement is governed by soil failure mechanism similar to those observed in previous studies (Ou, 2006). This is caused by an insufficient embedment length of soldier pile and lagging wall system compared to the excavation at the final stage.

An old riverbank wall of the canal collapsed after dewatering and excavation of the canal bed, which caused rapid drawdown instability and the phenomenon of wall bottom kick-out. Moreover, the analysis also showed that the embedment length of the soldier pile and lagging wall was not sufficient to resist the unbalanced force.
