Press-in technology to recover capacity of bridge pile foundation and application prospect in Vietnam

ABSTRACT

Key words: *Press-in, bridge foundation, pile foundation, riverbed excavation, resistance*

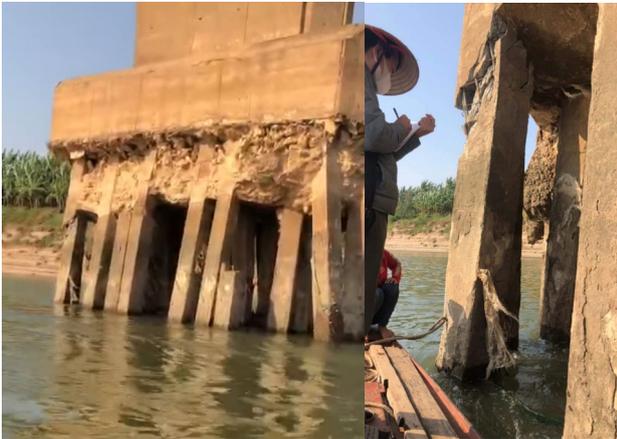
Fig. 1 The damaged Trung Ha bridge in Vietnam in 2023.

In recent years, in many countries in Southeast Asia, including Vietnam and Thailand, the process of riverbed sand exploitation has not been strictly controlled, causing significant lowering of the riverbed level in many areas, affecting the stability of the riverbank as well as construction works on the river. For river-crossing bridge projects, the lowering of the river bed causes the reduction of embedment length of the piles of the bridge pier foundation, leading to a decrease in bearing capacity compared to the original design, potentially causing damage and even bridge collapse.

Fig. 1 is the photo of a damaged bridge named Trung

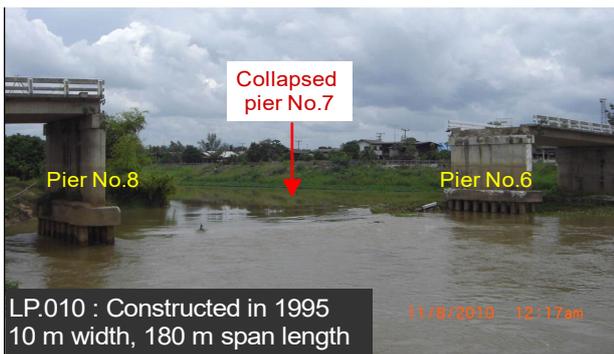
Fig. 2 The damaged LP.010 bridge in Thailand in 2010.

Ha bridge in Vietnam in 2023. **Fig. 2** shows another damaged bridge in Thailand that excessively subsided in 2010. A traditional method to repair the damaged bridges is adding new piles and expanding the foundation raft of the damaged piers. Although this bridge repairing method has overcome the consequences of bridge pier foundation subsidence, it still has not been widely applied to all bridge systems due to high cost and requiring long construction time. Therefore, in this paper, the authors propose a new method to reinforce bridge pier foundations without needing to construct additional piles and expand the foundation raft. **Fig. 3** illustrates the bridge pier foundation reinforcement method of this study, including

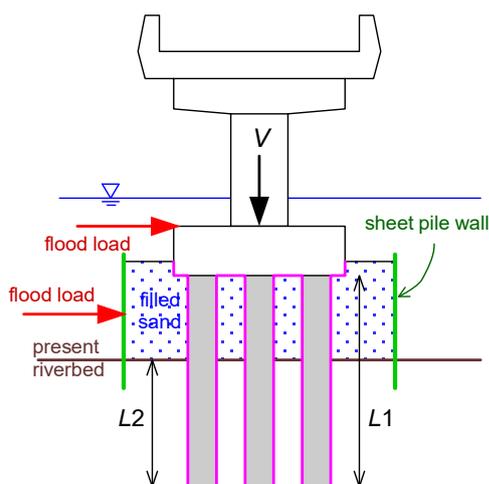
Fig. 3 The reinforcement method using Sheet Pile Wall (SPW).

two main steps as follows: First, use the Press-in method to construct sheet pile walls around the bridge pier foundation that needs reinforcement. Next, use sand or loose material to fill the foundation area inside the sheet pile wall.

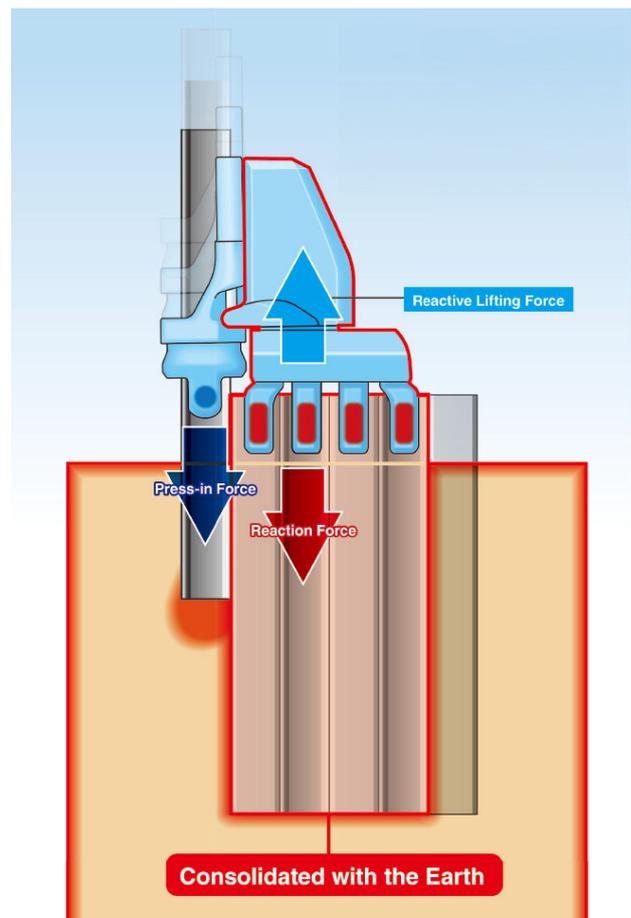
Fig. 4 The Press-in method.

The Press-in method (see Fig. 4) is a method of statically pressing piles that has the ability to minimize noise and vibration during construction, replacing the

traditional method of installing piles with hammers or vibratory hammers. The Press-in method can be used in places with extremely limited conditions such as narrow terrain, limited clearance, limited noise, on slopes, and on water... Press-in method assisted with augering and rotary press-in piling have overcome the limitations of the traditional static pile pressing method, which is inapplicable in places with difficult geology such as hard ground, rocks, and gravel. Many studies related to the Press-in method have been conducted such as White et al. (2002), Bolton et al. (2013), Ishihara et al. (2015), Watanabe et al. (2018). However, there are very few studies using the Press-in method to reinforce bridge pier foundations. Therefore, in this study, the authors conducted experimental research in the laboratory to evaluate the effectiveness of using the Press-in method to reinforce bridge pier foundations.

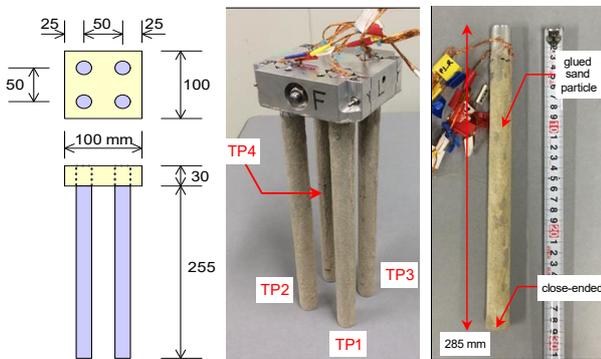
Fig. 5 The pile foundation model.

Fig. 5 shows the configurations and dimensions of the 4-pile pile foundation model. The model piles were composed with a pile cap or raft which was made of aluminium alloy JIS A2017. Geometrical and mechanical properties of the pile cap are listed in Table 1. The smaller size model piles having 20 mm diameter with 285 mm length were employed in the load tests on 4-pile pile foundation. Model piles were instrumented with strain gauges along the pile shaft to obtain axial forces, shear forces and bending moments during the load tests. Sand particles were glued on the pile shaft to increase shaft friction and to protect strain gauges from damage. Geometrical and mechanical properties of the model piles are listed in Table 2. Young's modulus, E_p , and Poisson's ratio, ν_p , were estimated from the compression tests of each model pile.

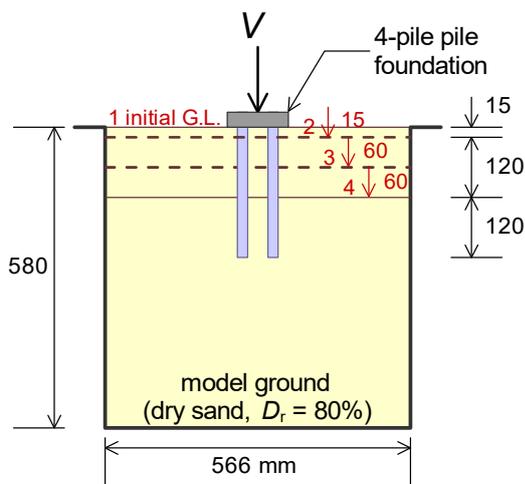
Fig. 6 Vertical load tests at the initial stage and in the embedment reduction stages.

Vertical load tests on the pile foundation model were carried out at the initial stage, in the embedment reduction stage (simulating riverbed soil excavation) and in the reinforcement stage. In the embedment reduction stage, the top ground was removed 3 times (1 time of 15 mm excavation and 2 times of 60 mm excavation) as shown in

Fig. 6 (steps No. 2 to No. 4). After the load test at step No.4, the sheet pile wall was set on the ground surface. In the reinforcement stage, the inside of the sheet pile wall was refilled with the sand in 3 steps (No. 5 to No. 7) as shown in **Fig. 7**. In the step No. 7, the pile foundation was recovered to a piled raft foundation where the raft was in contact with the ground surface again. The top sand layer was filled and compacted by steel rod to make the raft contact with the ground surface.

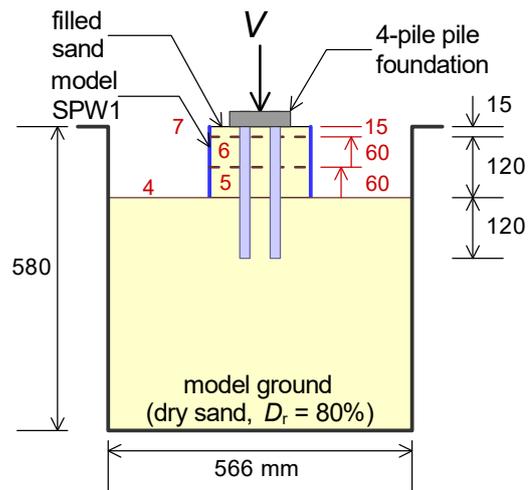
Fig. 7 Vertical load tests in the reinforcement stages.

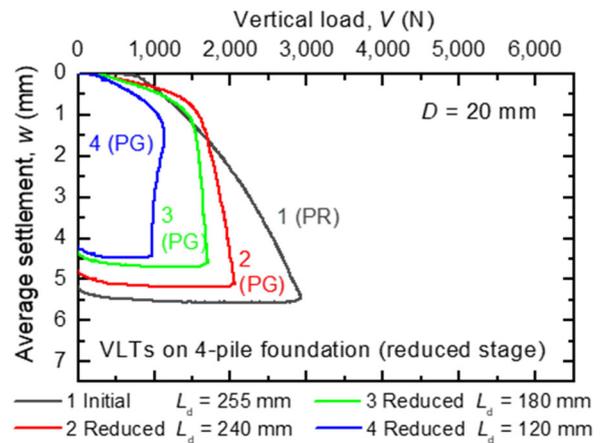
Fig. 8 Load-settlement curves of pile foundation model at the initial stage and the embedment reduction stages (Tikanta et al. 2017).

Fig. 8 shows load-settlement curves at the initial stage No.1 and in the embedment reduction steps No. 2 to No. 4. Note here that settlement was zeroed at the start of loading in each step for comparison. It is seen that vertical resistances and initial stiffness of the pile foundation decreased with the reduction of pile embedment length from No. 2 to No. 4. It is also seen that the load-settlement curves in the reduction steps No. 2 and No. 3 exhibit a plunging behaviour and the response in step No. 4 exhibits a softening behaviour, while the response at the initial stage No. 1 shows a progressive failure behaviour. **Fig. 9** shows load-settlement curves in the reinforcement steps No.5 to No.7, comparing with the results at the final embedment reduction step No.4 and the initial stage No. 1. It is seen that the vertical resistance and stiffness of the 4-pile pile foundation increased from step No. 4 to step No. 7 with increasing pile embedment length using the SPW reinforcement. In particular, the vertical resistance at the final reinforcement step No. 7 was much greater than that of the initial stage No. 1 (Tikanta et al. 2017).

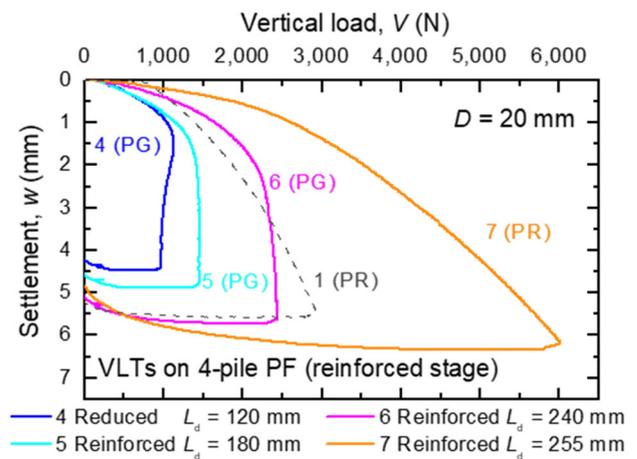
Fig. 9 Load-settlement curves of pile foundation model in the reinforcement stages (Tikanta et al. 2017).

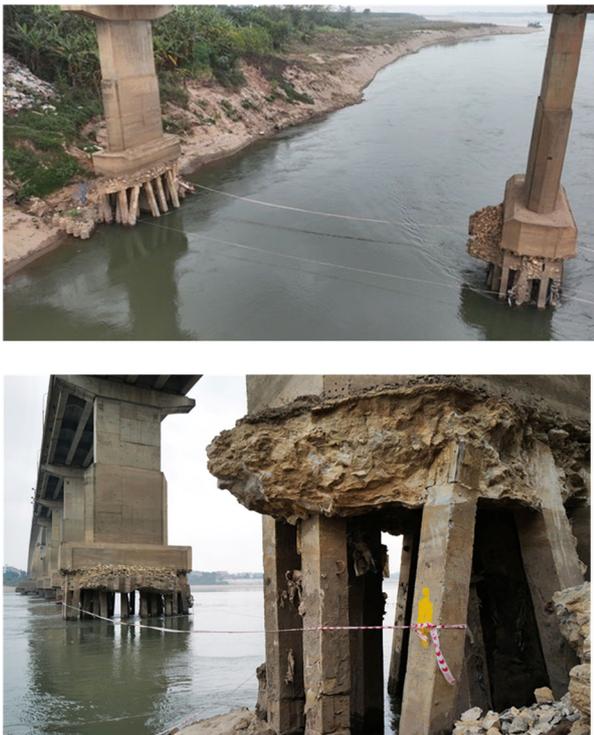
Fig. 10 Damaged bridges need reinforcement.

The network of local roads in Vietnam has more than 450,000 km of a total of more than 570,000 km of the national road network (equivalent to 88%) and serving more than 4,300 bridges about 80% of the population and 90% of the poor in the country (Nguyen and Hoang 2020). Lack of this network and low-quality roads and bridges in rural areas is one of the causes of poverty in Vietnam. This has reduced the ability to access social services, especially welfare services (healthcare, education ...), increased transportation costs, limited production transactions. To achieve the goal of poverty reduction and rural modernization, the government has focused on building and maintaining the local transportation system through programs and projects, especially reinforcing thousands of the degraded bridges (**Fig 10**).

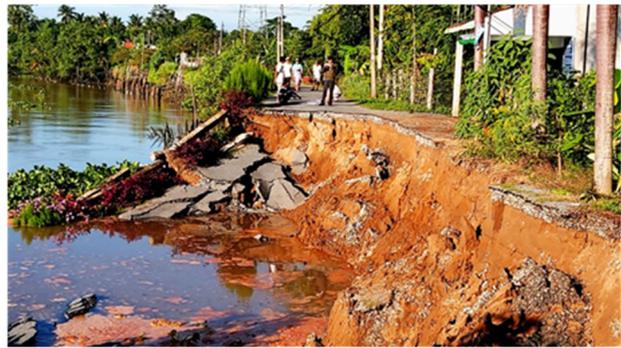
Fig. 12 Riverbank erosion in Dong Thap province of Mekong River Delta

According to reports from provinces/cities, there are 2,358 eroded riverbank and coastline sites in the country with a total length of over 3,133 km. In which, there are 206 points of special landslide (landslide directly endangers the safety of dikes, residential areas and important infrastructure) with a total length of 427 km; especially in the provinces of the Mekong River Delta with 104 extremely dangerous landslides with a total length of 293 km (**Fig. 12**), seriously threatening the lives and properties of the country and people, and causing the loss of about 300 hectares of land per year.

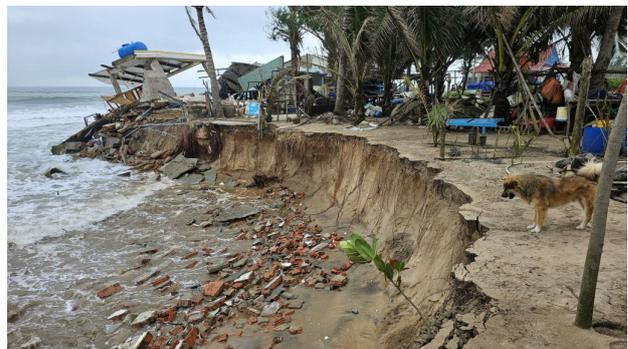
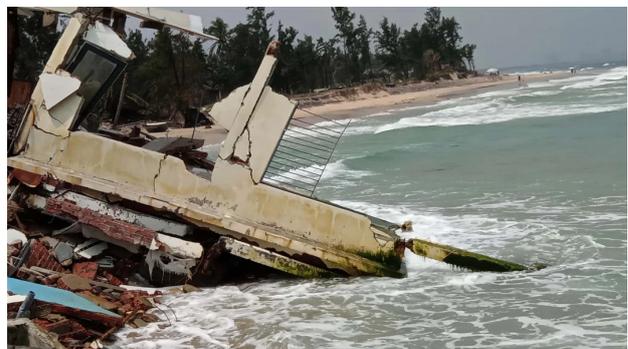
Fig. 13 Coastal erosion in Quang Nam province

Coastal erosion is a common phenomenon in coastal areas in all three regions of Vietnam, with 397 sections with a total length of over 920 km, of which erosion occurs in 233 sections with a total length of up to 492 km. Particularly, the coastal strip from Quang Nam to Phu Yen has 65 areas including 105 sections that are eroded. According to the investigation and calculation results of a group of scientists from the Institute of Geography and Quy Nhon University, the coast of Quang Nam province has 20 erosion sections of nearly 19 km (see **Fig. 13**); Quang Ngai province has 27 sections of over 35 km; Binh Dinh has 33 sections of nearly 34 km and Phu Yen province has 25 areas with nearly 21 km of erosion.

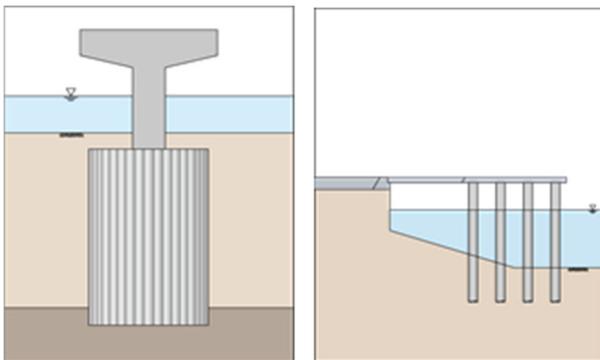
Fig. 14 Bridge pile foundation.

Sheet pile walls or tubular pile walls installed by the Press-in piling can be used as deep foundations. A steel tubular pile cofferdam foundation is commonly used, where steel tubular piles with interlocks are installed in series (Fig. 14).

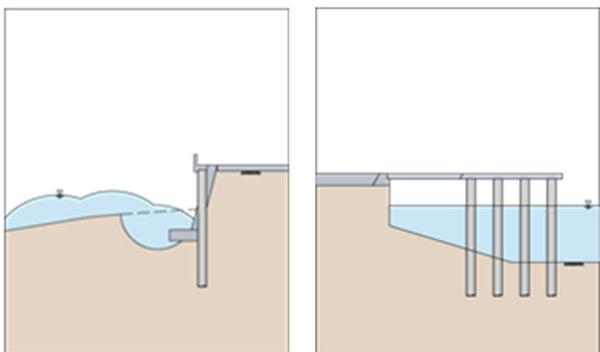
Fig. 15 Coastal protection.

Press-in piling can be used to construct embedded structures for coastal protection (Fig. 15) in a short time because it does not require a temporary platform.

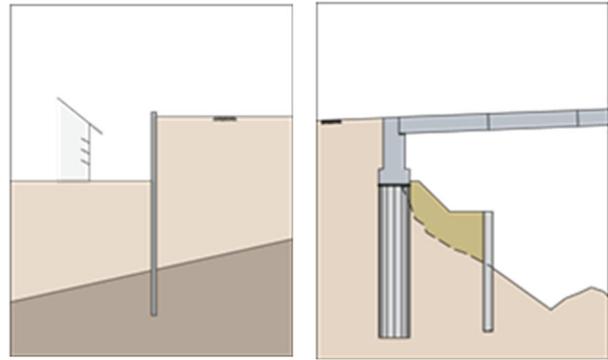
Fig. 16 Landslide prevention.

Stabilizing piles or walls can be used to reinforce existing embankments and prevent landslides (Fig. 16). Landslide prevention works utilizing steel tubular piles are widely used as measures against landslides.
