Case history of the press-in piling method on stabilization of a highly unstable steep embankment

Key words: Gyopress Method, Landslide, Continuous pile wall

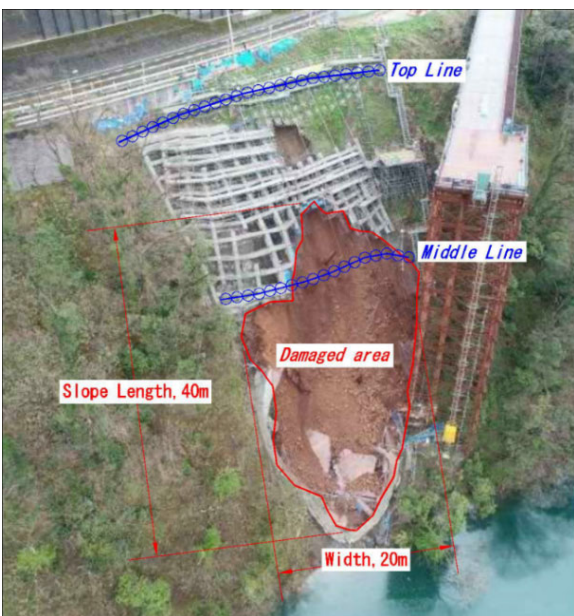
Figure 3. Status of damage^[1]

In April 2020, a large-scale slope collapse occurred. The collapsed slope, measuring 40 meters in length, and 20 meters in width, (Figure 3), affected the active National Route 41 running along the crest of the slope. Due to the ongoing risk of further collapses, approximately 2.7 km of the road near the border between Toyama and Gifu Prefectures was closed to traffic. Approximately 50 days after the disaster, a temporary road was restored, and the road closure was lifted. However, this was only a temporary solution; permanent measures needed to be taken that would not disrupt traffic on the restored road.

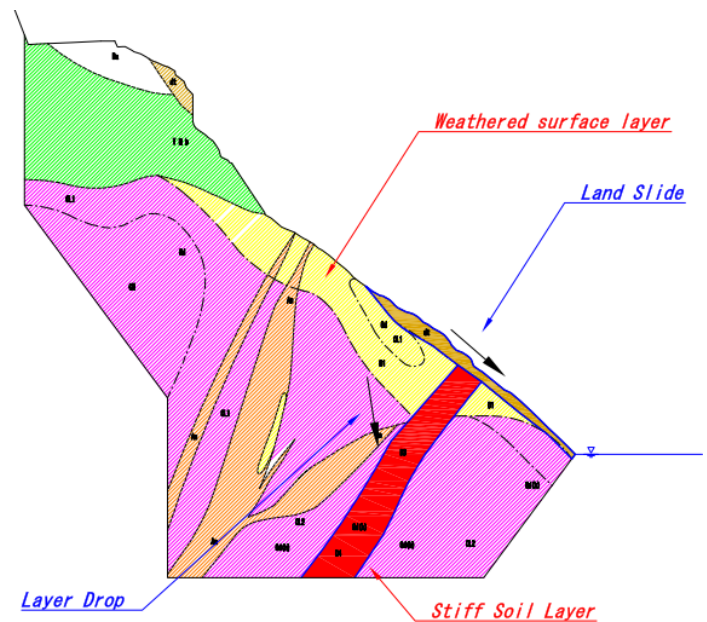
Figure 4. Geological profile

1. Ground conditions comprising weathered surface layer and stiff soil layer are complex (Figure 4)
2. Changes in natural conditions due to sustained heavy rainfall.

To address the previously mentioned factors, it was determined that a fundamental solution could not be achieved through the restoration of the collapsed surface layer. Therefore, structural configurations capable of accommodating the rigid deep-layered supporting ground were considered.

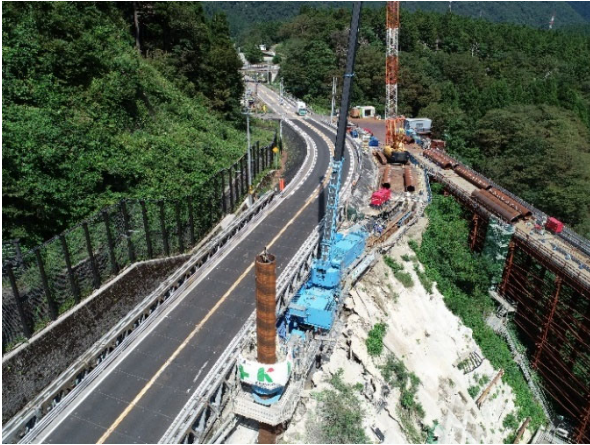
Figure 6. Machine layout (daytime)

The continuous steel pipe walls were installed using the Gyropress Method (Figure 6 and 7). Additionally, Non-Staging Method, called GRB SystemTM, was employed for the construction, where a CLAMP CRANETM, similar to the press-in machine, moved autonomously over the steel pipes to supply them to the press-in machine. The rationale for selecting this method is outlined below.

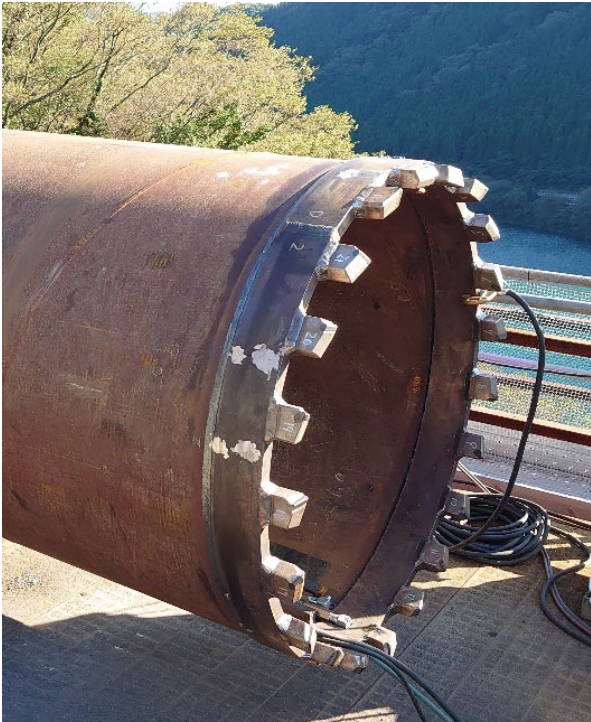
Figure 10. Cutting bits (upper row)

By selecting appropriate bits that match the ground conditions, it is possible to adapt to hard ground. For this project, 21 cutting bits were chosen for the upper row (Figure 10), while 27 cutting bits were selected for the middle row.

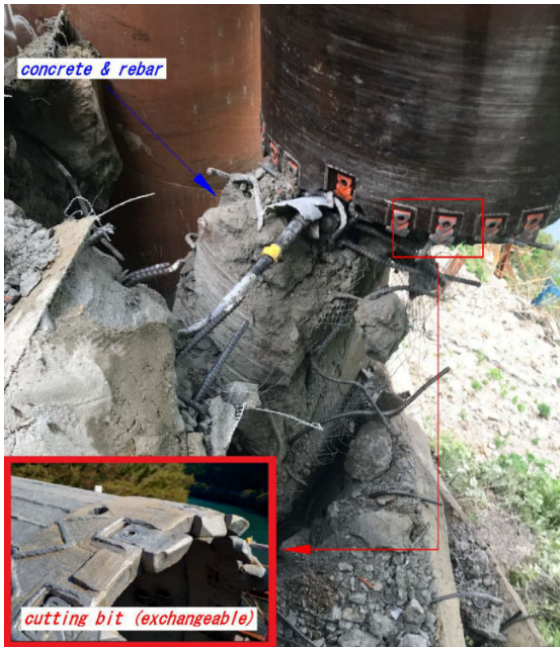
Figure 12. Removing work by core barrel

The collapsed area retained the existing structure, concrete covering, anchor steel wire, and rebar. Under these conditions, there was a risk that the construction of steel pipe piles could result in interference with the existing materials, potentially causing damage to the toes of the steel pipe piles. To mitigate this risk, it was necessary to remove or crush the existing materials before pile driving. However, entering the slope for removal work posed a danger due to the potential for further collapse. In this project, removal work was carried out using a core barrel with a GYRO PILER™ to minimize the excavated area just before driving the steel pipe piles, helping reduce the risk of collapse during construction (Figure 12). Immediate pile driving after removal also contributed to suppressing potential collapses induced by the removal work.

1. The Gyropress Method allows for rotational pressing even in hard ground layers with a compressive strength of 500 kN/m²
2. It is possible to carry out work even with existing concrete structures. The use of core barrel for removal purposes enables the integration of the usually separate processes of removal and installation into a single operation.
3. In situations requiring rapid recovery, such as during disasters, the use of the GRB System™ allows for the omission of the construction of temporary structures, expediting the recovery schedule.
4. Combining ICT technology (Implant NAVI) enables the realization of safe and high-quality steel pipe pile installation.

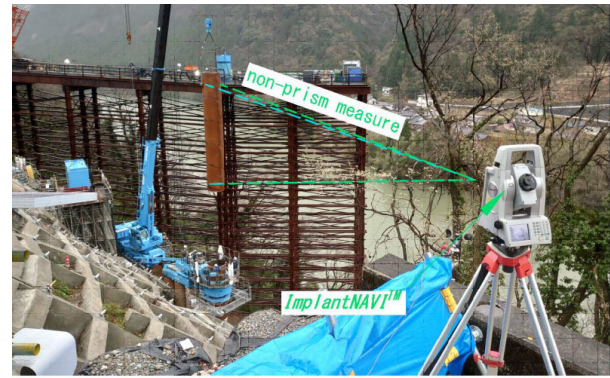
Figure 14. Measurement process

Implant NAVI™ is a tool that measures the penetration depth, displacement, and inclination of piles in real-time during construction, enabling high-precision quality management of pile construction.^[4] Before and during steel pipe piling, non-prism measurements (Figure 14) are continuously conducted using a dedicated total station.

During construction, both the upper and lower ends of the steel pipe piles are surveyed at two points each, enabling the measurement of planar and inclinations errors with respect to the designated positions without interrupting the piling operation. The measurement data is transmitted to a notebook PC terminal via Bluetooth™, enabling the real-time monitoring and adjustment of the steel pipe pile's status by the operators. This simplifies the process, condensing the usual three steps of marking the pile's designated positions, manual measurements by workers, and error calculations into a single step through the implementation of Implant NAVI™. (Figure 15)

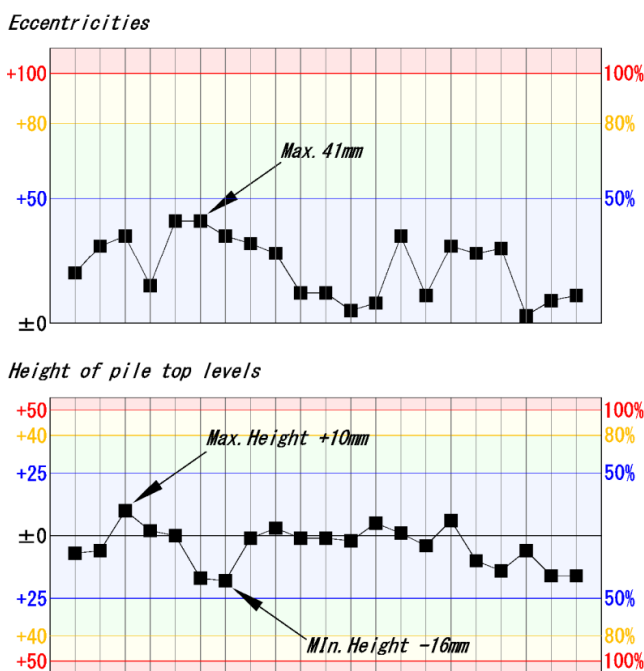
Figure 16. Measurement results

The entire surveying process during piling on this site was conducted using Implant NAVI. This project aimed to maintain the constructed accuracy within a 50% tolerance of the allowable error set by the client. After completion, the constructed form of the steel pipe piles was examined, revealing a maximum eccentricity of 41 mm (within the target value 50 mm) and a maximum difference in reference height of -16 mm (within the target value -25 mm). (Figure 16). This result indicates that high construction accuracy was achieved through quality control using Implant NAVI™.
