# Design and Installation of a Permanent Sheet Pile basement for the Manly Twenty95 Development

## ABSTRACT

**Key words:** Giken ECO600S, Permanent Sheet Pile Basement, Design, Axial load

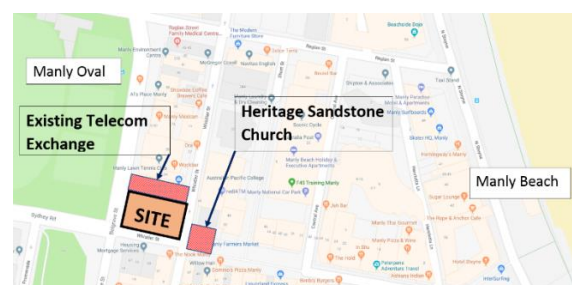
**Fig. 1** Site location

The project site is located on the corner of the busy intersection of Belgrave Street and Sydney Road in Manly, Sydney, NSW Australia – a 5min. walk from the surf beach and opposite to Manly Oval. Adjacent to the site is an existing telecommunications exchange and a heritage listed sandstone church (**Fig. 1**).

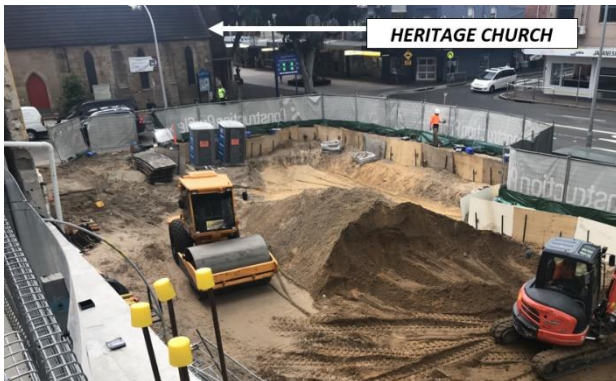
Photo 1. Site Image

The site is within the busy commercial/residential precinct of Manly and was formerly used as a park/carpark (**Photo 1**).

The client used plywood and fence posts and excavated the site about 1m before we commence our works (refer to **Photo 1**).

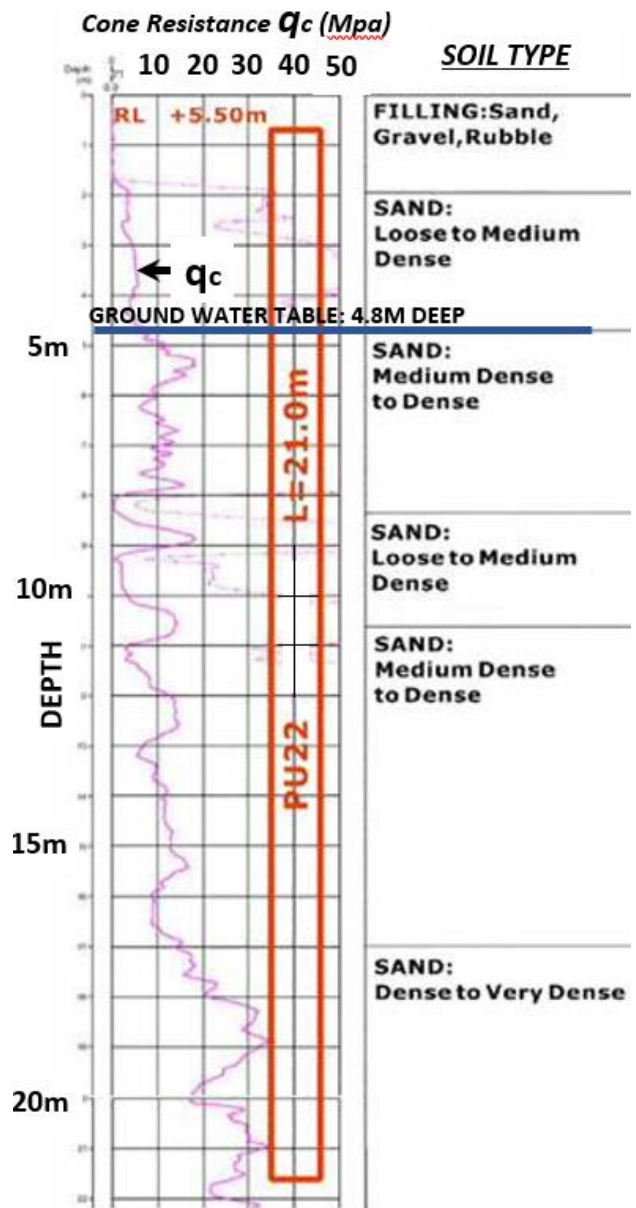
Fig. 2 Bore Hole Data

The site is underlain by Quaternary sediments comprising medium to fine grained marine sands. In this part of Manly, the sediments typically overlie Hawkesbury Sandstone at depths of 36 m to 39 m (**Table 1** and **Fig. 2**).

A number of CPT's and sampled boreholes were completed on site indicating loose to medium dense sand becoming dense then very dense.

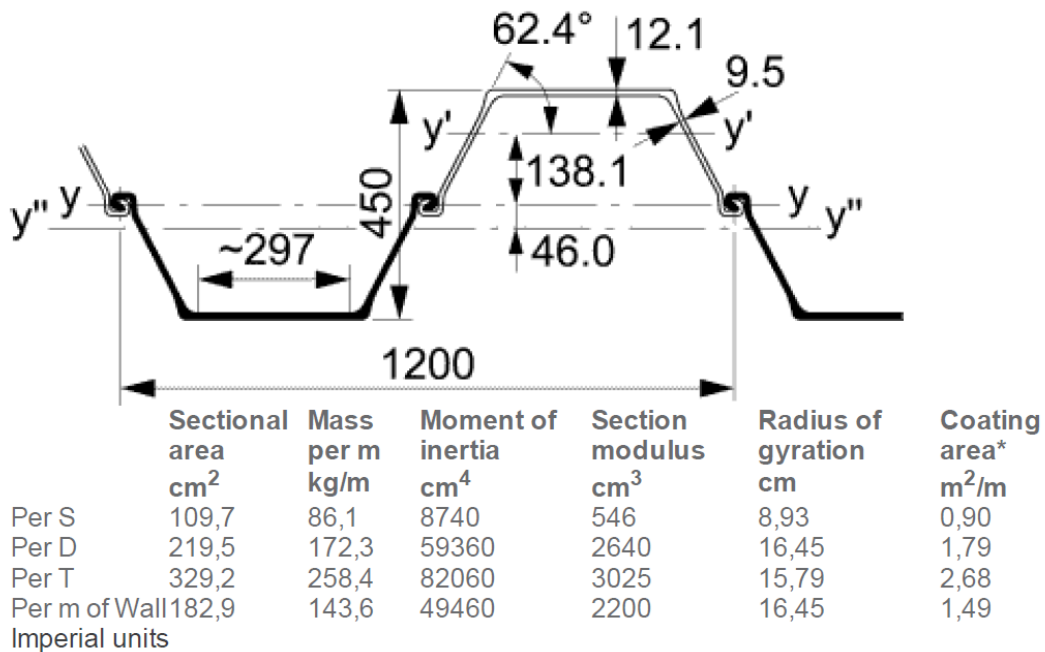
**Fig. 3** PU22 pile properties

A PU22 pile section, supplied as 600mm wide U piles, was determined as the preferred section to support the earth and water pressures in the temporary and permanent case (**Fig. 3**).

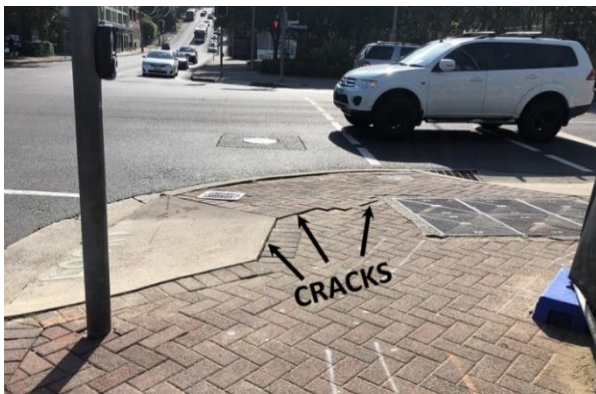
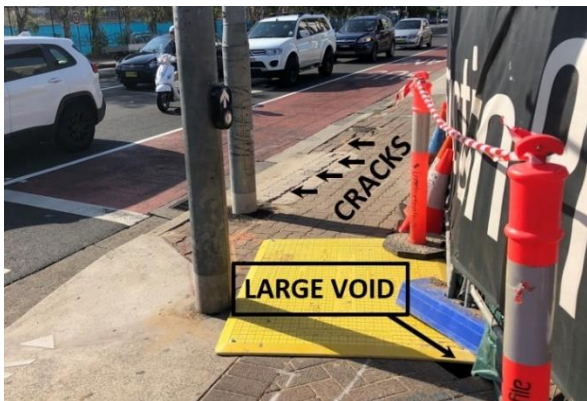
As can be seen in the **Photo 2** and **3**, we observed some crack and subsidence were caused, possibly by our augering works along the perimeter.

Patched repair of path was done by the client and fortunately no serious damaged been observed.
