Introduction of Video-CIM System to Pile Driving Construction at the Extremely Weak Ground

ABSTRACT

Key words: ICT construction, self-standing type of steel sheet pile, Video CIM management, monitoring

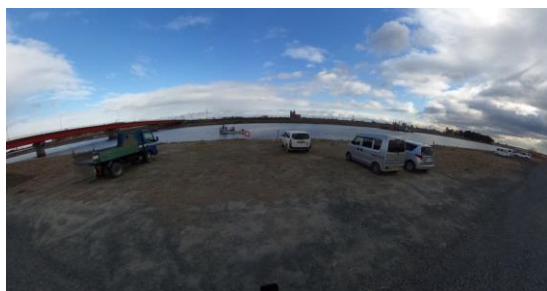
Fig. 3 View of the site through a full circumference type camera

In the project, the Video CIM (Suda et al., 2015; Kani et al., 2018) system was implemented besides an automated measurement system of pile displacement to monitor both the progress of construction and the movement of piles. **Fig. 3** shows an example of the video image ob-

tained through a full circumference type camera. The possibility of implementing the visual information system in the pile driving construction was discussed with the results of both monitoring systems.

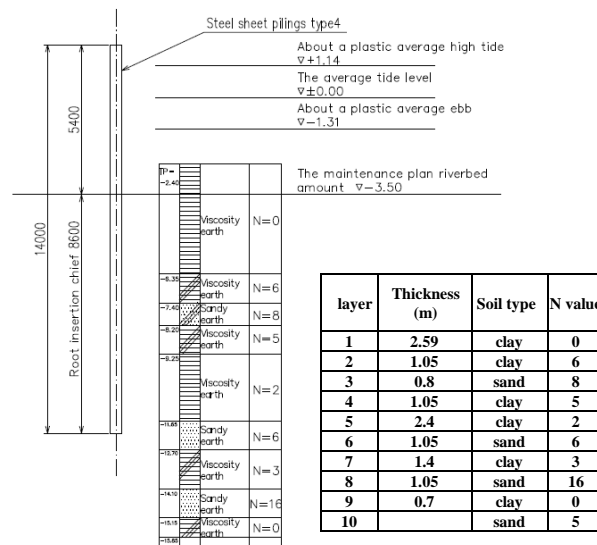
Fig. 5 Borehole log and properties of the ground

Fig. 5 shows a borehole log and the properties of the (1) Hanging work of a pile ground measured at the site. The ground was composed of alternation strata of weak clay and sandy soil. Fig. 6 shows the record of the jacking force obtained when a pile was driven into the ground. It can be grasped that the weak area is distributed from the shallow part to the deeper part at the upstream area of the river.

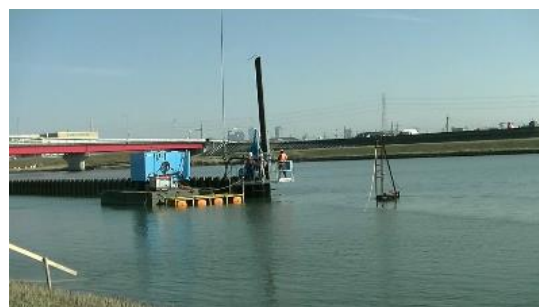
Fig. 9 Video image of the construction site

Generally speaking, the video data has a possibility to draw out various information not only qualitative information concerning physical phenomena but also their quantitative data such as displacement, deformation, vibration or so on. A network camera system was tentatively introduced in the site for grasping the site conditions and monitoring the behavior of the piles, as shown in Fig. 9. The video image taken with the camera was shared among the engineers not only at the site office but also at other offices out of the site on the PC or the mobile phone through the telephone communication system. Fig. 10 shows the video image monitored on the PC monitors of the head office. When the alarm system explained in 3.1. section caught some irregular phenomena, the site conditions were immediately checked through the video image of past hours to grasp the reason of the alarm and some countermeasures were speedily taken not to lead to a serious trouble or accident.

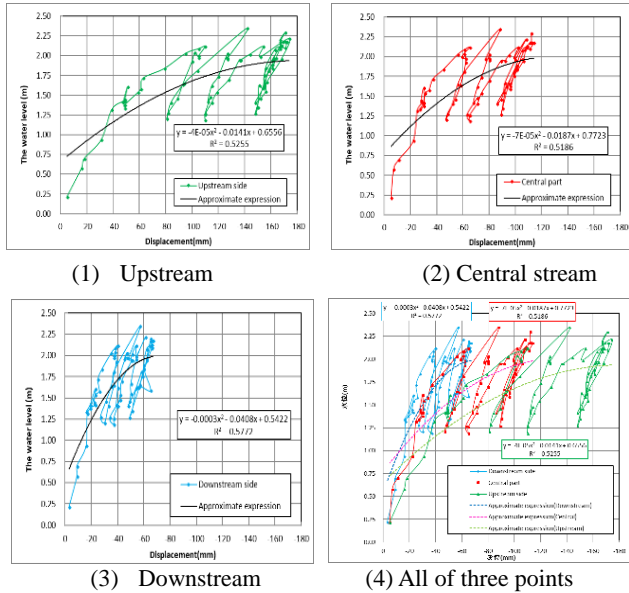
Fig. 14 Relationship between water level displacement and pile tip displacement

Fig. 14 shows the relation of the water level difference between inside and outside of the sheet piles to the displacement of the sheet pile tip. It is clearly observed that the pile tip displacement showed the typical behavior observed in the repetitive process of loading and unloading, being linked with the fluctuation of the water level difference. It is also found that the plastic displacement obviously increased with the repetitive loading process at the upstream area of the river, while the pile tip displacement showed the comparatively elastic behavior at the downstream area of the river. It can be said with

assurance that the ground became gradually weak from the downstream to the upstream and the plastic difference was induced beyond the design condition at the upstream area of the river.

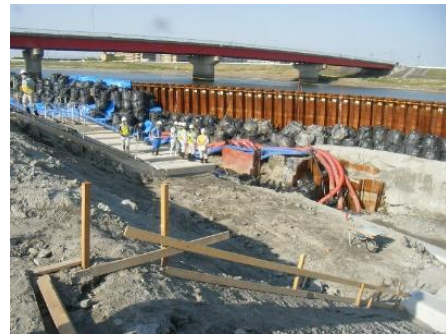
Fig. 15 Additional measure to prevent the sheet pile deformation with sandbags

The video image obtained by the camera was used for grasping the situation of the construction site, especially at the time when the larger displacement of the pile tip than the allowable displacement was measured by the displacement transducer. It was a quite effective system because the situation of the site could be grasped by engineers in charge of the project even if they were not in the site. They could give accurate directions for countermeasures against any undesirable situations. For instance, the situation of the sheet piles and the neighboring area in the site was checked with the video image shown on the monitor properly and some additional counter measures to prevent progress of the pile deformation by holding the piles with sandbags, or by removing the drainage pump to reduce the effect of water level lowering on the piles, etc. Fig. 15 shows an example of the holding works with sand bags. Fig. 16 shows the drainage pump moved from the closed area of the piles. Such rapid measures prevented a serious accident from happening in the site under the critical situation
