## Example of Construction of Sheet Pile Walls for Anti-Seismic Reinforcement of Railway Embankment

A construction of anti-seismic reinforcement of railway embankment was performed near Hirai Station in the JR Sobu Line. The site was located in a densely populated residential area. The working space was limited to the width of the slope of the embankment. Each pile was cut by four and carried in by medium duty trucks for Koshin site. On the other hand, a storage space for pile materials was prepared in Hirai site by using L-shaped sheet pile walls and excavation. The standard press-in method was adopted for Koshin site in the preliminary design. But, since it was difficult to carry in additional equipment after press-in work had processed, it was decided to use a versatile machine, ECO400S, in preparation for the probable hard ground which consisted of buried and abandoned materials in the embankment. For Hirai area, at the first pressing-in for temporally sheet piling, at 30 cm below the surface of embankment, the pile was blocked by rubbles. As a result, crush pilers were used to construct both temporally and real structure of sheet pile walls. The GRB system was used to perform

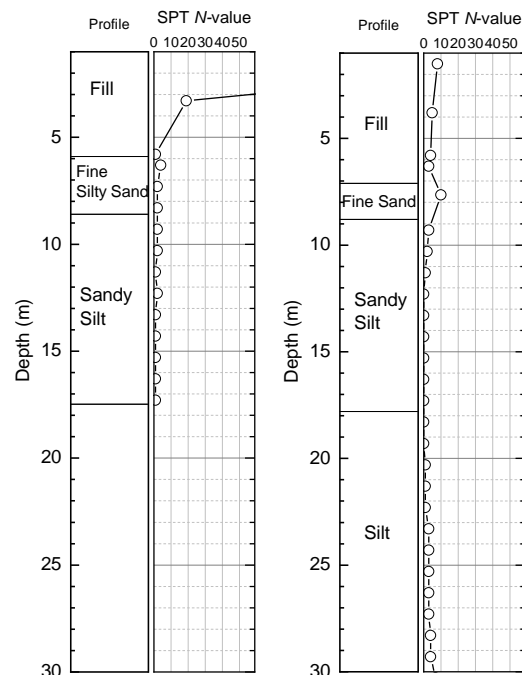
Fig. 3 Soil profiles and results of SPT

Fig. 3 shows the profiles of soil layers and SPT  $N$ -values at the site. The railway embankment was constructed on a fine sand layer having thickness of two or three meters. A soft sandy silt layer having  $N$ -values of almost zero underlay it. Some results showed high  $N$ -values from the surface to the bottom of embankment due to buried debris such as concrete blocks, bricks and so on.

As shown in **Fig. 3**, the silt layer below the embankment was very soft and augering was not necessary. Moreover, it was concerned that the resistance against extraction during press-in performance of subsequent pile became insufficient and result in forward inclination of the sheet pile. In order to overcome this problem, additional jack was provided at the front end of the piler machine. The jack was mobilized when the piler extract the sheet pile during pile installation if necessary. As mentioned above, augering was necessary only for hard contents of embankment in case that standard press-in was difficult. Total 62 of 601 sheet piling required pre-augering in Koshin site. On the other hand, most of all piles, 793 of 812 sheet piling required pre-augering in Hirai site.

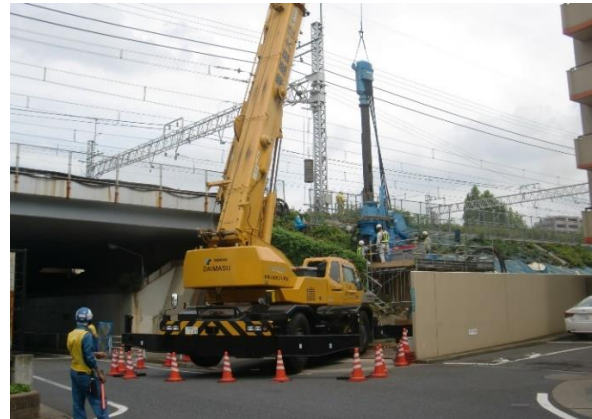
**Photo 1.** Construction of temporary working yard

**Fig. 8** shows temporary working space for Chiba side site. A rectangular space having width of 7 m and length of 40 m were constructed by means of an L-shaped sheet pile wall using type IV sheet piles having length of 7 m, with the embedded depth after excavation was 3.5 m. The first pile installation was carried out by the standard press-in. The piles were obstructed at 30 cm below the surface by debris. The piling method was changed to hard ground piling using a crush piler, ECO400S. **Photo 1** shows the piling work for the temporary sheet pile wall. The sub crane was protruded and set on the road.

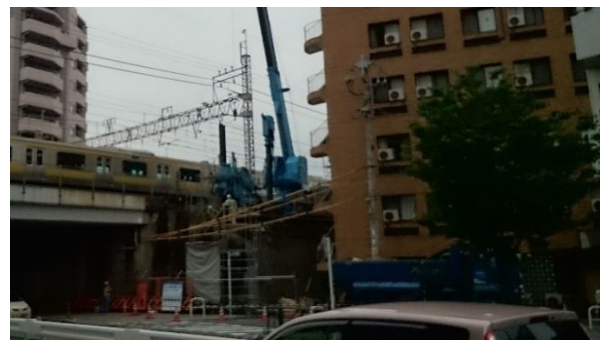
**Photo 2.** Near the end point of construction (Koshin site)

procedure was being performed. It is seen in **Photo 2** that the auger was stood between the piler and the clamp crane. This measure enabled to carry auger assembly together with the piler machine without a working space nearby. Moreover, it could avoid the danger of falling down long tall auger to a narrow space by the clamp crane.

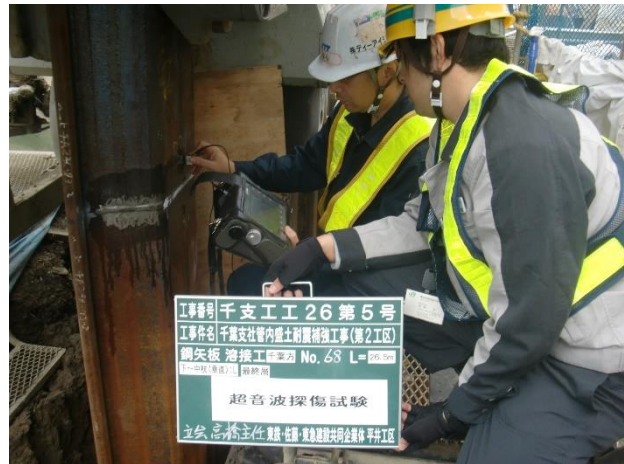
**Photo 3.** Ultrasonic test ongoing

For a permanent structure, welding joint was managed strictly in terms of its quality. Welders skill was tested at some initial welding stages under supervising by the official. The test of welding for one weld joint consisted of penetration test (PT) for the first pass, PT and ultrasonic test (UT) for the last pass and again PT for stiffening plate. These tests were conducted every 30 piles. In addition, the welding supervision engineer was obliged to stay resident in the site.

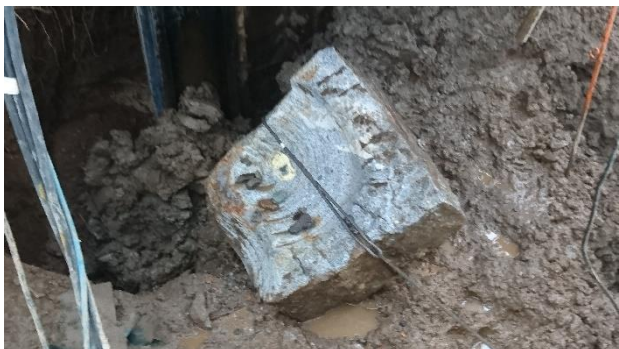
**Photo 5.** Fragment of granite shows trace of auger head

The embankment contained various unpredictable objects. In this site, the piling was obstructed quite often. **Photo 4** shows the exposed concrete structure after excavation for the temporary yard. The augering was partly interfered by the edge of the concrete and sheet piles were installed with slight inclination. In the main construction of the Tokyo side of Hirai site, a hard granite fragment was removed from augering hole. Surface of the fragment was carved by the auger head as shown in **Photo 5**. Besides this, we encountered embedded reinforced concrete and frequently the reinforcement twisted around the auger head.

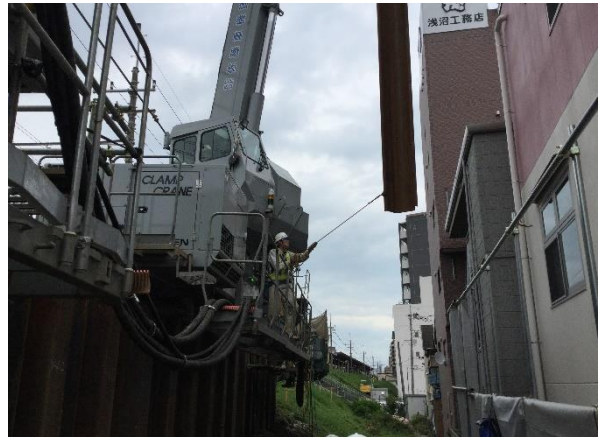
**Photo 6.** Clamp crane slewing at the minimum radius

The narrowest part was at the nursery school in **Fig. 7**. In the preparation stage of Hirai site, the structure had not been built yet and the ground was used as an open-air car parking lot. The general contractor decided to rent this space during the construction period. Unfortunately, the building was constructed, and the distance between the wall of building and the sheet pile center was 2.5 m. It was a minimum radius for a clamp crane to lift sheet piles vertically and turn to the piler for pile installation. Using an assist rope to prevent swaying of sheet piles, it barely succeeded in making rotation of a clamp crane. (**Photo 6**)
