Damage survey after The 2016 Kumamoto Earthquake

-Confirmation of tough Implant structure-

Dr. Tadahiko Okumura

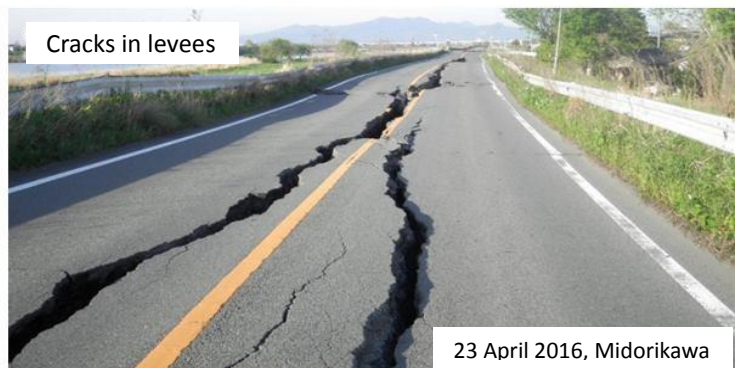
Photo 1

The typical example of earthquake damages is a viaduct construction site of local railway and Kyushu Shinkansen (Bullet train) between Fukuoka Prefecture and Kagoshima Prefecture near Kumamoto station of JR Kyushu Railway Company. The slight cracks on the ground surface in access railway line were investigated at the site of continuous steel pipe walls of diameter 800 mm. However main body of Implant structures had no damage, though levee walls and soils adjacent to main railway line deformed largely laterally (See photo 1).
