# Steel Pipe Piles, Tubular Sheet Piles, Steel Sheet Piles Confronting Natural Disasters

Toshiharu Hirose

Japanese Technical Association for Steel Pipe Piles and Sheet Piles (JASPP)

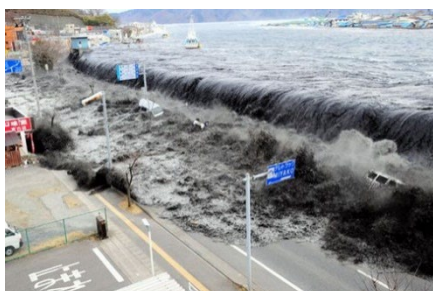
Photo 1.7 A huge tsunami that hit Miyako city, Iwate Pref<sup>10)</sup>

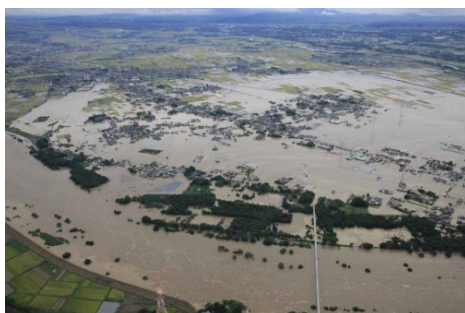
Typhoon No. 18, which occurred on September 7, 2015, went north over the southern Sea of Japan. After making landfall on the Chita Peninsula of Aichi Prefecture at around 10:00 on September 9, it advanced to the Sea of Japan and became an extratropical cyclone at 21:00 on the same day. After that, due to the influence of the moist air of Typhoon No. 17 flowing from the south into the low pressure that had changed from the typhoon, heavy rains spread over a wide area from western Japan to northern Japan, and the Kanto and Tohoku regions experienced record rainfall. In particular, from September 9th to 10th, Nikko City, Tochigi Prefecture, recorded 551 mm of rainfall in 24 hours, which was the highest since observation began in 1975, and other observation points (16 points) also broke observation records for the 24-hour precipitation. Under these circumstances, heavy rain special warnings were issued by the morning of the 10th in Tochigi and Ibaraki prefectures. The Kinugawa River overtopped and overflowed in Ibaraki Prefecture, which is located in the midstream region. In the early afternoon, the embankment on the left bank of the Kinugawa River in Misaka-cho, Joso City, collapsed for approximately 200m. Eventually, a wide area in Joso City sandwiched between the Kinugawa River and the Kokaigawa River was submerged, the city hall main building, which had been completed the previous year, was flooded, and more than 5,000 houses were completely or partially destroyed, causing extensive damage due to long-term flooding (Photo 2.1). The levee breach of the Kinugawa River was the first case since it had occurred in Tochigi Prefecture in August 1949, and the levee breach of a state-managed river in the Kanto region was the first since it had occurred in the Kokaigawa River in August 1986.

Photo 2.1 Flooding situation in Joso City, Ibaraki Prefecture (9/10)<sup>15)</sup> (Provided by Kanto Regional Development Bureau, Ministry of Land, Infrastructure, Transport and Tourism)

The restoration work for the collapsed levee was carried out for two weeks as an emergency restoration by means of a rough cofferdam and steel sheet pile double cofferdam (Fig. 2.1). After that, in January 2016, during the non-flood season, the main restoration work was started. After removing the rough cofferdam and the steel sheet pile double cofferdam that had been constructed during the emergency restoration work, the embankment foundation was replaced, impermeable steel sheet piles were installed to prevent water leakage thorough embankment, and the embankment and bank protection work was carried out and completed at the end of May.
