Field reconnaissance insights from the 2024 Noto earthquake

ABSTRACT

Key words: 2024 Noto earthquake, reconnaissance, Sheet pile, Liquefaction, Landslide

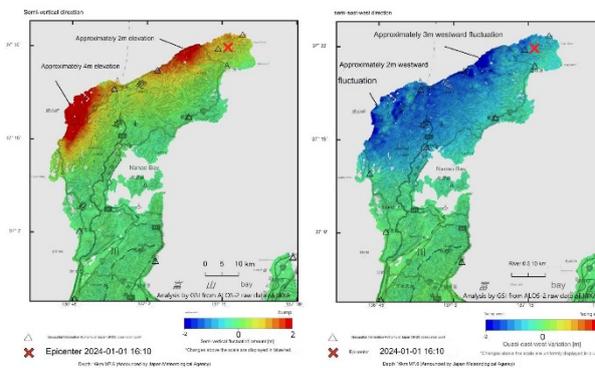
The 2024 Noto Peninsula Earthquake significantly altered the region's coastal landscape. SAR intensity images captured by the ALOS-2 satellite before and after the earthquake show extensive land emergence, particularly around Minazuki Bay, where the coast extended seaward by about 200m. This was due to a substantial uplift of approximately 4m in the region. Utilizing both satellite imagery and aerial photography, it was estimated that a total of 4.4 km² of new land was exposed along the coasts of the Noto Peninsula. **Fig. 5a** depicts a section of a concrete wall at Kuroshima Port in Wajima, which was raised nearly 3m. **Fig. 5b** illustrates the near-vertical and east-west directional deformation of the Earth's crust.

Fig. 5 (a) Coastal crust uplift at Kuroshima Port in Wajima **(b)** Crustal deformation distribution map (Modified from GSI crustal deformation Map, 2024)

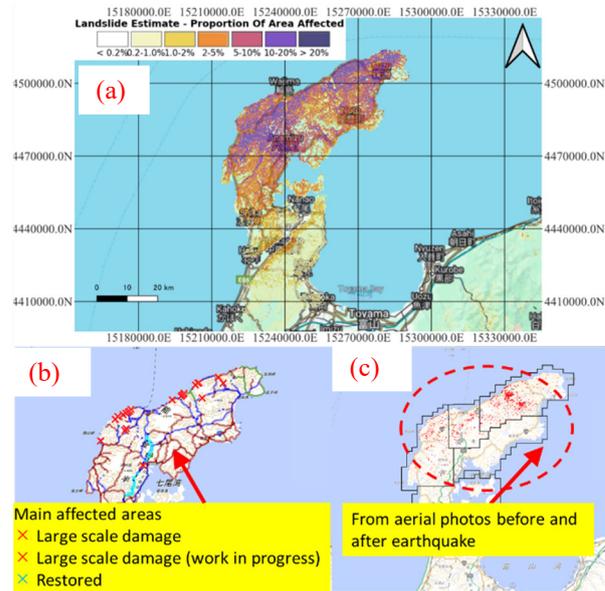
terrain. An extensive number of landslides occurred, as revealed by aerial imagery captured by the Geospatial Information Authority of Japan (GSI). **Fig. 12(a)** and **(b)** show the landslide estimates provided by the United States Geological Survey (USGS), illustrating the distribution and extent of slope failures and sediment depositions from GSI data, courtesy of the Ministry of Land, Infrastructure, Transport, and Tourism (MLIT). The correlation between the observed and estimated landslide distributions post-earthquake is notably strong. **Fig. 12(c)** displays the roads that have sustained significant damage and are either under restoration or have been restored.

Fig. 12. (a) landslide estimates due to the 2024 Noto earthquake by the USGS (b) distribution and extent of slope failures (c) distribution of roads with significant damage
