# Flash Report on Damage Caused in Mexico City, Mexico, by the 2017 Puebla-Morelos Earthquake

Tsuneo OHSUMI

## ABSTRACT

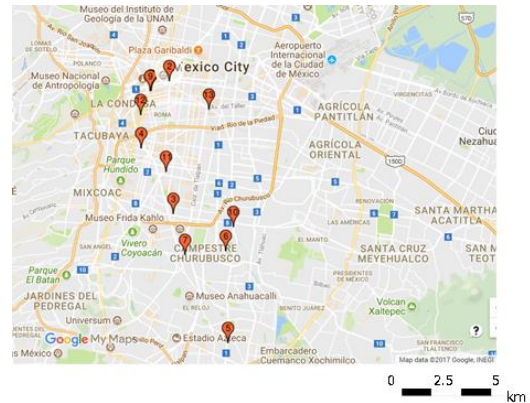
After obtaining approval from the Emergency Committee, the demolition work started on October 10, 2017 in the CDMX. There are 13 buildings already confirmed for demolition, since it was specified that in the first three cases, the state will use surveyors and an engineering team to determine the demolition method. These 13 buildings were selected as survey points in this study as shown in **Figs. 3.1** and **3.2**.

**Fig. 3.1** Map showing the 13 buildings designated for demolition (Google Maps®)

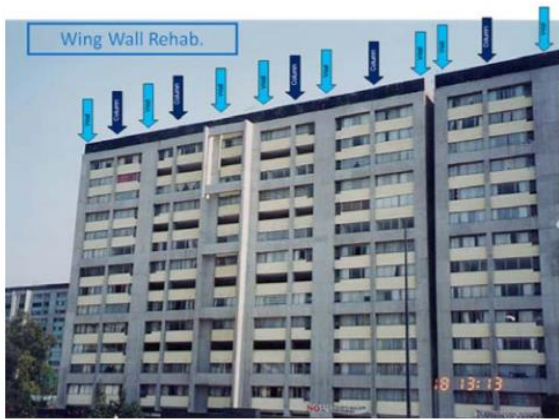
The Tlatelolco Complex area was heavily damaged in the 1985 earthquake. For example, the 14-story RC Nevo Lion building in the Tlatelolco Complex, which included a north side and southern wing connected by an Expansion Joint, suffered a collapse of the two north side buildings that resulted in many casualties. After the 1985 earthquake, the Nevo Lion was renovated with new wings and walls with JICA (Japan International Cooperation Agency) support (**Fig. 3.4**).

**Fig. 3.4** Renovated Tlatelolco Complex, after the 1985 earthquake. (Courtesy of Prof. Nakano with Tokyo Univ.)

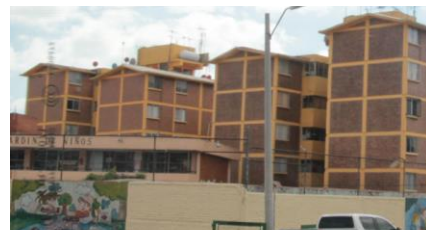
**Fig. 3.7** Typical housing in Mexico City. (photo taken by T. Ohsumi on November 21, 2017)

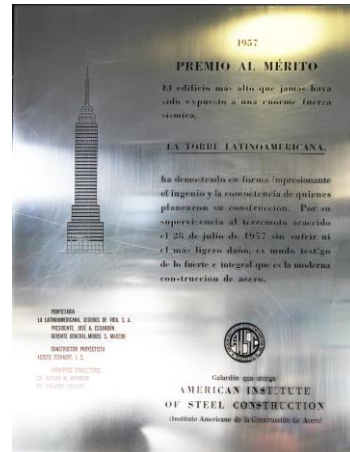
**Fig. 3.11** Memorial plate in the Latin American Tower. (photo taken by T. Ohsumi on November 21, 2017)

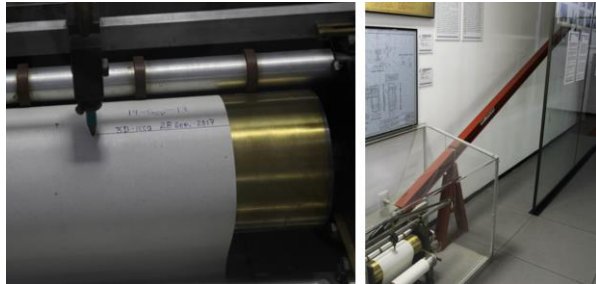
**Fig. 3.13** Deformation meter in the Latin American Tower. (photo taken by T. Ohsumi on November 21, 2017)

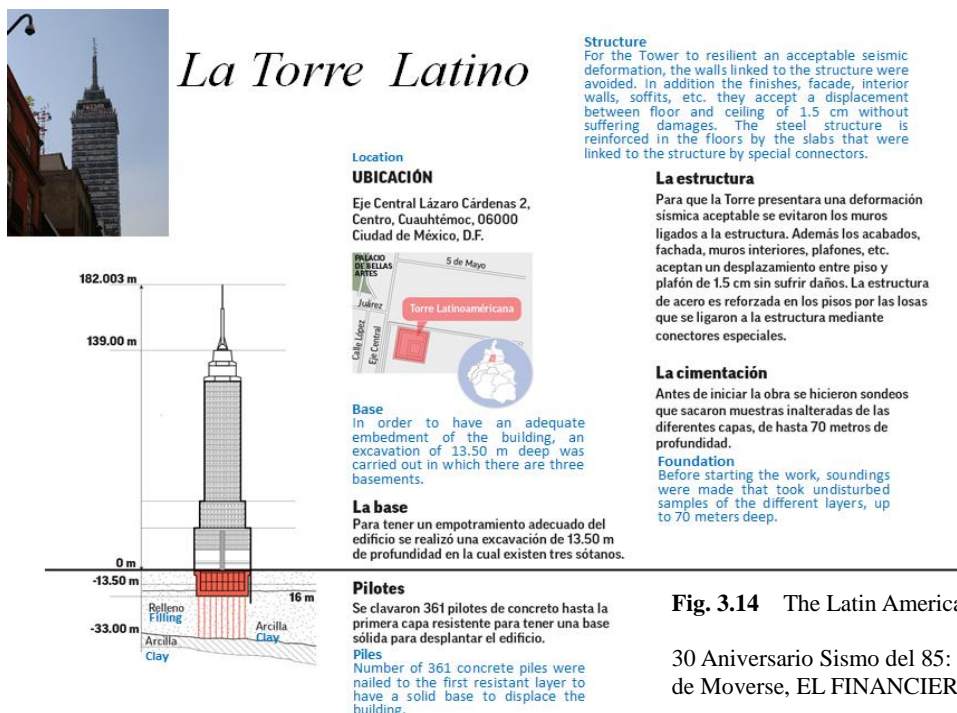
The Latin American tower was inaugurated on April 30, 1956. It was designed by Adolpho Zeevaert, in consultation with N. Newmark and Leonardo Zeevaert. The Latin American Tower is a source of pride for the inhabitants of the Mexico City metropolis, as it broke several engineering records during its construction using Mexican technology. The structure survived the 1957, 1978, 1979, 1985 and also the September 2017 earthquakes with only minor nonstructural damage. A memorial plate was installed in the Latin American Tower (Fig. 3.11) and it describes how the Tower has been able to sustain multiple episodes of strong seismic forces. Figs. 3.12 and 3.13 show the seismometer and deformation meter of the tower, respectively. Deformation is registered as the proportion of movement within a range of permissible values in the tower. Fig.3.14 shows the Latin American tower technology.

**Fig. 3.14** The Latin American tower technology.

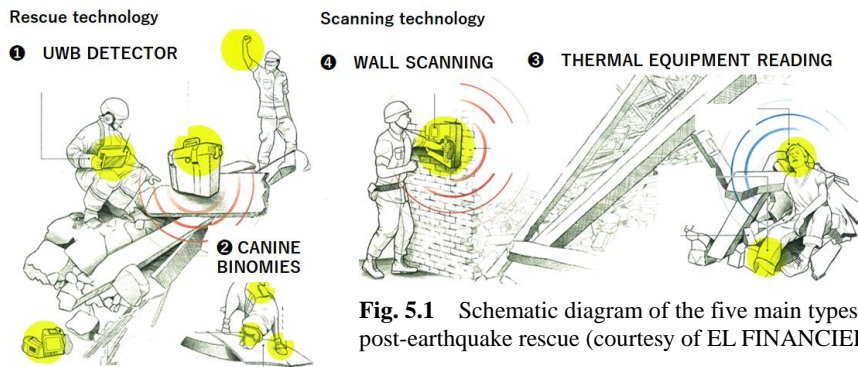
In addition, the “canine binomials” are important additions to the rescue efforts, and consist of a trained rescue dog and a handler. The relationship between the two, and with the individual being rescued, is one of trust and empathy. The dogs are able to detect even faint odors of buried individuals and their physical dimensions allow them to travel through smaller spaces than humans would be able to. Navy’s staff is responsible for training the dogs for 12 to 14 months, and they are employed in rescue tasks for six to seven years. **Fig. 5.1** shows the scanning technologies, which are described in detail below.

**Fig. 5.1** Schematic diagram of the five main types of scanning technology used in post-earthquake rescue (courtesy of EL FINANCIERO, September 22, 2017)
