Case History-3

Control Measures for Installation and Removal of Temporary Earth Retaining Walls

Dr. POH Teoh Yaw

Geotechnical Engineering Department, Building and Construction Authority, Singapore

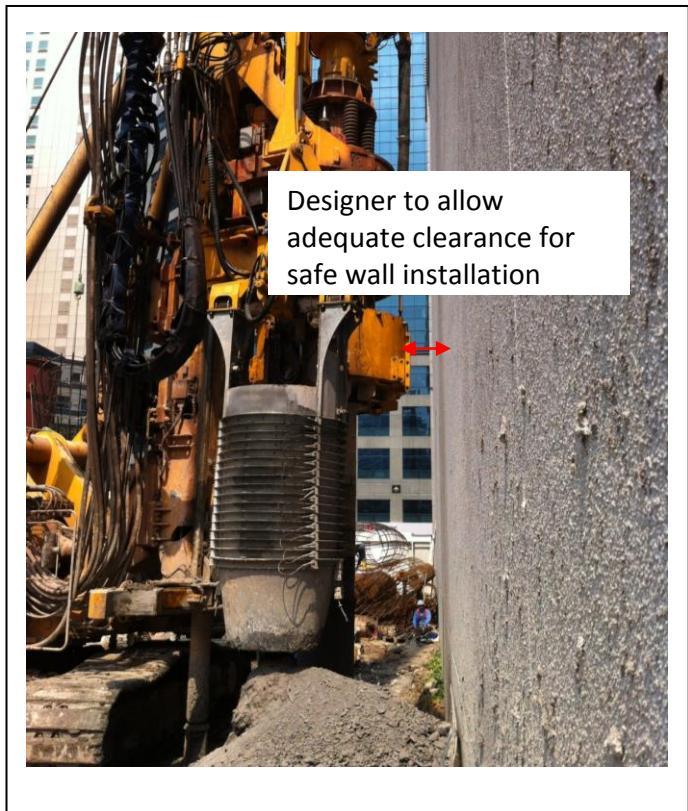
Picture 1

As the city developed, buildings get closer. Due to high land prices in the city, developer may need to optimise the land use. This often resulted in basement constructed next to adjacent buildings. Such situation poses great challenges to the construction team. Installation of retaining wall in close proximity to existing buildings requires proper selection of machinery and tools and proper control and supervision of the piling works. In addition, designer should also need to allow adequate set-back distance for the safe installation of the retaining walls. Damage to the neighbouring building may cause unnecessary repair cost and also delay in construction program. Figure 1 shows an example of installation of retaining wall in close proximity to existing building. Figure 2 shows a typical basement construction in close proximity to existing building where various control measures can be adopted to minimise potential damage to adjacent buildings.

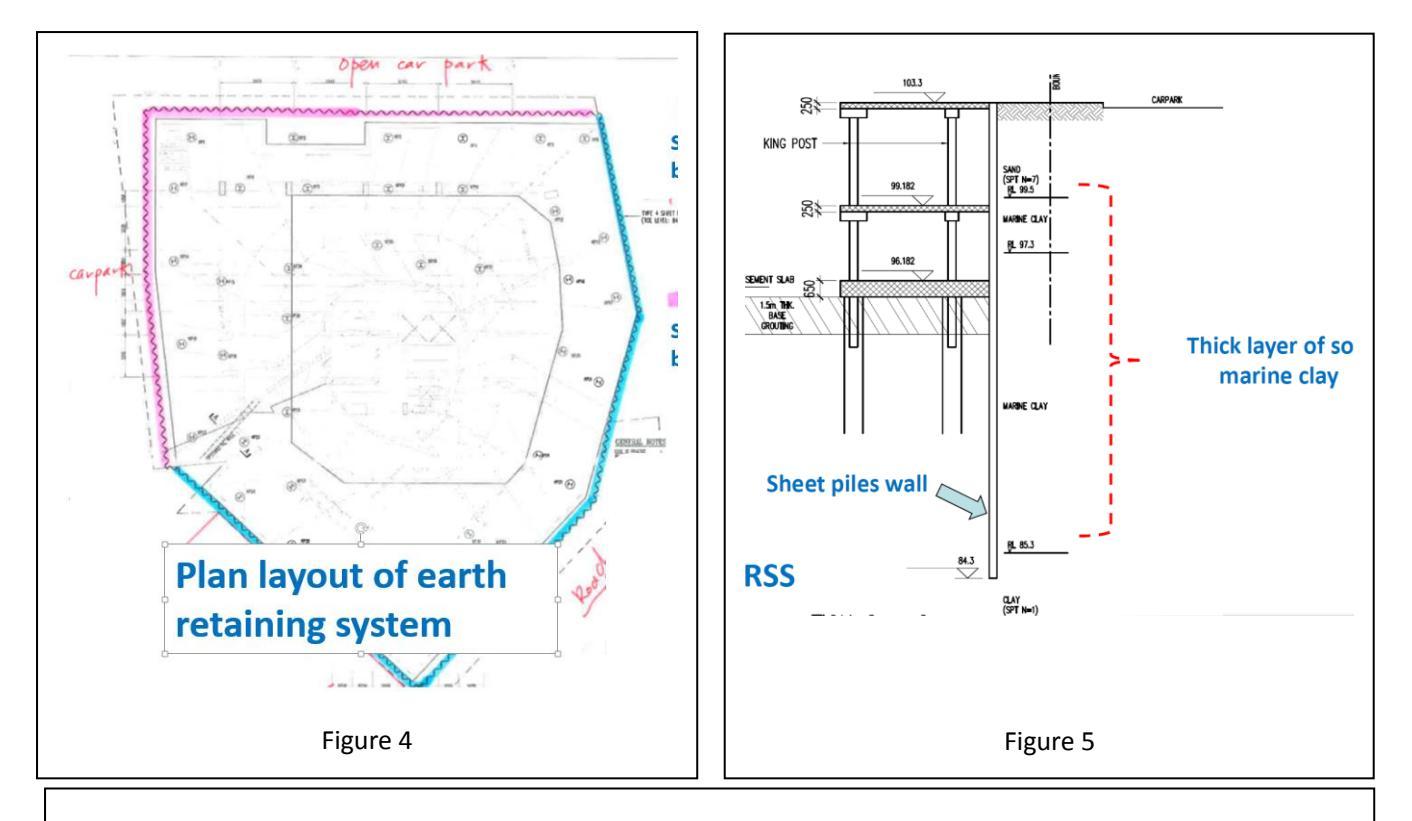
Figure 4 shows a plan layout for a high-rise private residential development with 2-level of basement. Figure 5 shows the section of the retaining wall system. The ground conditions consisted of Fill layer overlying a thick layer of soft marine clay. Sheet pile wall and compressive ring slabs (where part of the permanent basement slab was used as compressive ring to support the basement excavation) was adopted as retaining system. Such retaining wall system is getting popular among designer in Singapore as it is a robust retaining system that able to provide effective support to restrict ground movement, and hence minimizing potential damage to the adjacent buildings. Ground movements at the end of basement construction was within its design limit as shown in Figure 6. The builder decided to remove two sections of the temporary sheet pile wall next to open car park. Vibro-hammer was used for the sheet pile extraction. Excessive ground movement was observed after the sheet pile extraction and the open car park and the adjacent road was damaged. This case study show that it is necessary to implement control measure such as proper equipment and method statement during sheet pile removal to avoid potential damage to adjacent properties.
