Contribution of geotechnical engineering towards recovery from damage caused by the 2011 Tohoku earthquake - Summary of the 2019 Ishihara Lecture in Rome -

Ikuo Towhata

ABSTRACT: The 2011 Tohoku earthquake with the moment magnitude of 9.0 caused unexpected and disastrous damage over the entire Tohoku and Kanto Regions of Japan. While tsunami damage has been widely known, liquefaction affected people's properties as well. The post-earthquake reconstruction of communities addressed many geotechnical issues, and the present paper attempts to introduce them to readers within the limited page allocation.

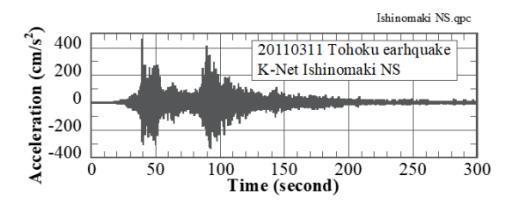
Fig. 3. K-Net acceleration record of Tohoku earthquake at Ishinomaki

People's doubt on safety of nuclear power plants and the consequent closure of most reactors were of substantial economic influence. Although they are important as well, the present paper cannot touch upon them due to page limitation. The seismic aftermath was characterized by the long duration of aftershocks (Fig. 2). Because strong aftershocks continued for many months and there was a fear that another big "one" was coming soon, it was difficult to resume the recovery efforts immediately after the earthquake. Another difficulty came from the long duration time of strong shaking (Fig. 3) because of the huge seismic energy (Mw=9.0) and a need for revised design codes was felt. Another issue is the coseismic subsidence in the coastal area (Fig. 4). Because the subsidence exceeded 1 meter in the epicentral area, tsunami height relative to the ground level became higher by the same amount than the original expectation.

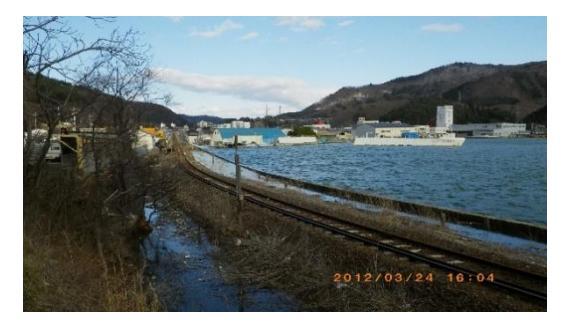
Fig. 4. Lowered ground level due to coseismic subsidence in Bansekiura near Sendai City

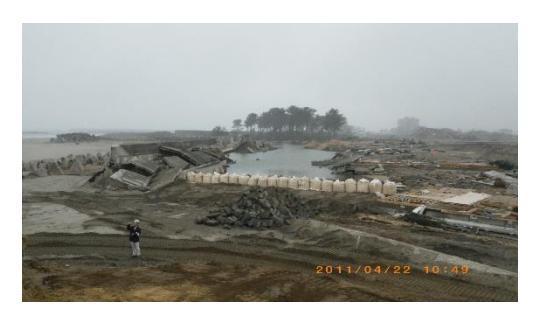
Tsunami is a phenomenon of water but mitigation of tsunami damage is closely related with geotechnical engineering. Fig. 5 demonstrates the shape of a sea wall destroyed by incoming tsunami. Sea water overtopped the wall and scoured the landside foot of the embankment. After the wall was lost during the first tsunami attack, the following tsunami attacks were able to flow into land without much resistance. This implies the need for scour-resistant design of sea walls. It is noteworthy, further, that the former tsunami disaster in Banda Aceh in Sumatra, Indonesia, in 2004 was characterized conversely by the effects of retreating water whose flow concentrated at the weakest points of sea barriers, as eyewitnesses told the author during his reconnaissance.

Fig. 5. Damaged seawall near the Abukuma River mouth

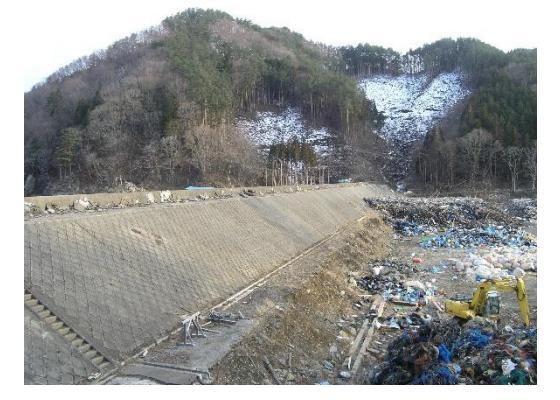
daily life because people were living mainly on fishing in the sea. Thereafter, the national government constructed high sea walls to protect many local communities. Fig. 7 shows one of them in the Tohni-Hongo Township. The height of this wall was designed by considering the tsunami height in 1896 that was the highest in the known history. Then, people felt safe and came back to the coastal area behind the new wall. It was unfortunate that the tsunami in 2011 was even higher than the wall and the community was destroyed (Fig. 8). If the community had remained in the high places, nobody would have been killed in 2011, although living on fishing would have been inconvenient. This tragedy shows that empiricism cannot always give us perfect safety and that we have to overcome a dilemma between safety during rare natural disasters and convenience in daily life.

Fig. 7. Sea wall in Tohni-Hongo that was constructed prior the disaster in 2011

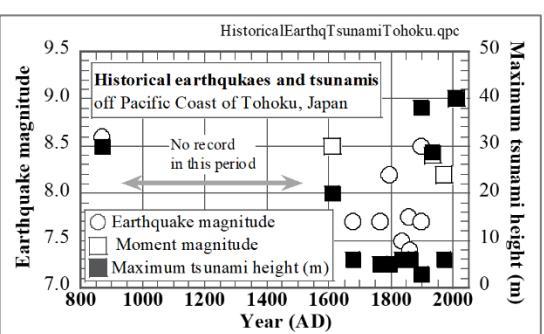
The disaster in 2011 showed a very difficult feature of tsunami disaster mitigation. The coast of Tohoku Region experienced big tsunami disasters in 1896, 1933 and 1960 prior to 2011 (Fig. 6). The memory of the gigantic event in AD 869 had been gone after many centuries. Following the 1933 disaster, many local communities decided to relocate their sites to higher places where the risk of tsunami was obviously negligible. Then the problem was the inconvenience of

Fig. 6. History of devastating tsunami in east coast of Tohoku Region

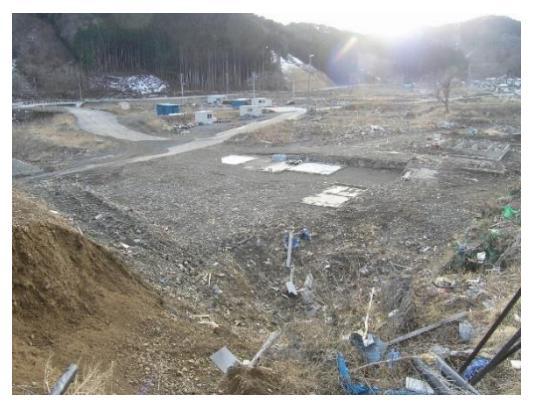
Fig. 8. Destroyed community behind seawall (Tohni-Hongo Township)

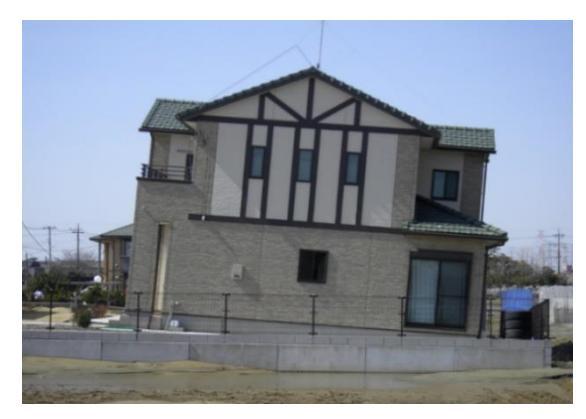
Figure 9 indicates a house that tilted due to subsoil liquefaction and extreme softening. Affected houses were located on recent reclaimed land and, generally, the responsibility for the poor quality of the land belongs to the owner of the land (owner of the house) or the architect as the representative of the owner. In other words, the legal liability is not with the contractor or developer. Due to this, the owners who were hardly experts of construction business and soil mechanics claimed the product liability of developers and contractors to whom, nowadays, more liability is assumed. It is still difficult, however, to assume 100% liability to them because the man-made island can be affected by the behavior of the underlying natural ground whose deficit is not necessarily the responsibility of the developers/contractors. Another possible problem in this regard is that ground improvement would have raised the land price upon purchase. The dilemma between safety and price of residential land is yet to be overcome.

Fig. 9. Tilting of house situated on liquefied subsoil in Kashima City

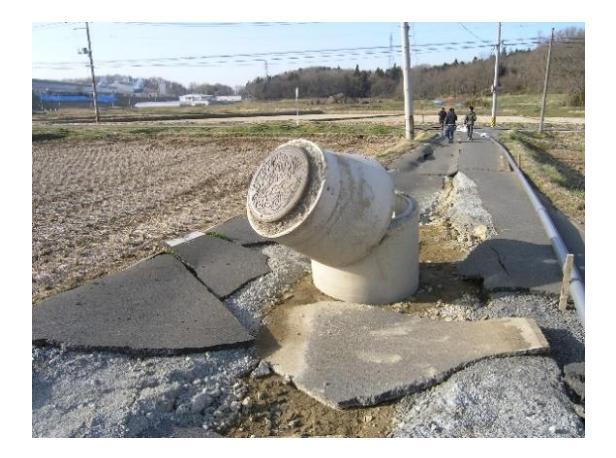
Fig. 11. Backfill liquefaction effects on embedded pipeline; note that no liquefaction happened in the farm land (Naganuma City in Fukushima)

Fig. 10 is a typical damage of embedded lifeline that was affected by liquefaction. Noteworthy is that liquefaction damage of lifeline is possible to occur not only in such liquefaction-prone ground as man-made islands but also in terrace geomorphology which hardly liquefies. Therein, the problem is the quality of backfill soil where compaction is desired but difficult in practice. See liquefaction in backfill in Fig. 11.

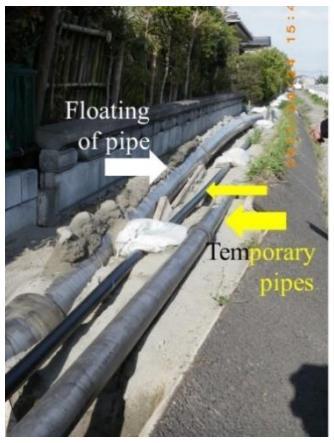
Fig. 10. Floating damage of water pipeline in Itako City

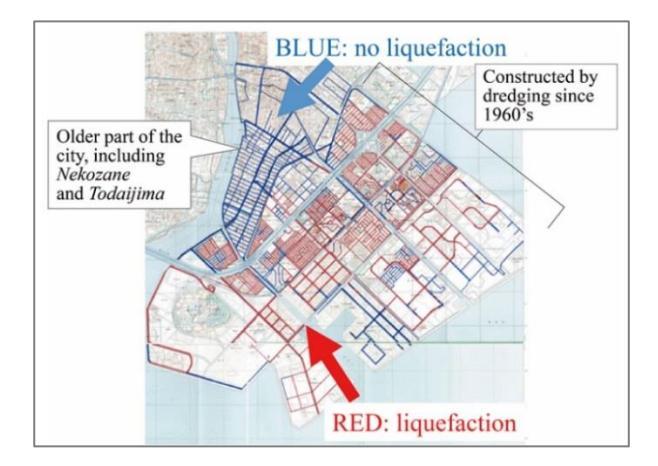
Fig. 12. Effects of soil age on liquefaction susceptibility of subsoil; example in Urayasu City

One of the important novel findings after the liquefaction reconnaissance was that the age of sandy soil significantly affected the proneness to liquefaction. Fig. 12 illustrates the distribution of liquefaction in Urayasu City. This city started its history as a small fishermen's village that was situated on a small sandbar (peninsula) at a river mouth. Shown by blue color in Fig. 12, this part of the city already existed in the 13th Century, according to local legends, and the subsoil here is probably as old as 1000 years or more. No liquefaction damage is known in this part of the city. In contrast, the remaining parts of the city are resting on very young man-made islands that were constructed after late 1960s. Significant liquefaction happened there unless soil improvement had been locally practiced; see red part in Fig. 12.

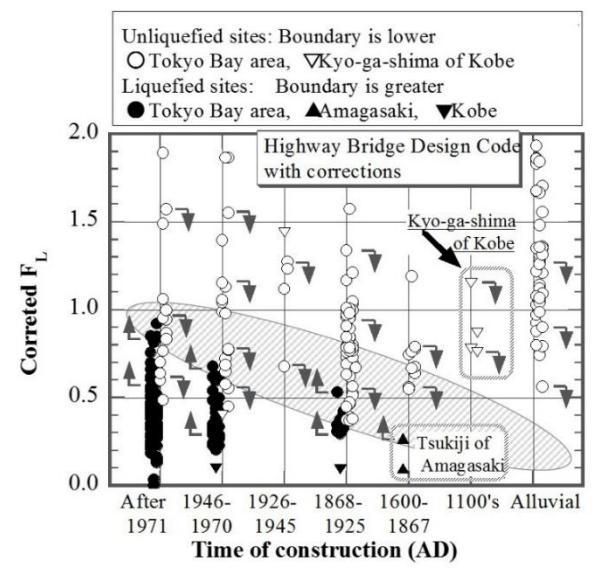
Fig. 13. Variation of assessed factor of safety with age of soil

Seeing such age effect at many places, the author and his group worked on many case histories during the earthquake in 2011. The factor of safety against liquefaction was calculated at many places by using available bore hole data and nearby seismic records. It was found that the border of the factor of safety between liquefied and unliquefied sites, which is equal to 1.0 in principle, decreases with increasing soil age (Fig. 13), suggesting that aged soil has additional liquefaction resistance that is not accounted for in existing design codes. As a consequence, aged soil was less prone to liquefaction in spite of the factor of safety less than unity. Fig. 14 illustrates the increase in liquefaction resistance with soil age. While data from many other literatures are plotted together, the authors' output is illustrated by shaded rectangles and practice can increase the liquefaction resistance by 40% if age is 400 years or more (for details, refer to Towhata et al., 2016b).

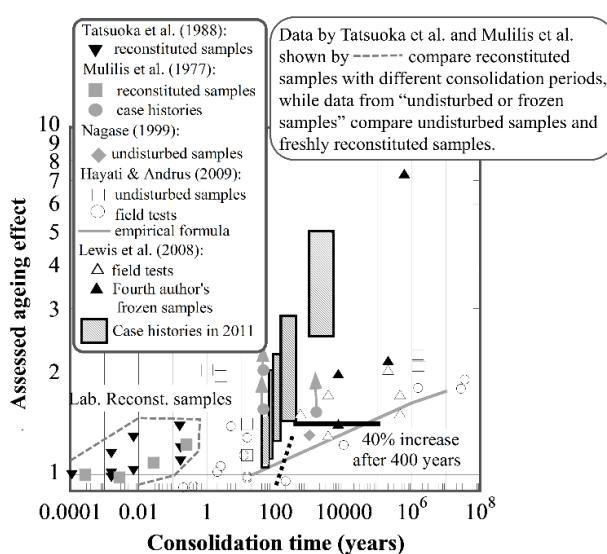
Fig. 14. Effect of soil age on increase in liquefaction resistance of sand; note that the quantitative trend in this figure is valid to Japan only (Towhata, 2018)

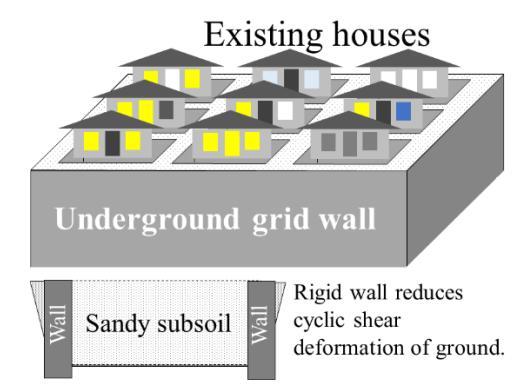
Fig. 15. Mitigation of liquefaction risk by installed underground walls of grid shape in narrow space among houses

Accordingly, there were only two possible methods of ground improvement; lowering of ground water level (Suwa et al., 2014; Yasuda, 2016) and construction of underground walls of grid shape (Suzuki et al., 1995). The latter method reduces the cyclic deformation of subsoil during earthquake shaking and thus reduces the possibility of liquefaction; see Fig. 15. Obviously, the first option is substantially less costly than the second one. About ten municipalities started to achieve unanimous agreement of residents in target areas. Some of them failed because residents did not wish to spend their money on future safety. Several municipalities achieved agreement and chose ground water lowering that was less expensive and did not even need personal expenditures (Fig. 16). Urayasu City unfortunately could not take this option because the city rests on 40-meter thick soft alluvial clay that caused significant consolidation problem from 1970s to 1990s and even nowadays. It was feared that additional consolidation settlement might be triggered by drainage and ground water lowering. Challenge had to be avoided in the framework of the people's project. Therefore, to carry out the second option of underground wall (soil-cement mixing) in a very narrow space between houses (Fig. 17), a small and light-weighted jet-grouting machine was developed (Fig. 18).

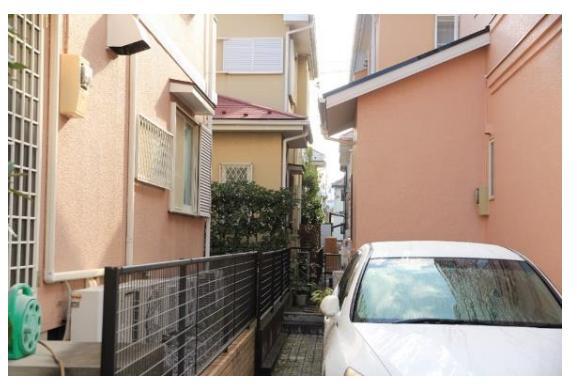
Fig. 17. Narrow space between houses in Urayasu City

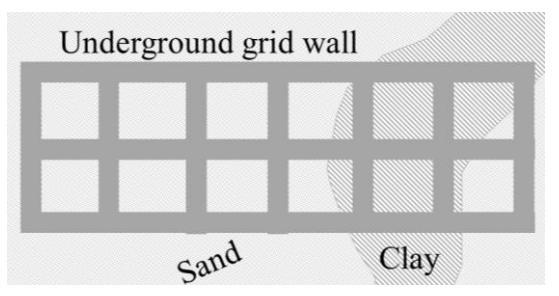
Fig. 19. Conceptual plan of installed grid wall in residential block

Figure 19 shows the idea of grid wall in a residential area. It was thought important that all the families in a target block of town unanimously agree on the project so that a complete set of grid wall might be installed. If any one family declines, the grid will be incomplete and its integrity during strong ground shaking will be of question. Noteworthy is that completeness of grid requires jet grouting even in clayey subsoil that may be encountered in a part of the target area.

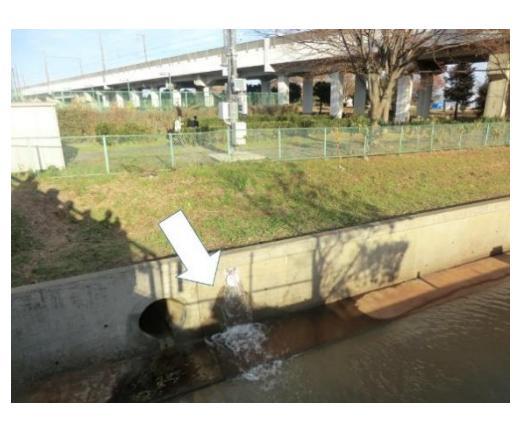
Fig. 16. Ongoing drainage and lowering of ground water level in Kuki City (photograph by Prof. Koseki)

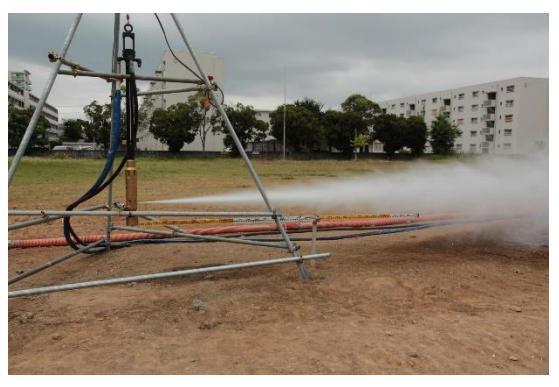
Fig. 18. Newly-developed small and lightweighted jet-grouting machine

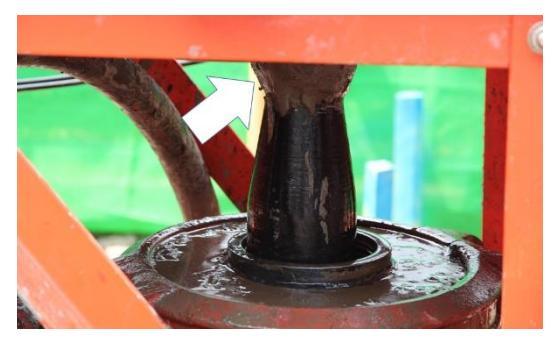
Fig. 20. Hindrance of jet grouting by unforeseen buried plastic drain

- Clay deposit did not allow uniform jet grouting; grout flowed away only through favorable channels or came out of the ground surface directly,
- Unforeseen plastic drains, that had been installed during land construction in 1970s or earlier in order to promote consolidation, twined around the grouting device and stopped the operation (Fig. 20).

- Higher jet pressure is applied to remove clay and drain from the device,
- Jet grouting is repeated two times to further ensure the successful work,
- The device is carefully inspected during jet grouting in order to detect possible twining of plastic drain,
- If drain twines, it is removed from the device and jet grouting is executed once more.

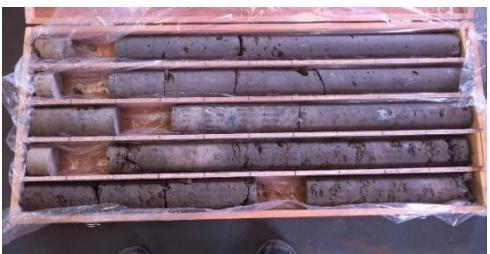
The improved procedure was adopted and drilled cores collected from the site were inspected to demonstrate 100% satisfaction (Fig. 21). Only one problem was the elongated construction period. Residents did not like it and voting showed that only one community with 33 families still agreed unanimously on the project. Thus, the ground improvement was finally executed in a very small scale in spite of the original idea (Fig. 22).

Fig. 21. Collected specimen of solidified clayey soil after modified working procedure

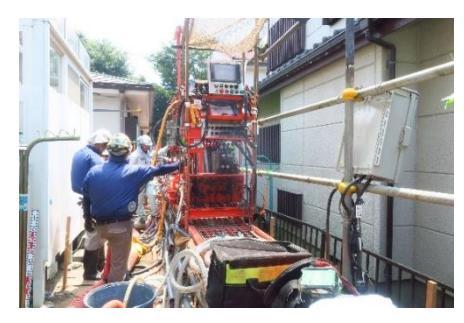
Fig. 22. Ongoing ground improvement by small jet grouting device in a very narrow space among houses

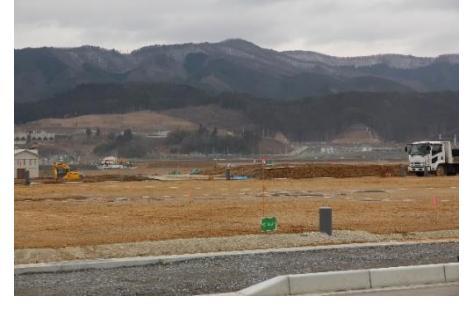
Fig. 24. Vast size of elevated ground in Rikuzen-Takata City

This chapter takes example of Rikuzen-Takata City in Iwate Prefecture that was inundated by tsunami up to the elevation of 10 to 17 meters. Considering this extent of inundation, the reconstruction project decided to construct a new sea wall of 12.5-meter height associated with elevating the ground surface level to 7-12 meters by earth filling as well. The volume of filled soil and the area of thus elevated ground are 114.2 million cubic meters and 3.03 square km, respectively (Figs. 23 and 24). One fear is that nine years have passed after the disaster and some people have moved out of the city, while others have got new houses at the top of hills (Fig. 25). Those people may not come to live in the newly elevated land. Because the population has decreased, it is not clear whether or not the newly elevated

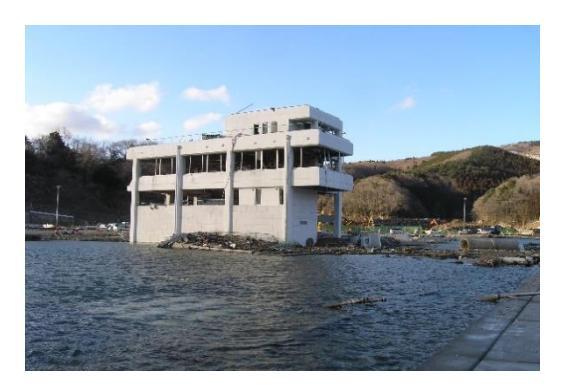
city will be fully occupied by residents in near future. Last and not least, it should be borne in mind that the ground level is likely to settle down by more than 1 meter during the fault rupturing (Fig. 26). Hence, the tsunami, which comes later, becomes higher than the expectation by this amount relative to the sunken ground.

Fig. 26. Tectonic subsidence in Onagawa Harbor near Sendai where ground level is lower than the previous level by more than one meter
